**LOW HAZARD IN-CHANNEL DAM VISUAL INSPECTION REPORT**  
(Primarily non-embankment structures)

DAM NAME: East Fork White River Dam DATE: 2/3/2012 ID# 3-13

# LOW HAZARD IN-CHANNEL DAM VISUAL INSPECTION REPORT

# East Fork White River (In-Channel) Dam

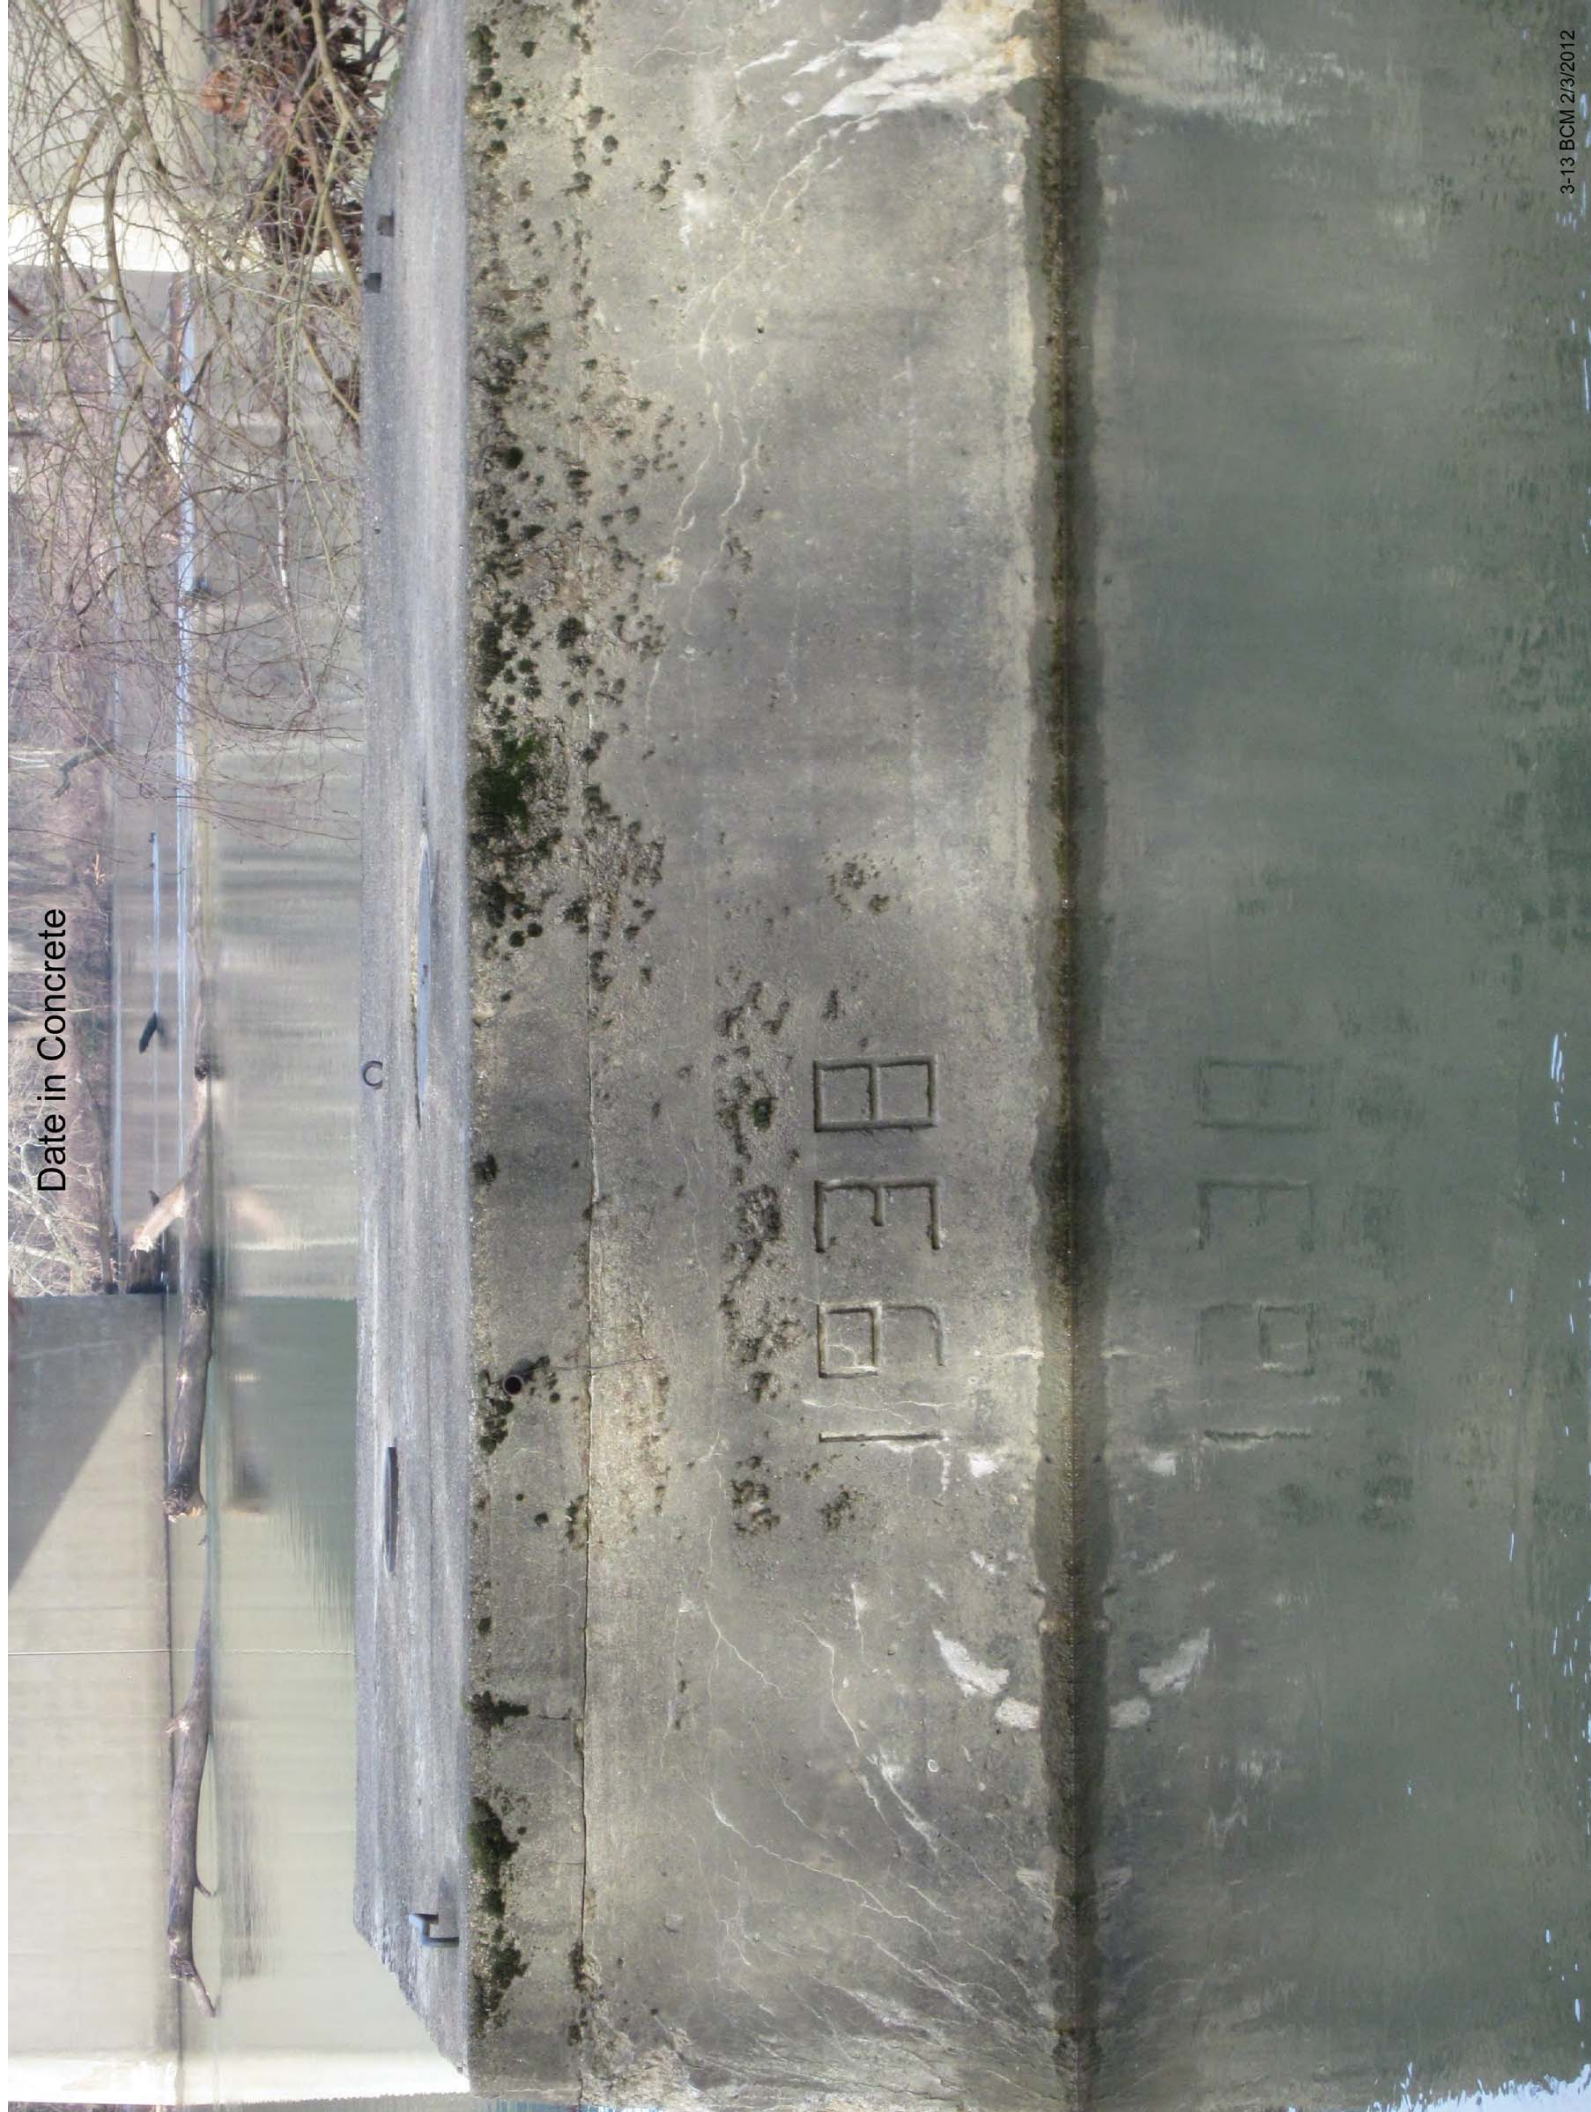
Date in Concrete

There is a concrete structure at the left end with this year etched in it.

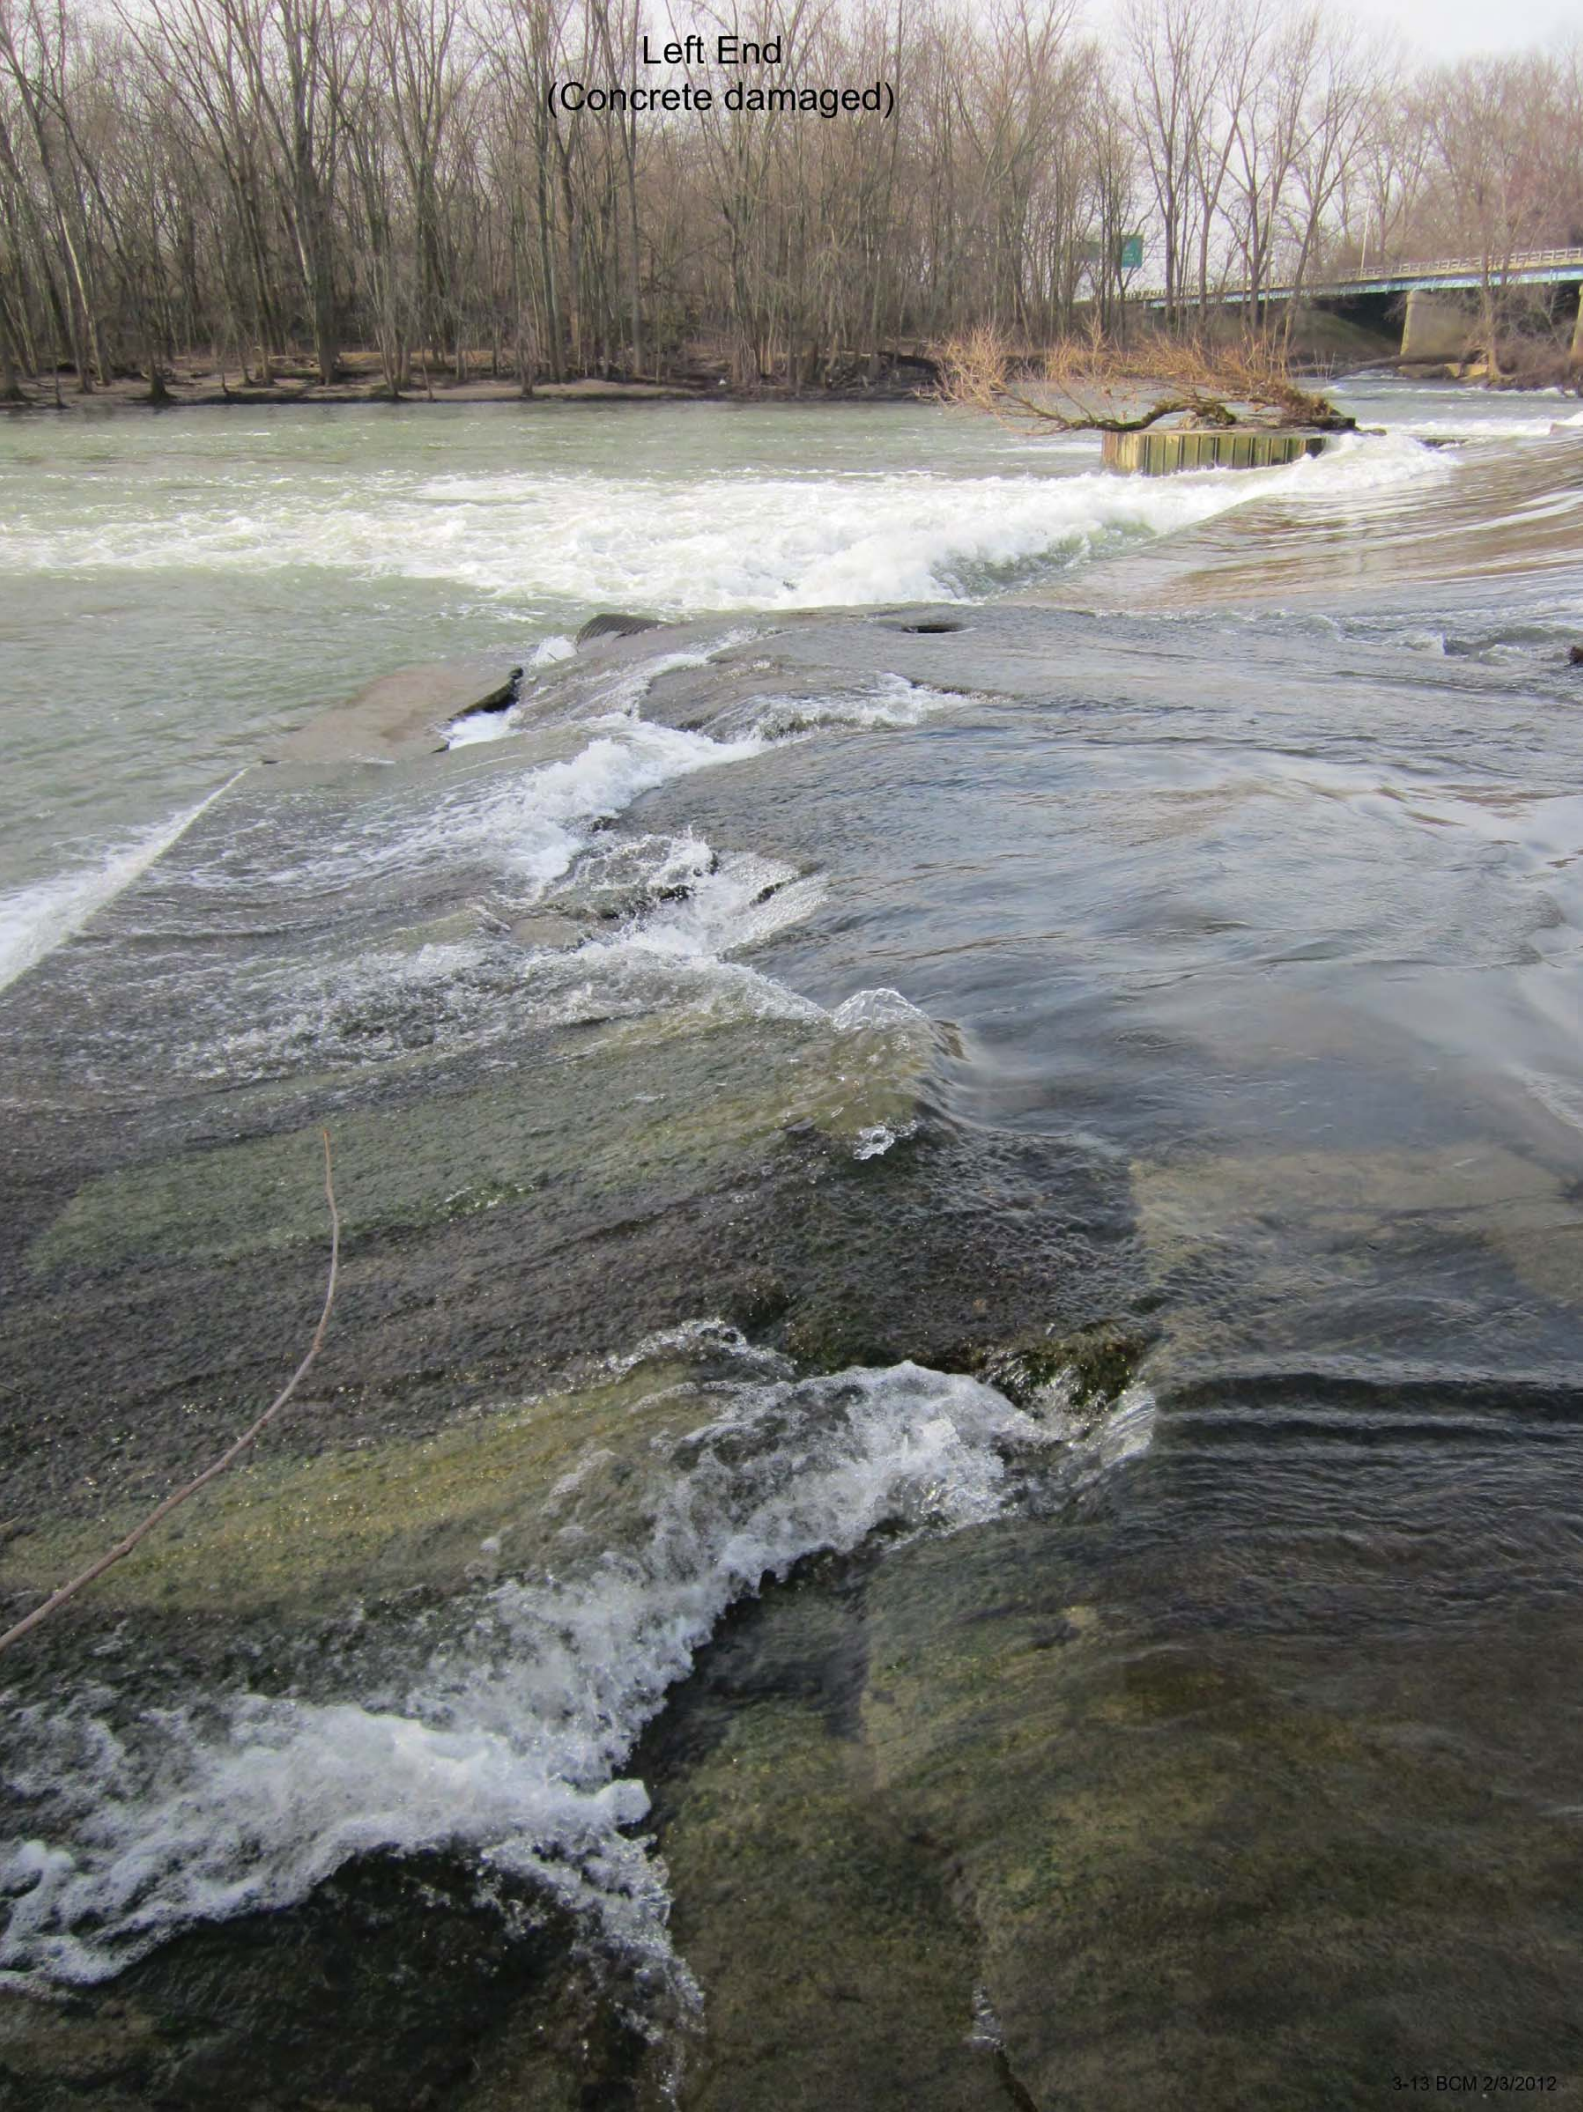
Left End  
(Concrete damaged)

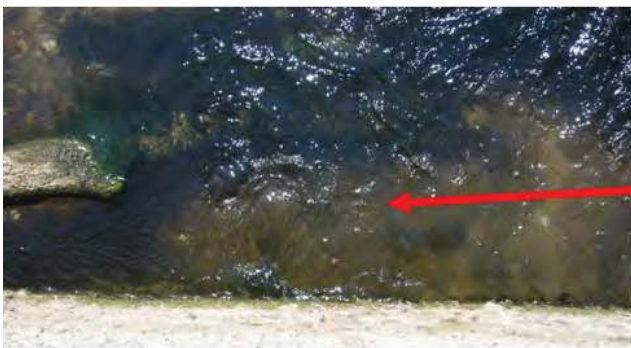
CONDITION OF OVERFLOW SECTION POOR CONDITION - 3 AREAS ALONG DAM  
SEEPAGE OBSERVED GOING THROUGH CRACKS OR BOILING UP  
BENEATH DAM. (BASKETBALL SIZE)

Area of 5  
basketball sized  
boils. Boils start  
about 55' left  
(east) of bridge  
pier & continue  
an additional 17'.
