Assessing the Effects of the Removal of a Low Head Dam on a Portion of the East Fork White River at Columbus, Indiana

Prepared for the City of Columbus, and the Columbus Redevelopment Commission, December 2017

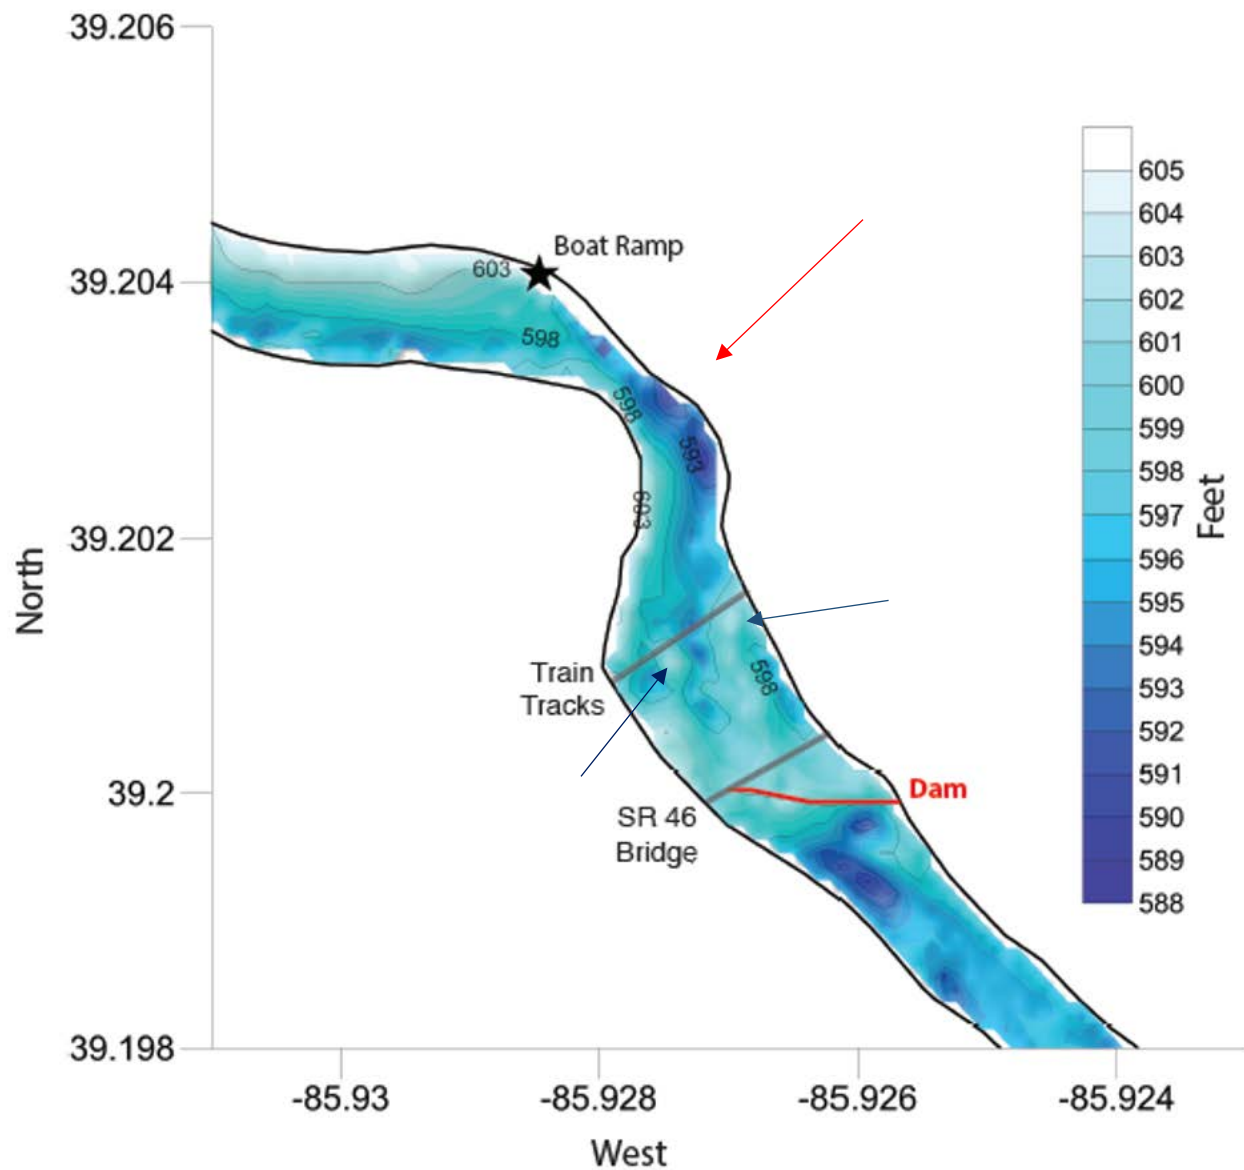
Figure 4: Bathymetric Map of portion of the Study Area, East Fork White River at Columbus, IN. This detail from the larger bathymetric map shows more clearly the sediment transport through the project area. Note the deep pools moving from the right bank to the left bank. The transverse flow from left bank pool above the railroad bridge (red arrow) is interrupted at the bridge and focused into the center of the channel, this is in part due to the remains of a rubble access road (see blue arrows) placed in front of the railroad bridge. The rubble road is acting as a barrier to flow and sediment transport.

A strong caution is given to consider the effect of the rubble in front of the railroad bridge on sediment transport. Field observations suggest that the rubble structure is acting as a grade control and altering sediment transport. The only deep portion of the channel is found in a break in the rubble (Figure 4).

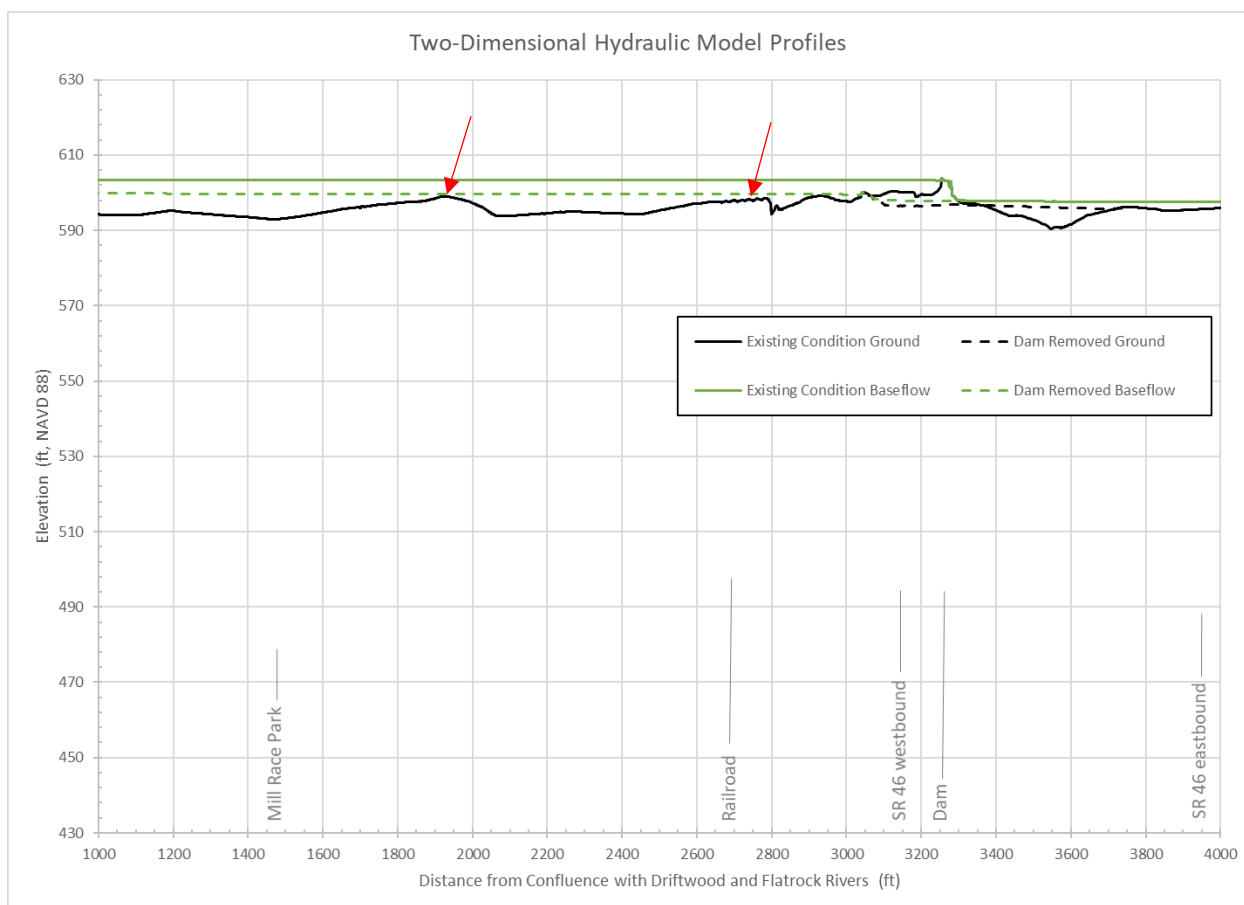
The bathymetric data can also be used to evaluate sediment storage behind the dam, by creating a longitudinal profile of the study area. Figure 5 shows a longitudinal profile for the study area. Note that there are two distinct wedges of sediment upstream from the dam. The first occurs near the confluence of the Flatrock and Driftwood Rivers at Mill Race Park and the second occurs at the railroad bridge. The upstream wedge is sediment in transport, as the sediment flows in from upstream it slows in response to the change in channel bed slope created by the dam, and very important to note – the rubble dam in front of the railroad bridge. Both of these sediment wedges show the classic dune form with the backslope tailing upstream, the crest, and then the slip face on the downstream end. The difference in the two wedges is significant. The wedge at the railroad bridge is truncated at the crest by the rubble dam, indicating that the rubble dam is acting as a grade control – just like the dam. It is also important to note that the sediment wedge behind the railroad rubble dam is similar in size to the sediment load behind the dam. The dashed line indicating channel bed surface with the dam removed also shows that as the dam is removed the rubble dam will become the new grade control, or “dam”. Figure 5 also shows that there is not a significant amount of sediment upstream of the dam, and a large portion of the upstream sediment in storage will go to filling in the plunge pool below the dam.

Figure 5: Channel-bed surface for existing conditions, and with the dam removed. East Fork White River at Columbus, Indiana. Red arrows indicated existing sediment wedges upstream of dam.

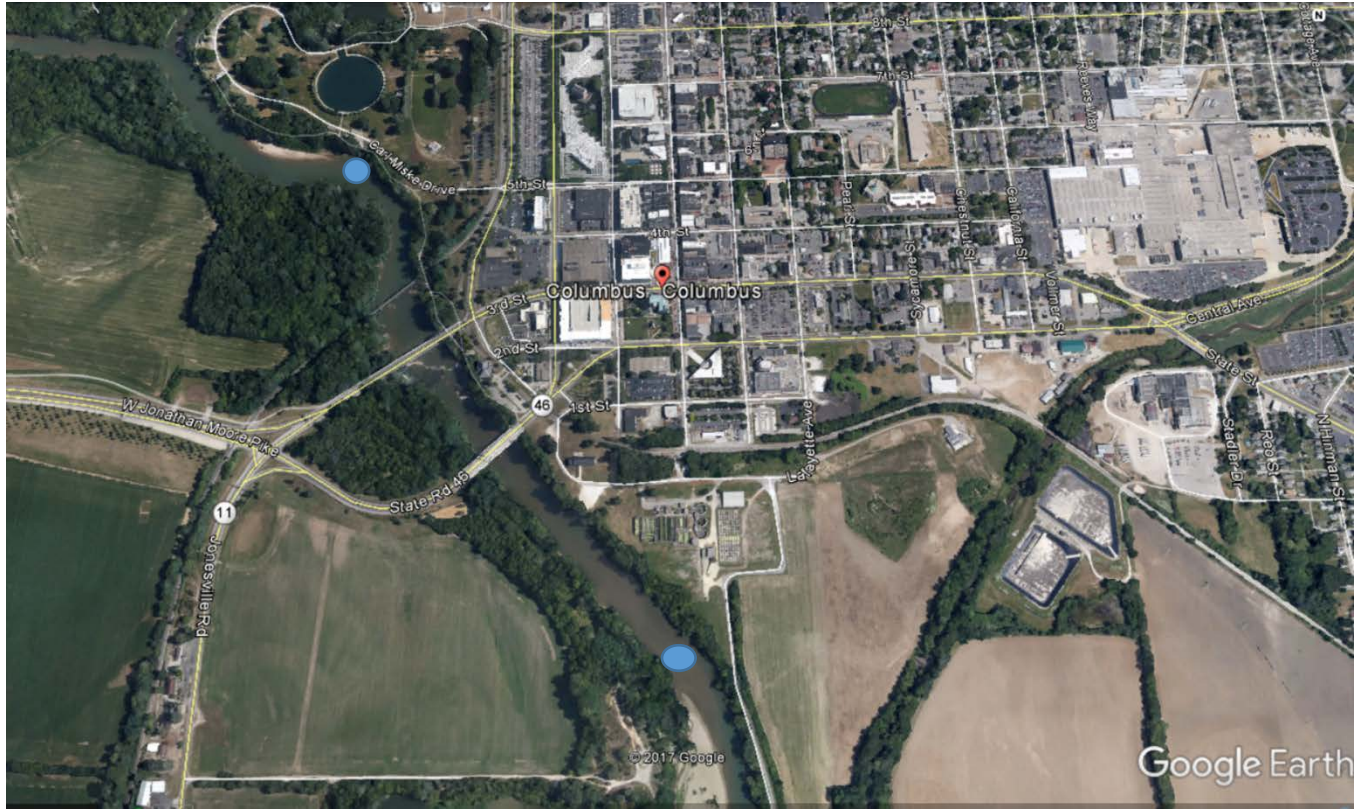
Figure 6: Sediment transport in the study area. Field observations and measurements indicate that the sediment wedge behind the dam extends upstream (1,830-ft) to the first pools located upstream (upper blue dot). The bed and water elevations are graded from the confluence downstream to the lower blue dot (2,500-ft), indicating that there is effective sediment transport above and below the dam, and the system should be expected to quickly grade to the existing reach slope of .001 (Figure 5).

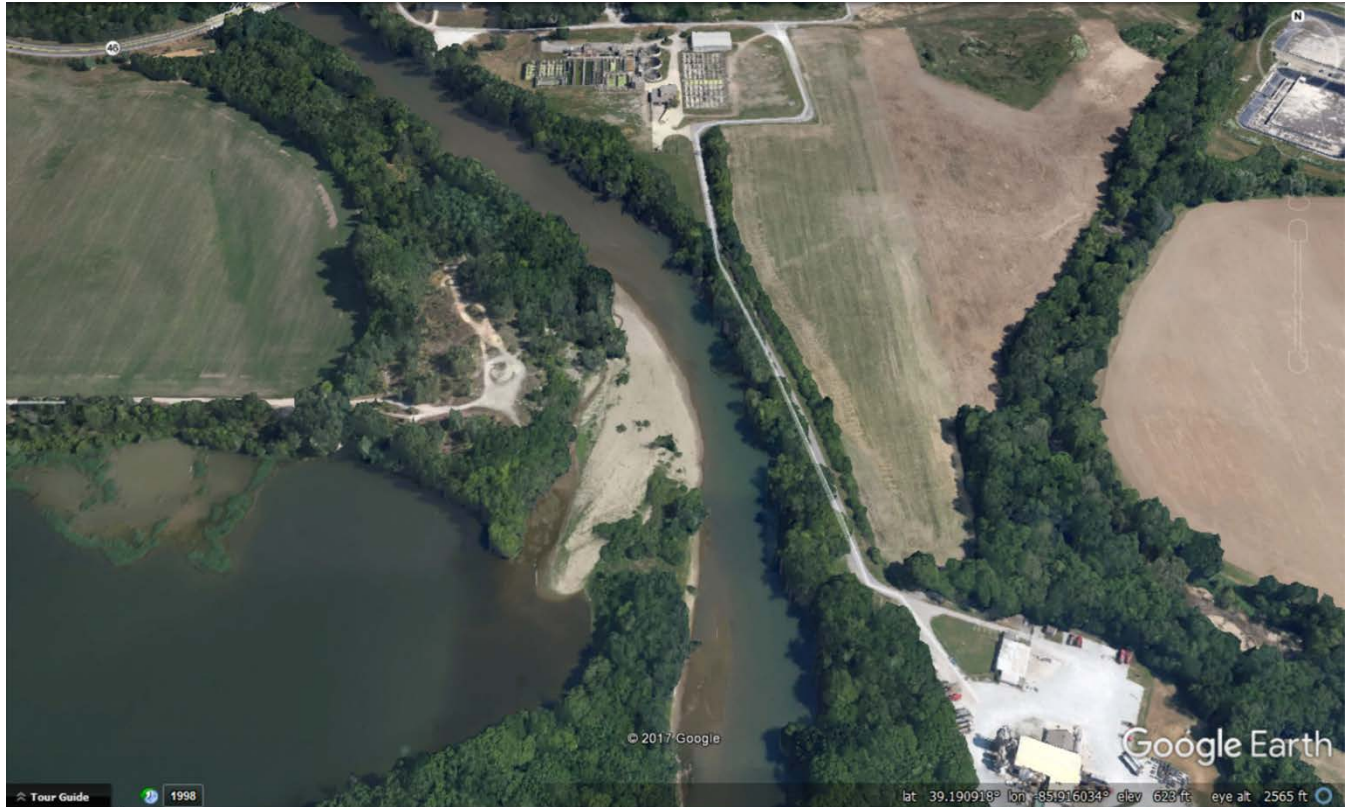
Figure 8: Point bar sampling location, note breach on right bank and sediment transport into the old sand and gravel pit. The scale can be confusing. The recently deposited bright sand has a surface area of 152,000 ft², and an average thickness of 5.0-ft. The volume of sand in this bar is approximately 28,148 cubic yards. See Figures 9 and 10 for scale.

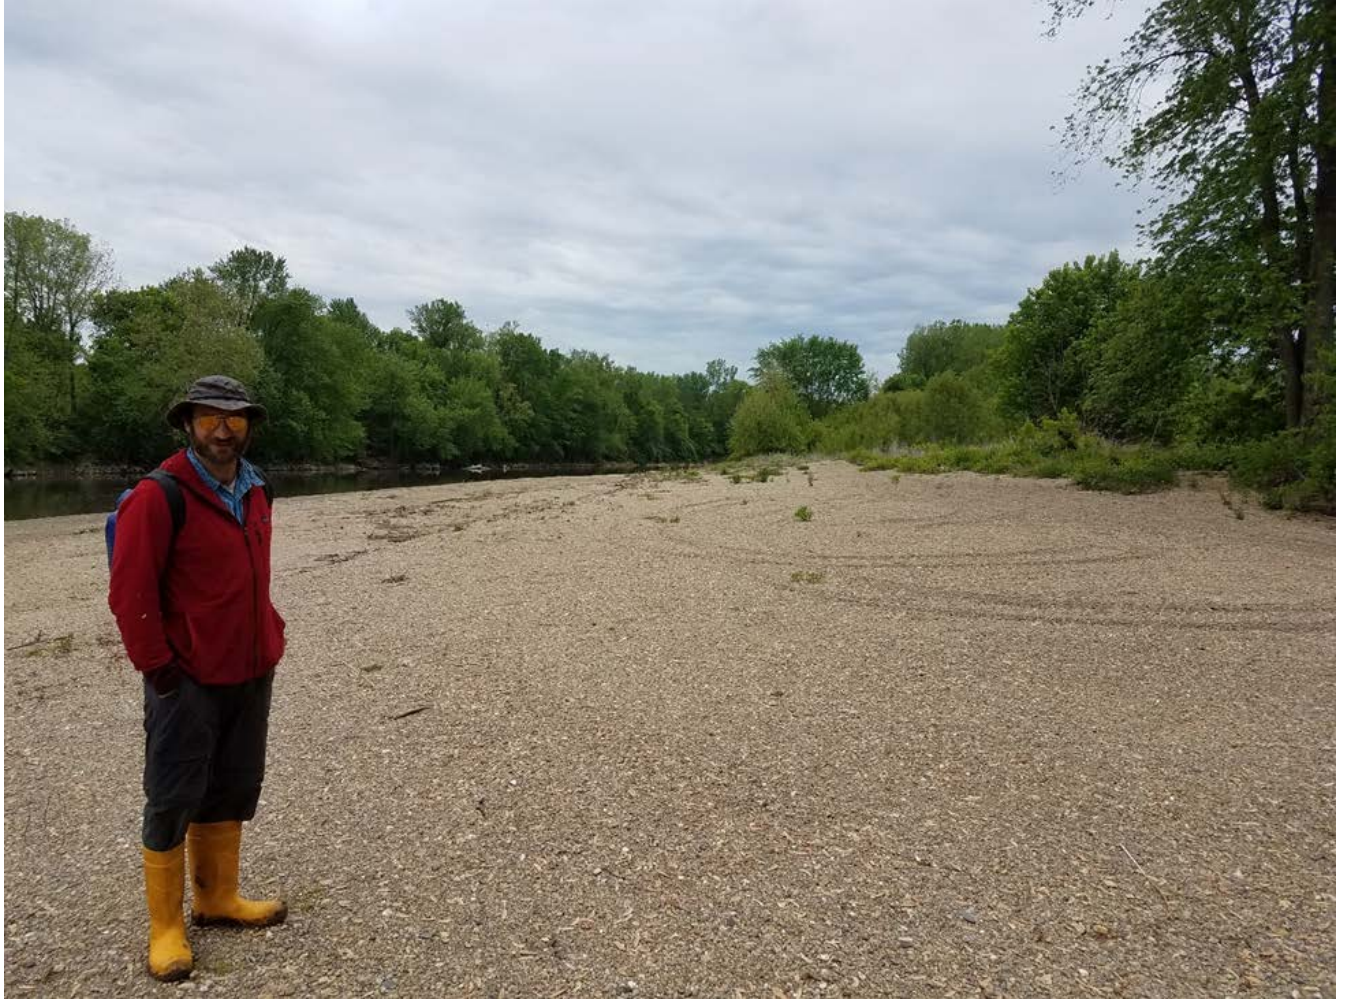
Figure 9: Downstream point bar. The long axis, parallel to the river, is 1230-ft, and the midline axis, perpendicular to the river is 200-ft. For comparison, the EFWR at Columbus has a predicted bankfull width of 228-ft.

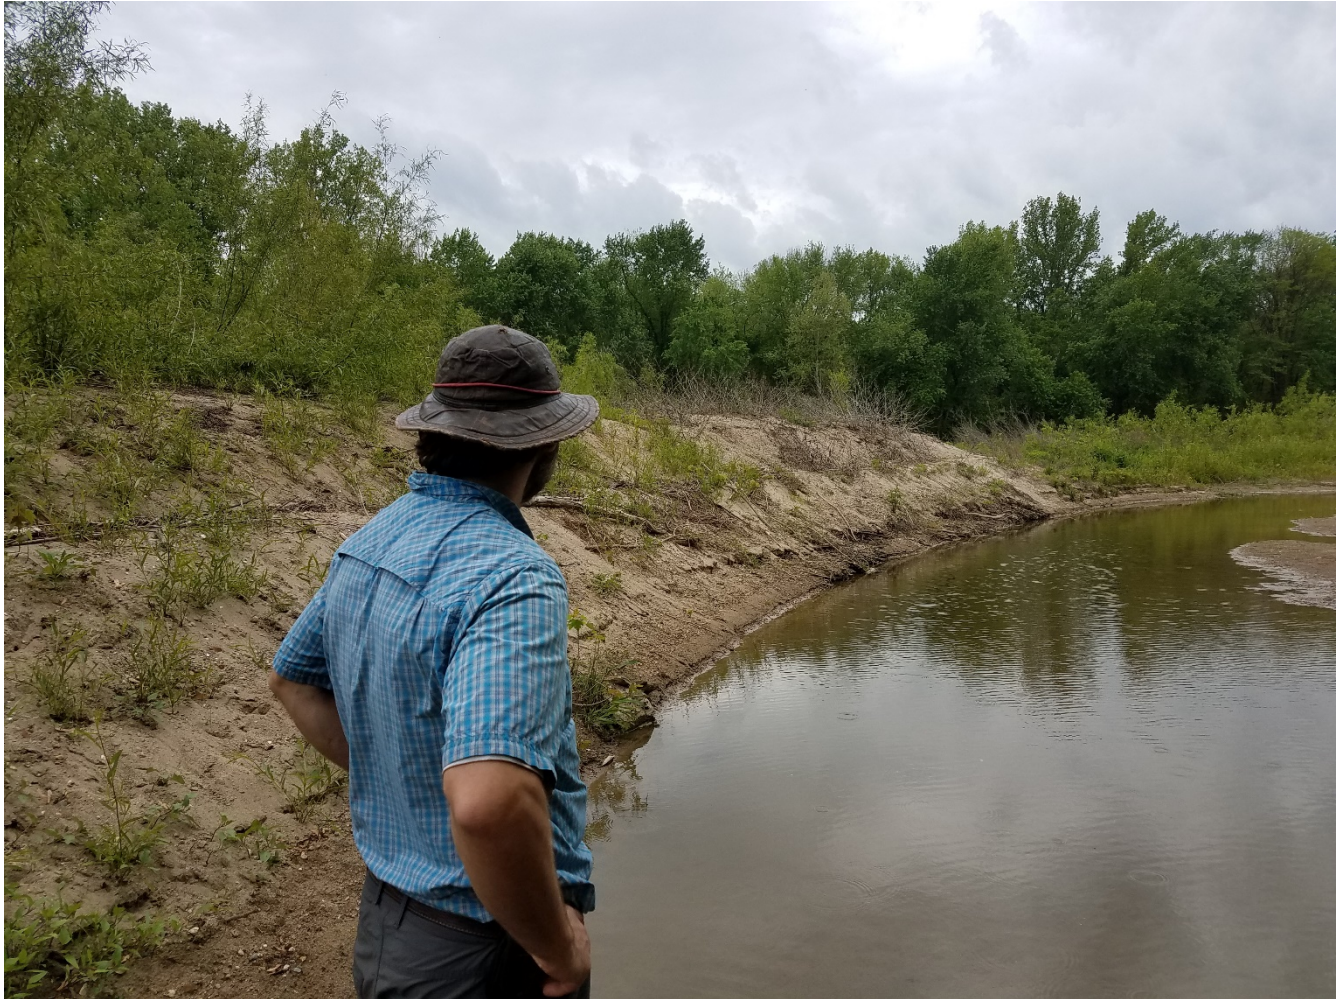
Figure 10: Sediment deposition into the gravel pit. Broxton Bird for scale. Note that in the interior lake side of the point bar, sediment height is > 6.0-ft, and there is little established vegetation. The deposition is recent.

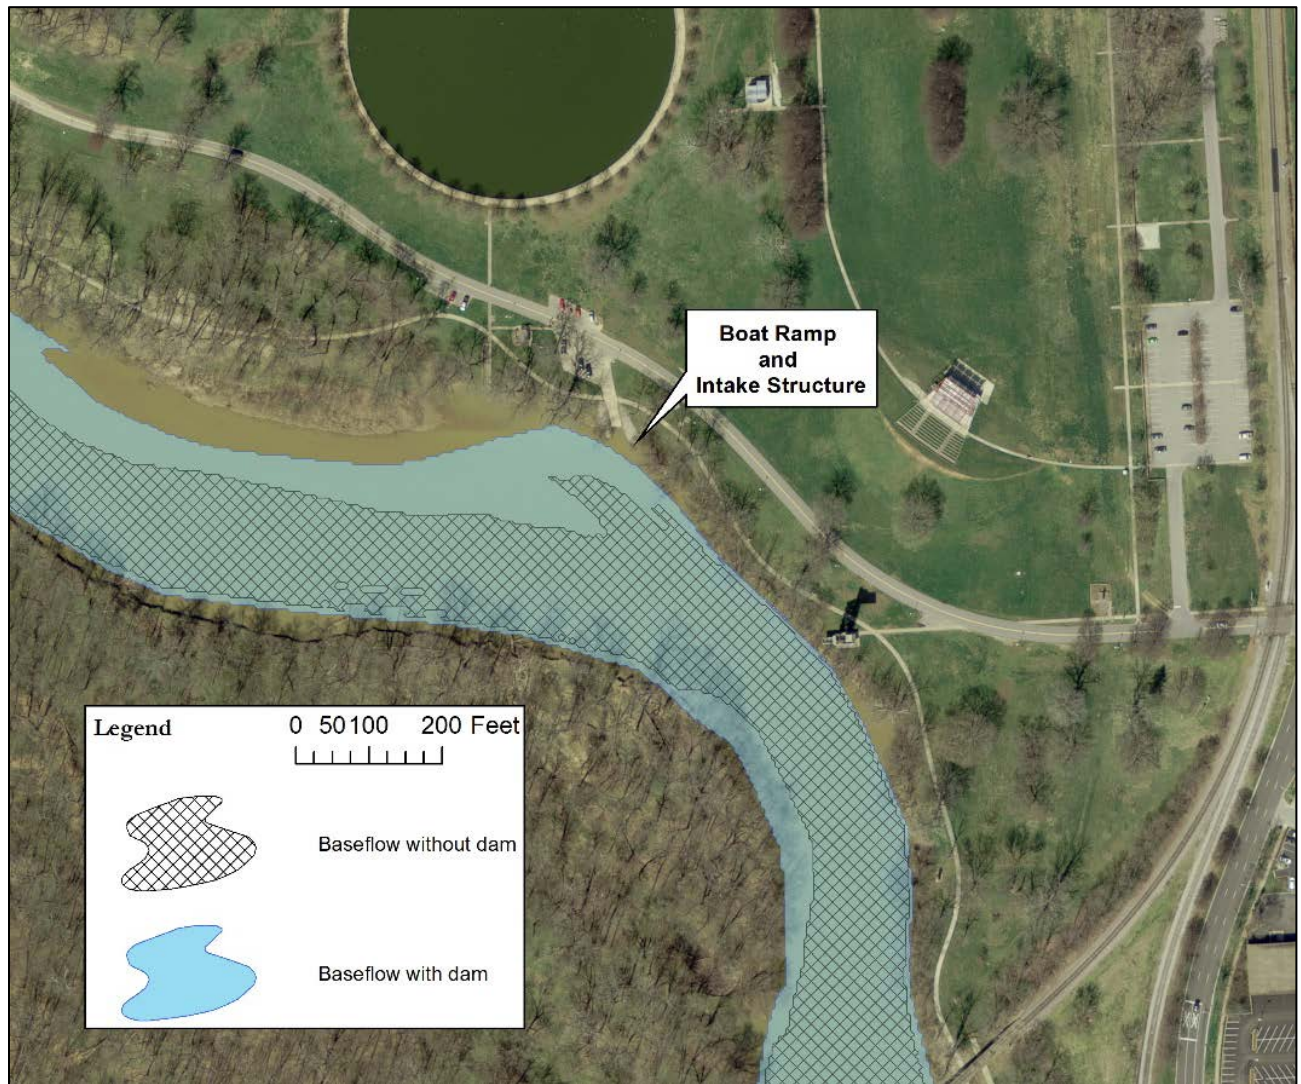
If the dam is removed and no grade control structures are constructed to maintain current water levels, modification of the intake structure near Mill Race Park is likely necessary due to the lowered water surface elevation. The water surface is approximately 50 feet narrower on the north bank, as shown in Figure 12.

Figure 12: Baseflow Water Surface Inundation Comparison

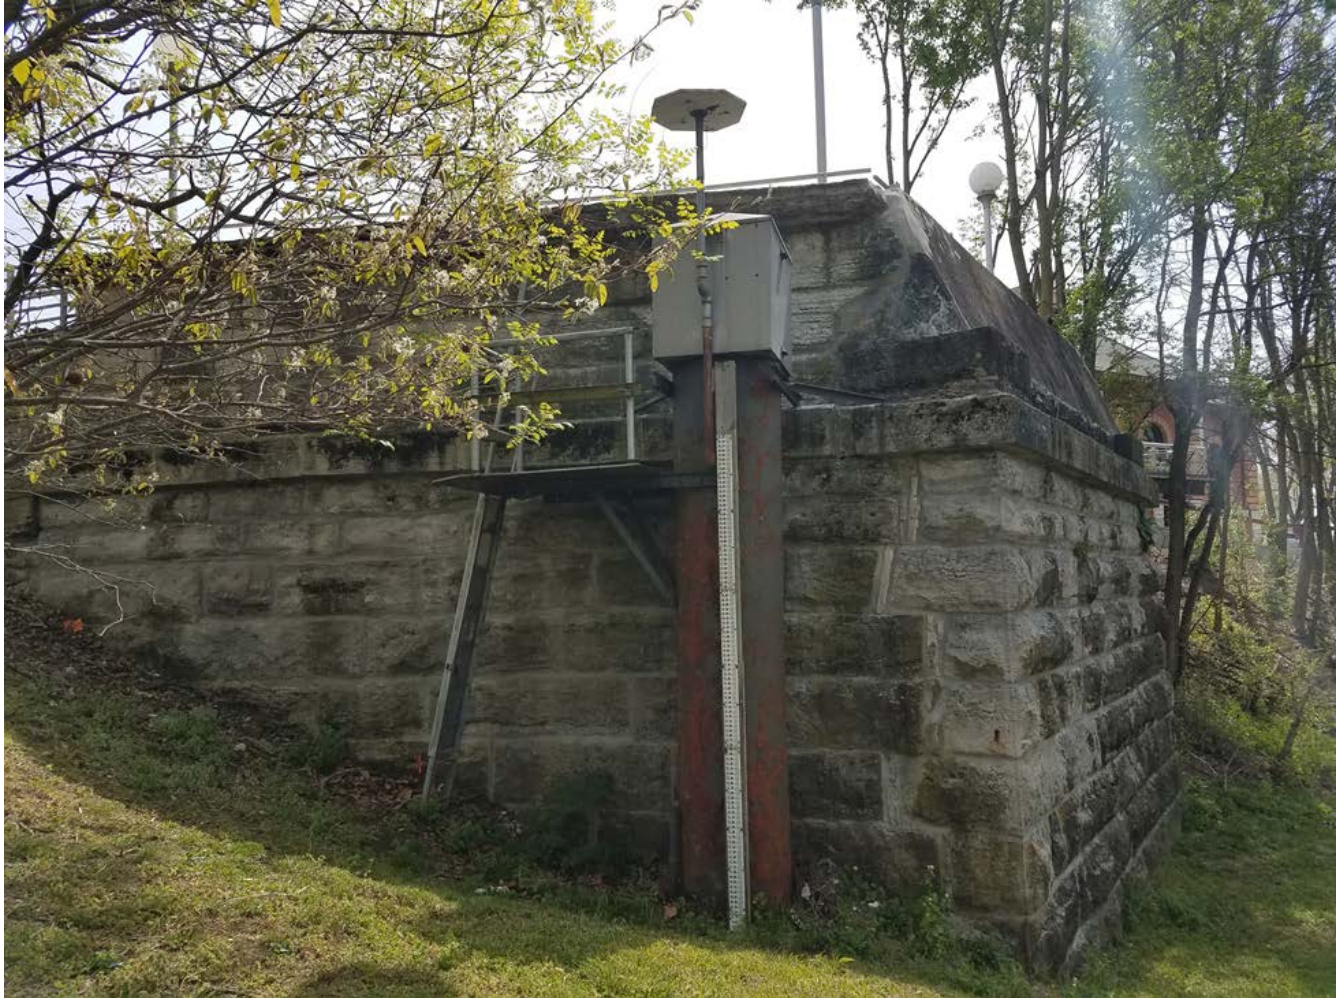
The left bank in the primary study area has been filled, raised, and armored, in the upstream portion of the project area (Figure 15). The difference in elevation is striking. There is a stable bankfull attachment to the floodplain on the right bank, and for a wide range of flows the right bank offers the only storage

Figure 15: Armored left bank in the project area. Note elevation of stage gage.

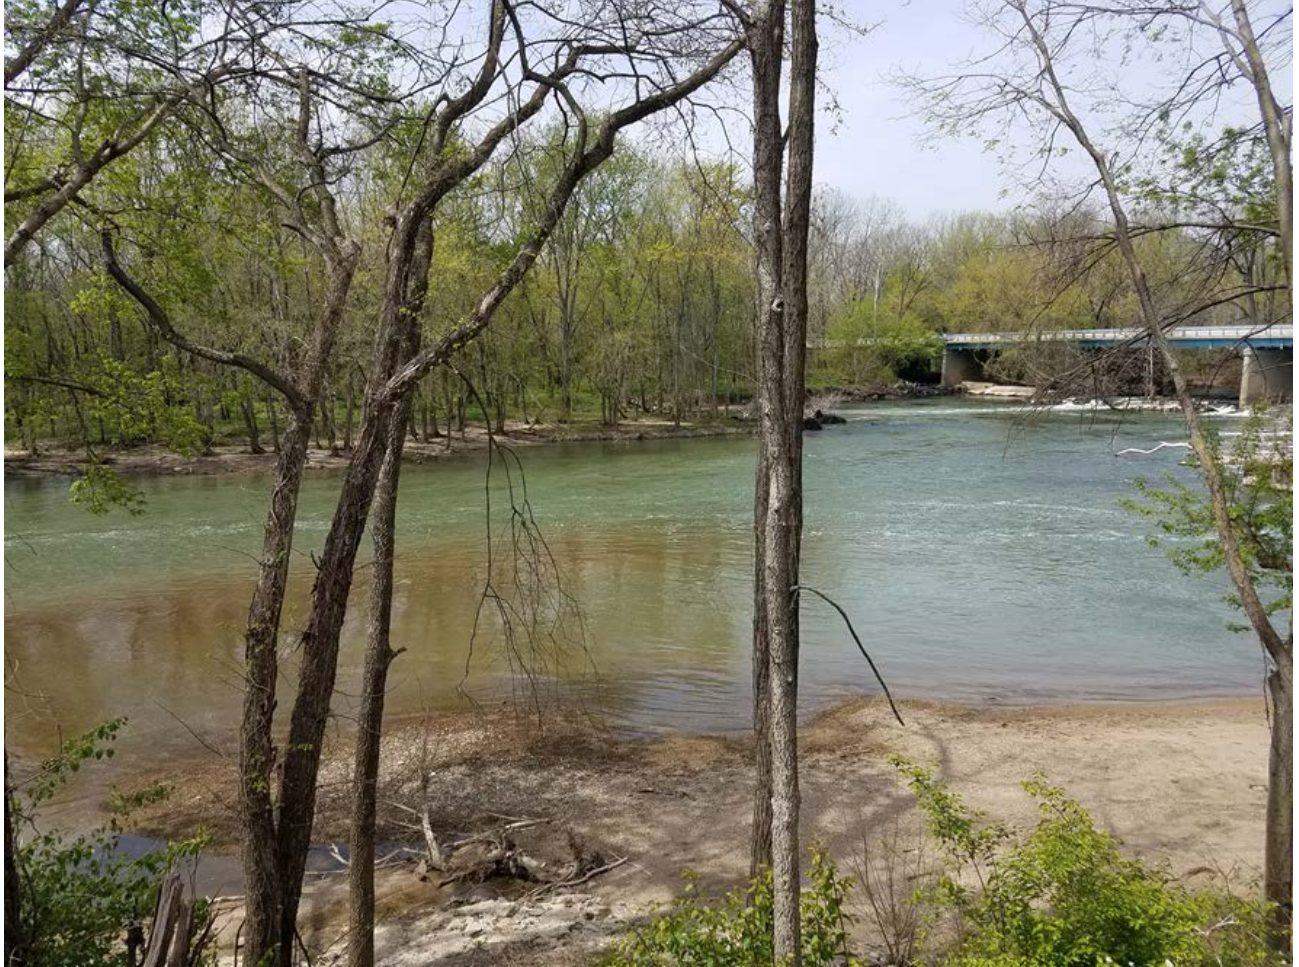
Figure 16: Looking to the west at the right bank in the project area. Note the stable and smooth transition to the very restricted bankfull floodplain, and the large sediment wedge directly downstream of the dam. Flow is being directed towards the right bank by the breakdown and lowering of several sections of the dam.

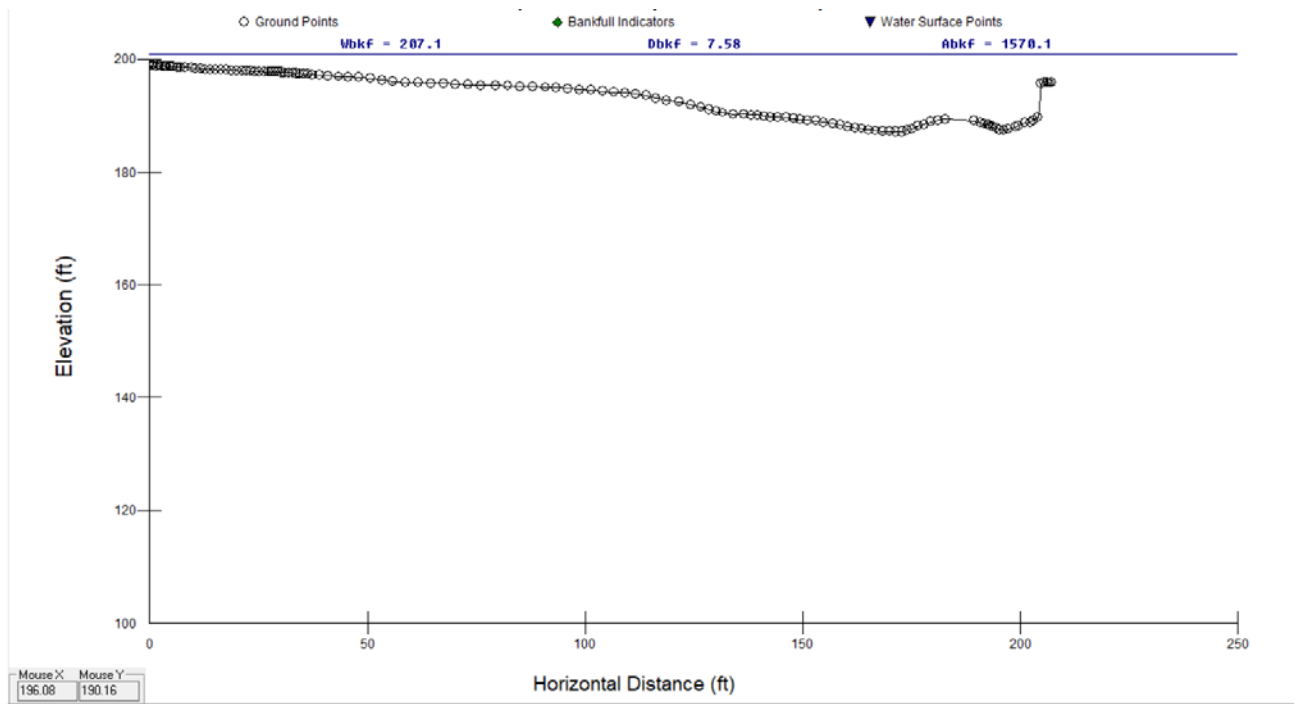
Figure 20: Cross-section EF 8, is located upstream of the boat ramp at Mill Race Park. Cross-section EF 8 is a textbook example of a low gradient alluvial stream cross-section, it shows the slope of the point bar on the left bank and the pool on the right bank (Rosgen, C4 stream type). A Rosgen C-type stream is described as a low gradient, meandering river, with point bar and riffle/pool morphology, and alluvial channels with broad well-defined floodplains. The “4” in the C4 designation indicates a gravel bed. The cross-section shown above is from the left bank point bar over to the pool along the right bank (see Figure 19). The Indiana regional curves predict that the bankfull width at this location would be 228-ft (measured is 207.1-ft), bankfull mean depth is predicted to be 7.42-ft (measured depth is 7.58-ft), and the predicted cross-sectional area is 1660-ft² (measured is 1570-ft²). Maximum bankfull pool depth is predicted to be 10.5-ft, and the measured maximum pool depth is 13.7-ft. Those channel dimensions indicate a stable channel near Mill Race Park. Stream banks in that section of the river are variable. The banks on the left side of the channel near cross-section EF 8 are much higher than the right bank, with the top of bank being over 9-ft above the water surface. Mean depth when this cross-section was measured was 4.8-ft. Mean bankfull depth is 7.58-ft at this site. Banks on the right side have a top of bank that is usually less than 3-ft above the water surface that is inundated at bankfull stage, but the left bank has exposed sand above the bankfull stage, making the left bank very unstable (Figure 22).

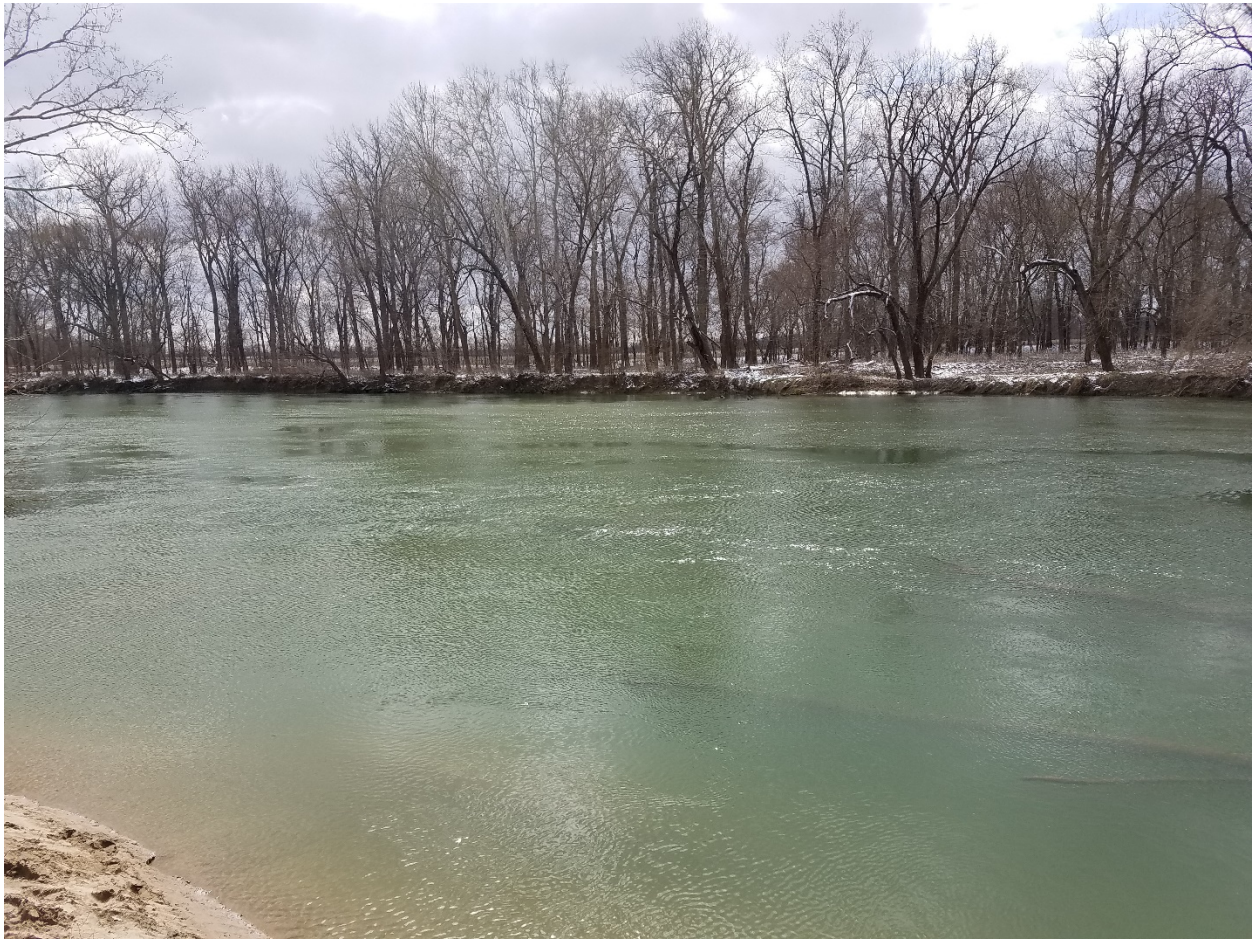
Figure 21: Stable right bank above project area near cross-section EF8. Soil on the right bank in this area is primarily Shoals silt loam (Figure 23). Typical for a floodplain, the soil is flat, with 0 to 2 percent slopes. The soils are frequently flooded for a brief duration. Note older stable trees along the channel, and the wide floodplain.

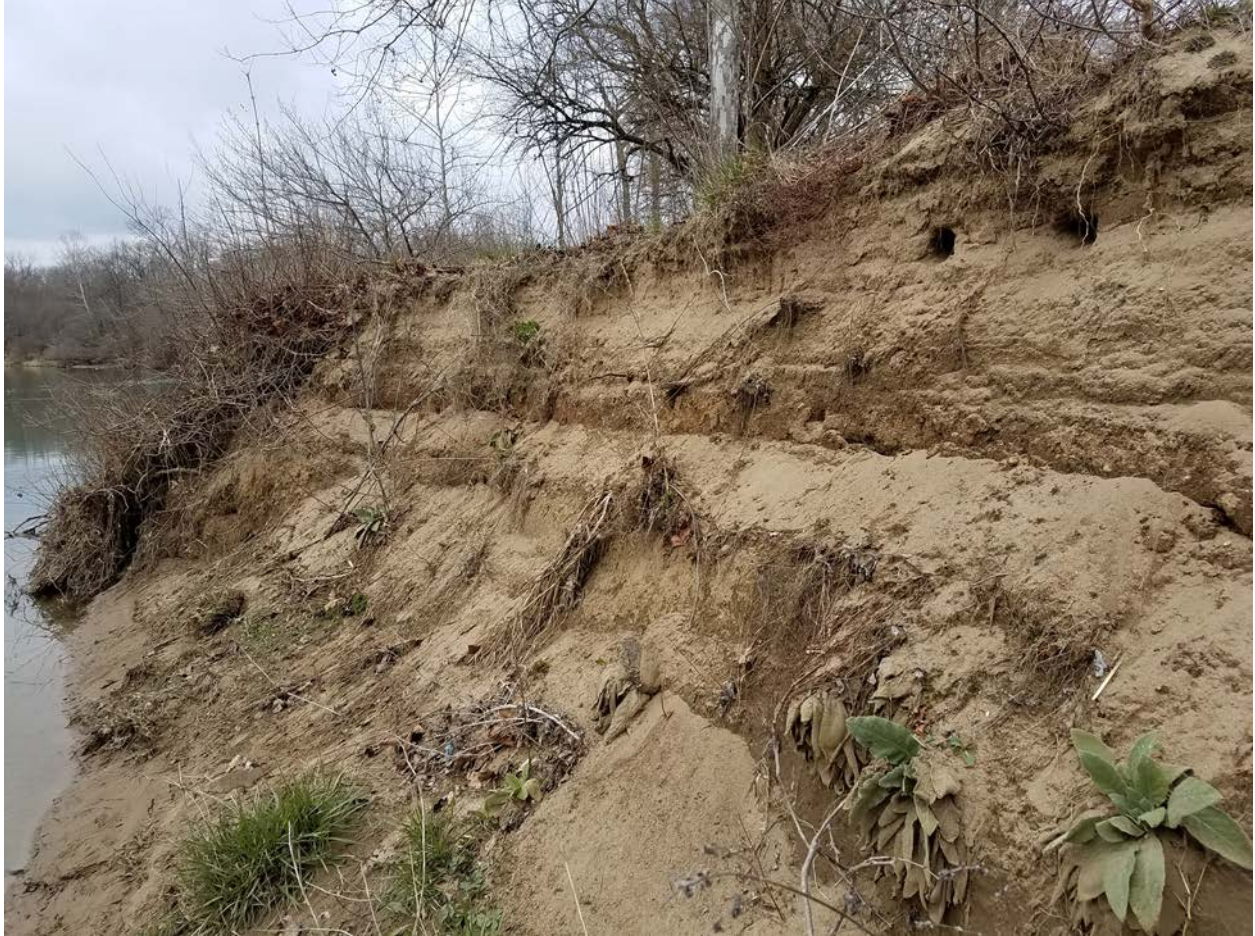
Figure 22: Stonelick soil (SuoAH) on the left bank upstream of the project area (Figure 23). Stonelick is a fine sandy loam, that is developed on floodplains with 0 to 2 percent slopes. Note that the slope angle refers to the surface soil on the floodplain, not the bank angle. Stonelick soils are typically frequently flooded for brief duration. Note the lack of vegetation on the bank.

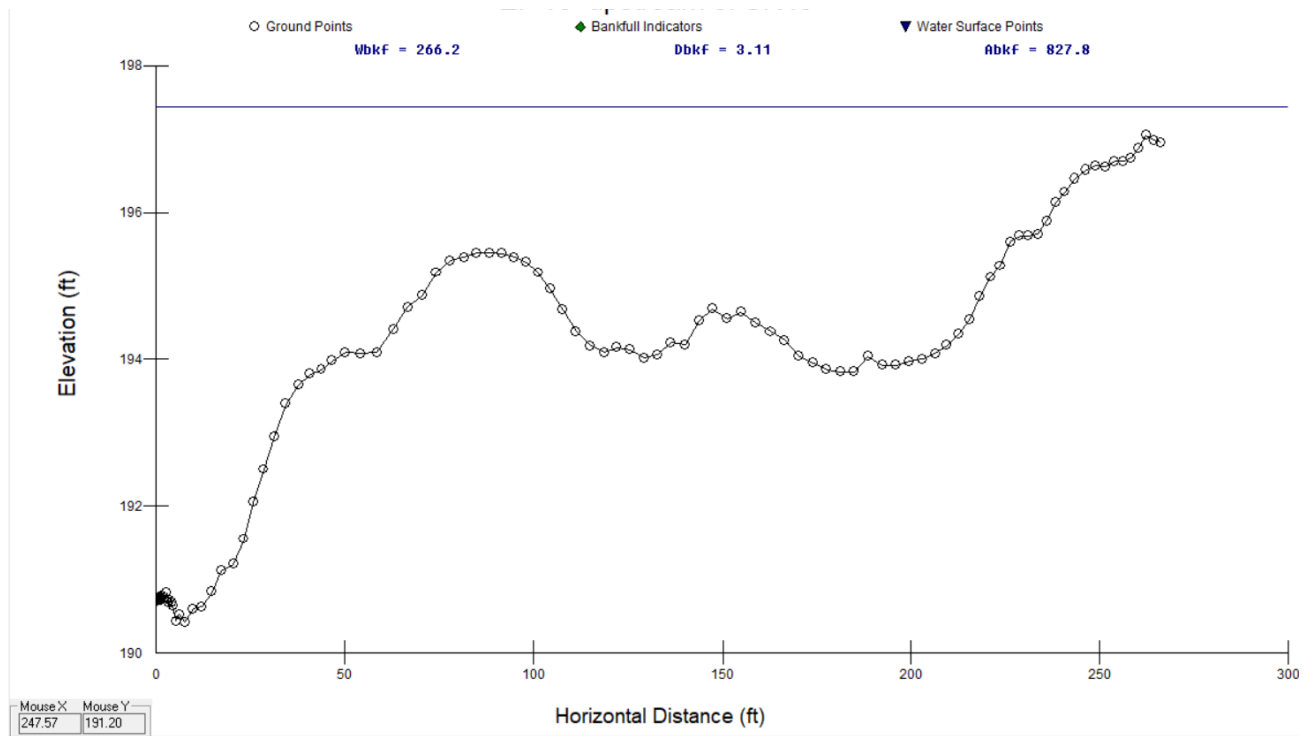
Figure 24: Cross-section EF 16, upstream of SR 46 and the railroad tracks. The thalweg (deepest portion of the channel), flows along the left bank in this section before transverse flow starts to shift flow across the channel towards the right bank. The railroad bridge interrupts the flow path and moves the flow into the center of the channel. Note the significant loss of cross-sectional area as sediment builds up behind the dam. The upstream cross-section had a bankfull cross-sectional area ($Abkf$) of 1578 ft², whereas this cross-section has a $Abkf$ of 827.8 ft², a reduction of 48%.

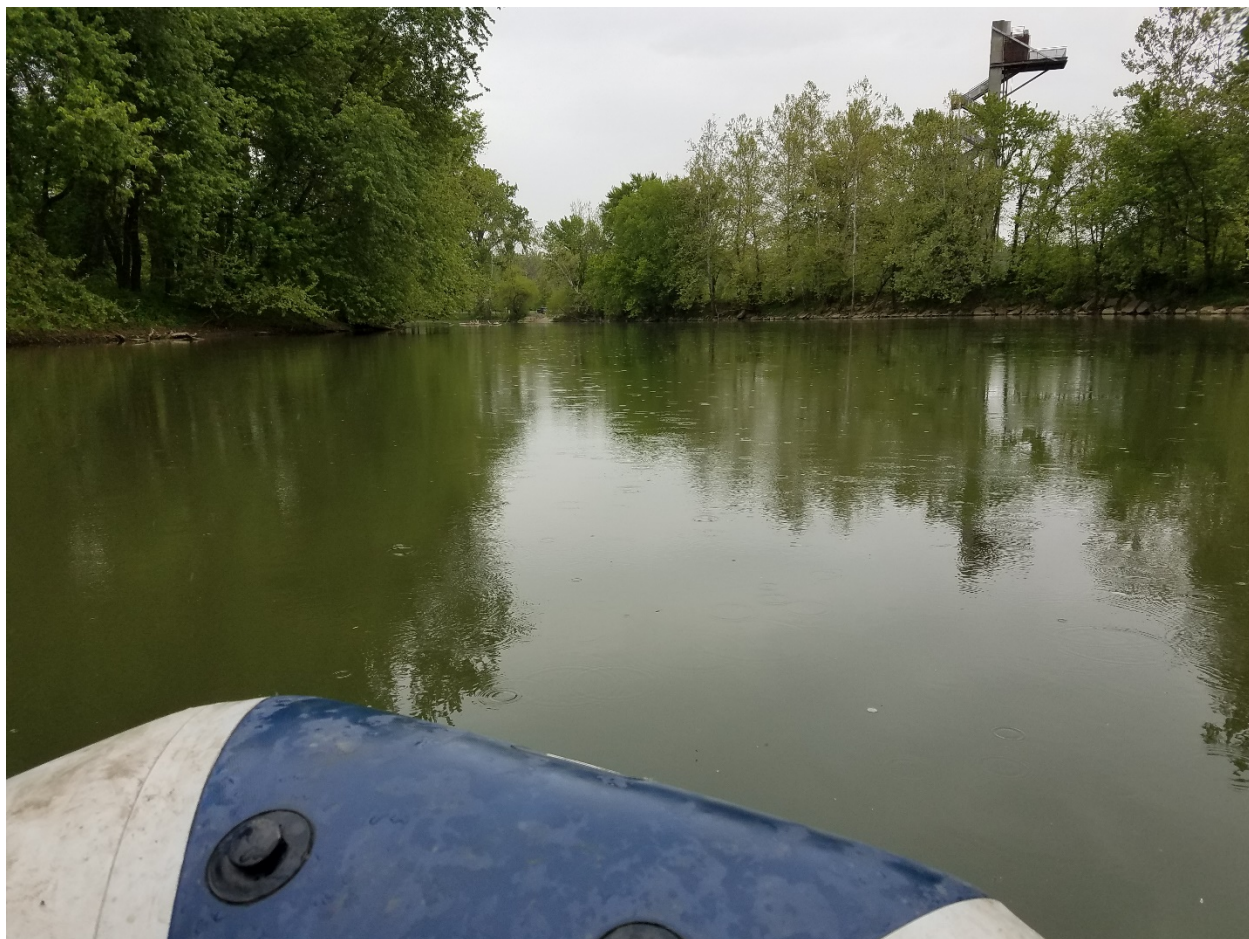
Figure 25: Above the railroad bridge looking northeast towards the park (near cross-section EF16). Note the high banks on the left bank (park side). Another image of the left bank follows in Figure 26.

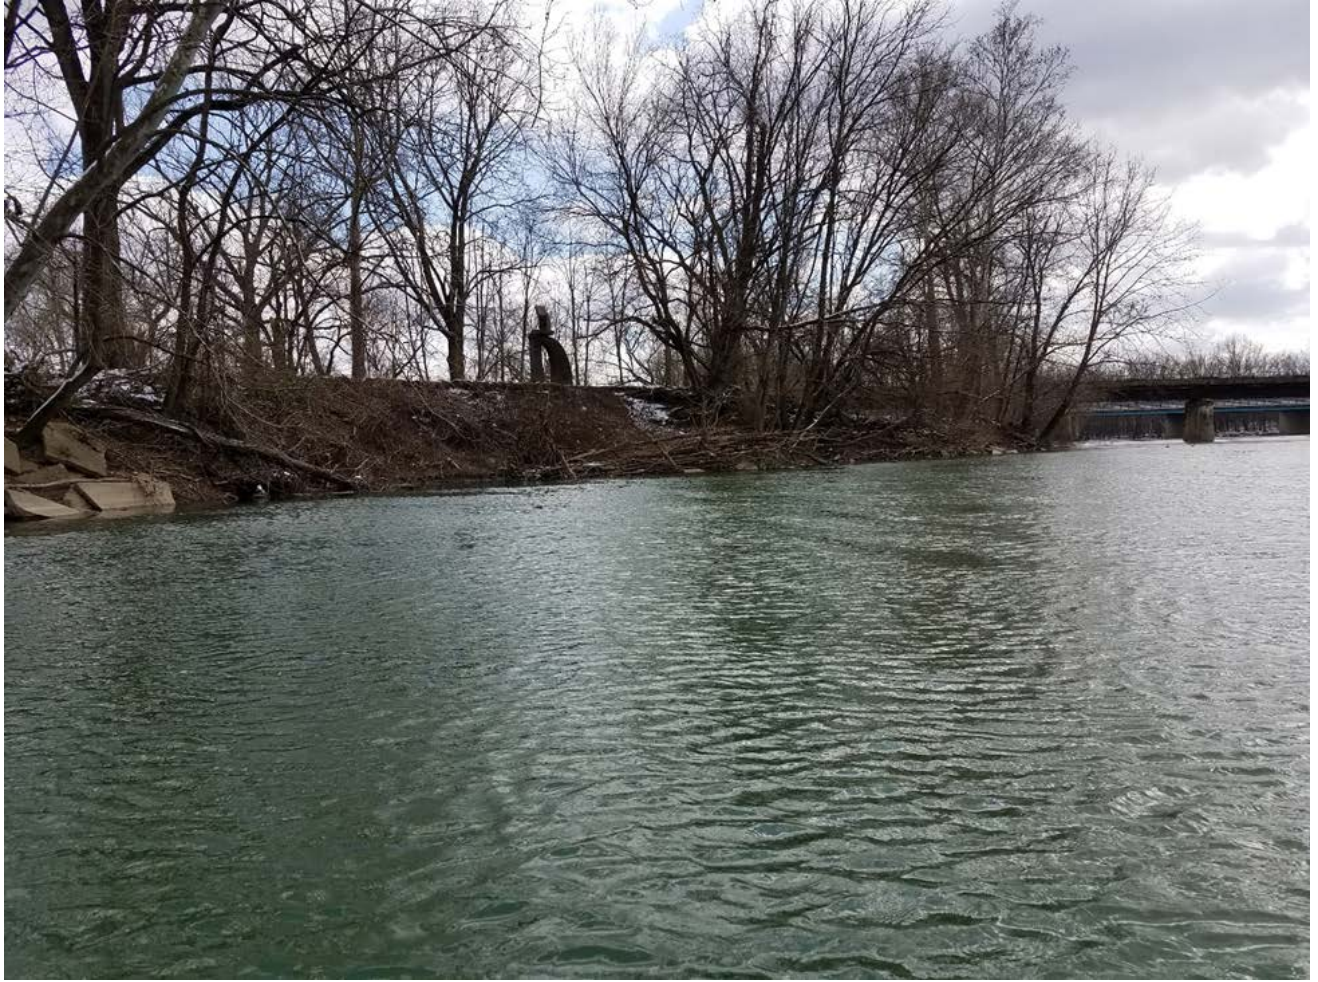
Figure 26: Left bank above railroad bridge. The USGS topographic map of this area shows the top of left bank with an elevation of 620 ft., 10-ft higher than the right bank. Much of the left bank in the Park is geomorphically a high terrace. At the bankfull stage there is still significant (>3-ft) bank above the bankfull flow elevation. The bankfull flow will erode the bare bank and weaken the overlying bank resulting in continued bank failure. Note the concrete piled along the bank, and the lack of vegetation in between the trees.

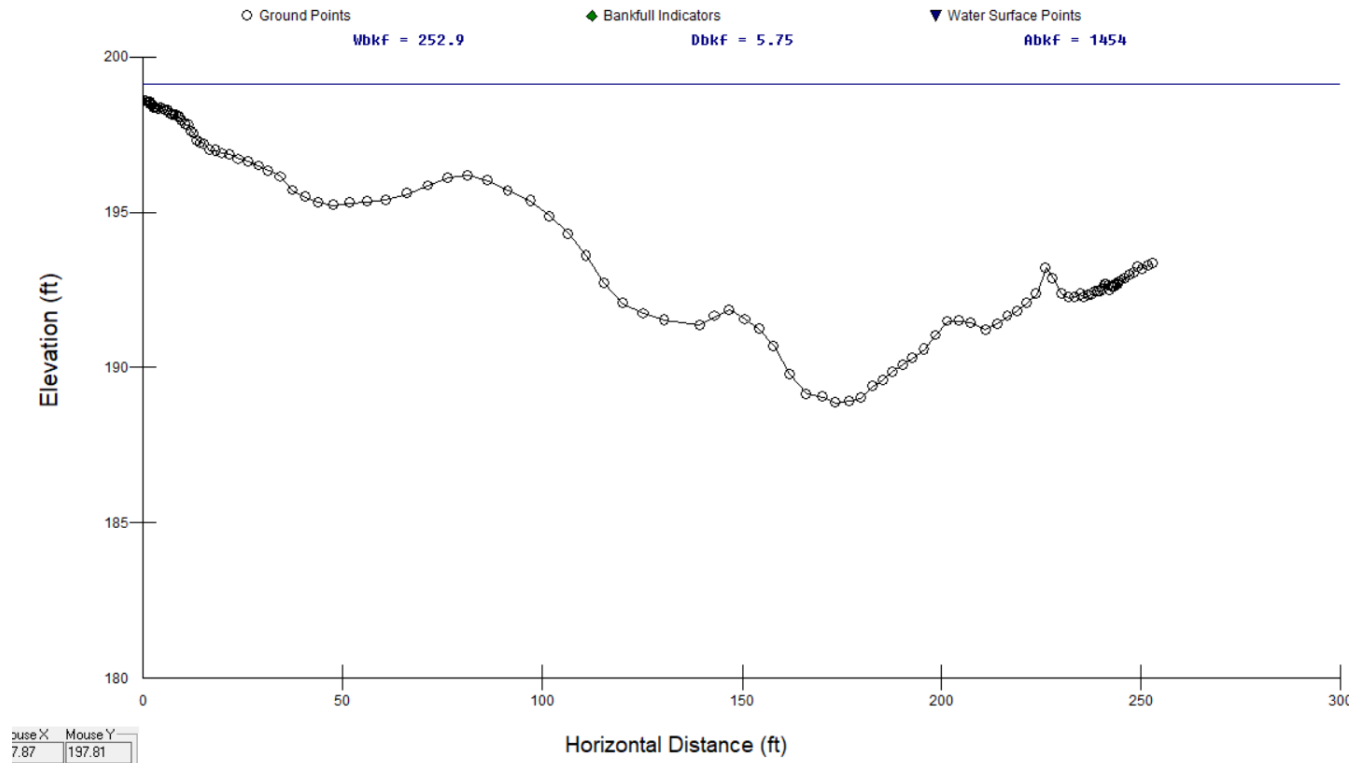
Figure 27: Cross-section EF 17, downstream of dam, in project area, maximum channel depth is 10.6-ft, as predicted. Partial dam failures have focused flow to the right bank coming into the dam. As flow comes over the dam on the right bank it has scoured a small area immediately to the right, and downstream of the dam. Flow converges downstream of that point and moves the thalweg towards the center of the channel. The bankfull area for this cross section is 1598 ft². Note that the Abkf has increased to predicted size downstream of the dam.
