Assessing the Effects of the Removal of a Low Head Dam on a Portion of the East Fork White River at Columbus, Indiana

Prepared for the City of Columbus, and the Columbus Redevelopment Commission, December 2017

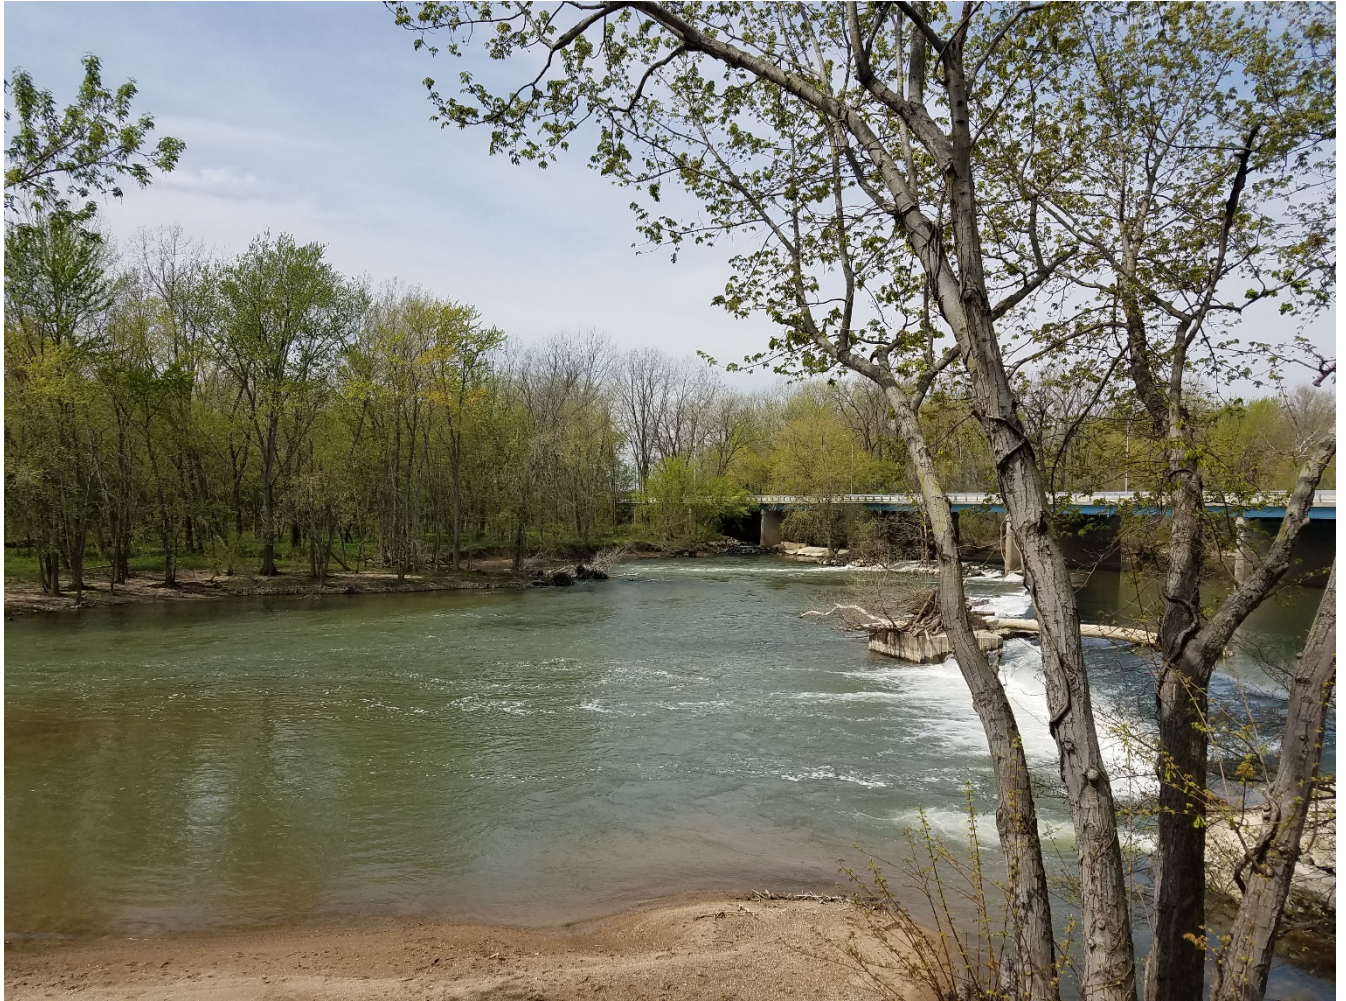
Figure 28: Upstream project area near EF17. Note scour zone on far bank, flow convergence, and significant deposition along left bank (foreground).

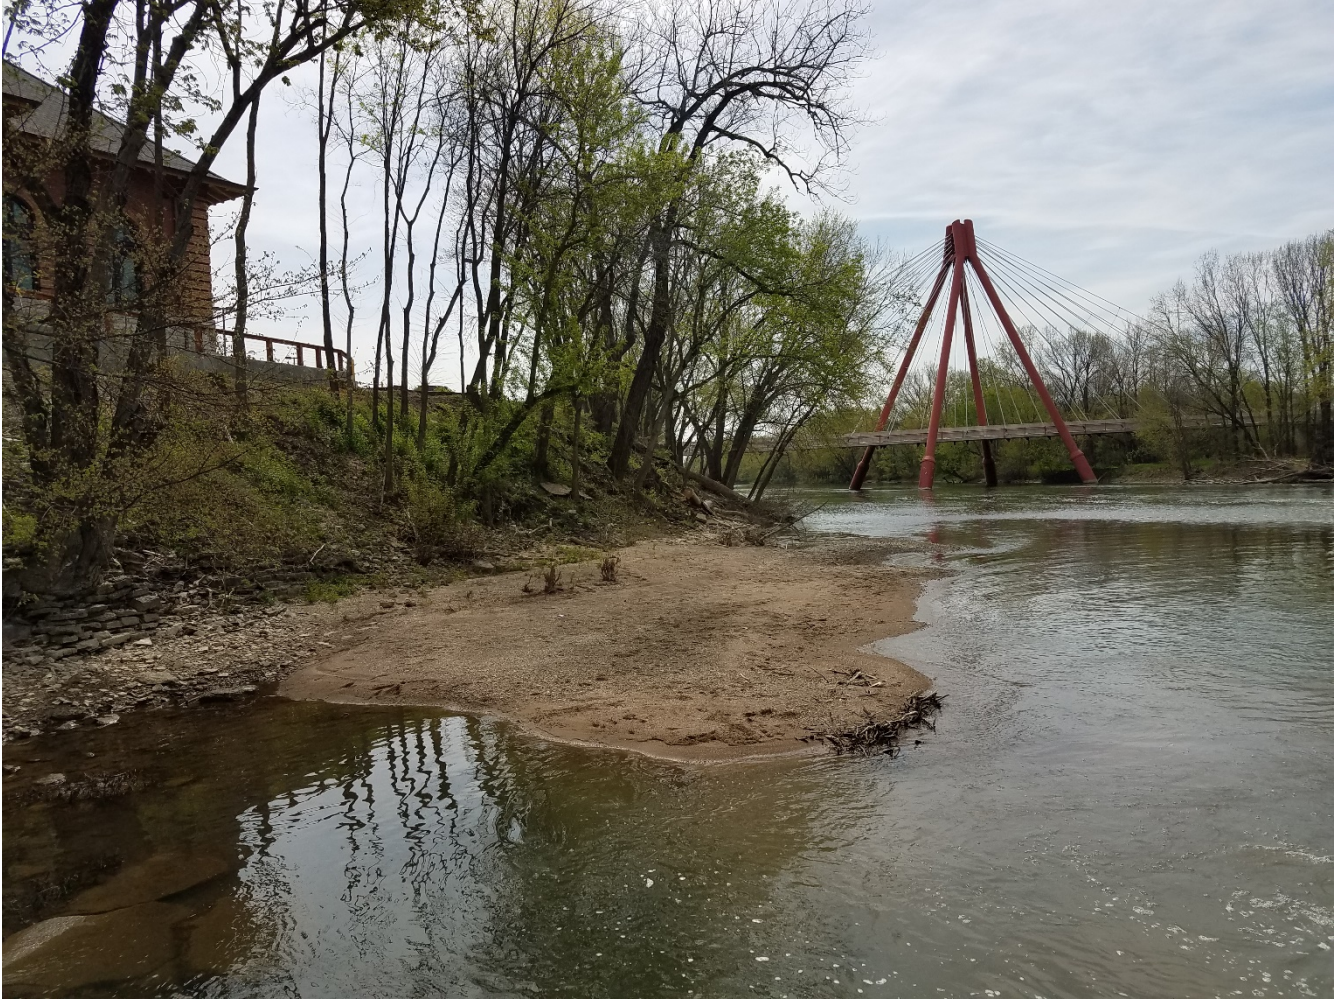
Figure 29: Left bank in the project area near EF17. Note escarpment wall and sediment deposition.

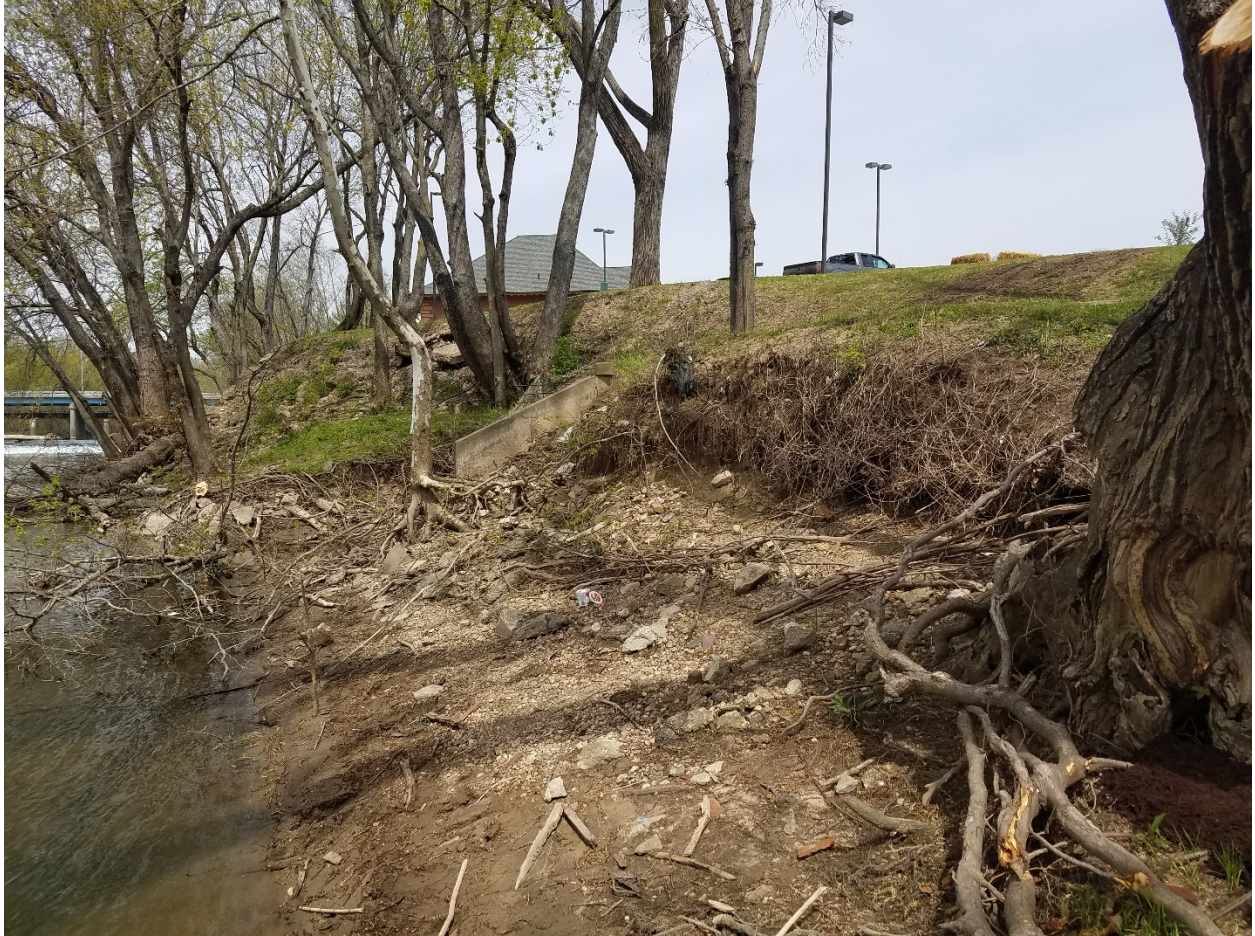
Figure 30: Left bank in project area near EF17, downstream from the escarpment at the transition down to the Genessee silt loam high terrace. Erosion is isolated, and appears to be influenced by the concrete storm water wing wall position in the bankfull stage flow path. Upper surface is 21-ft above the water surface, and the lower tread surface is 8.5-ft above the water surface.

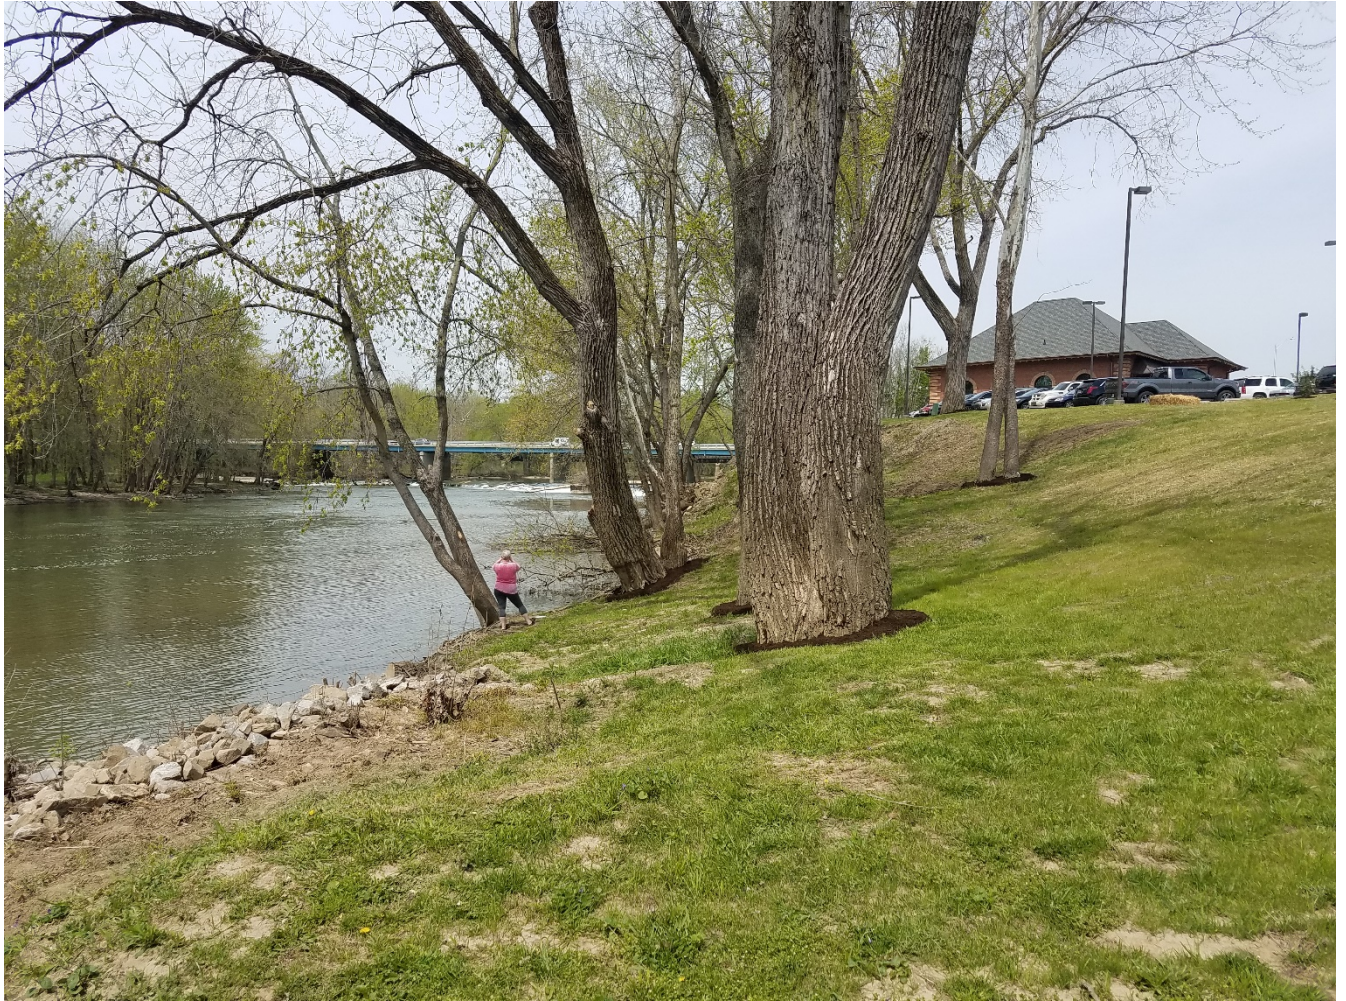
Figure 31: Left bank of the project area near EF17. Transition from escarpment to terrace.

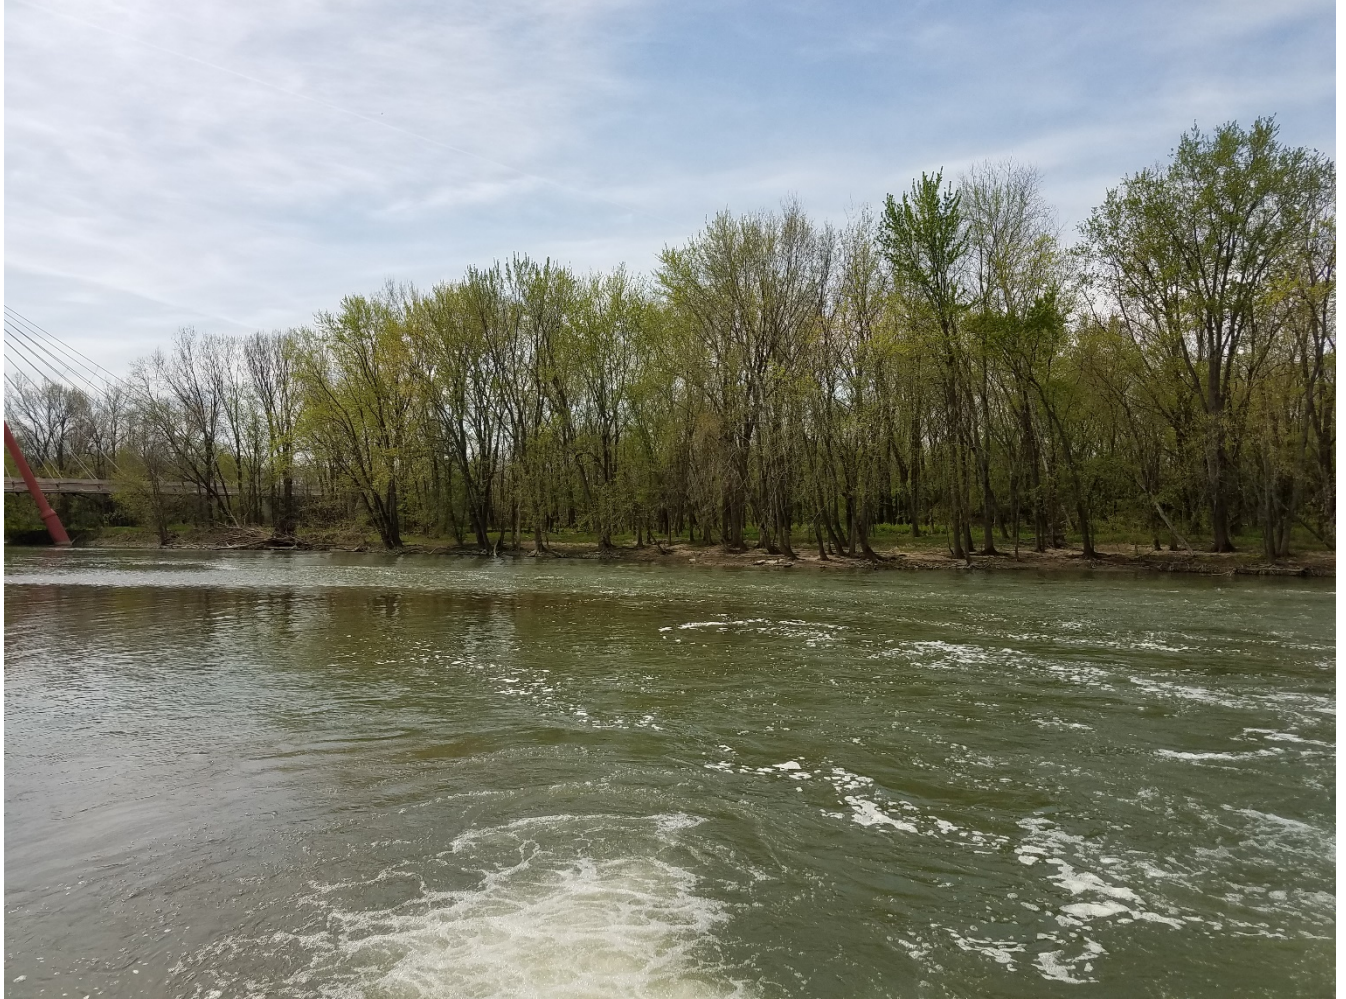
Figure 32: Looking southwest downstream from the left bank towards the right bank (near EF17. Note the smooth transition onto the very restricted right bank floodplain, and the center channel flow convergence.

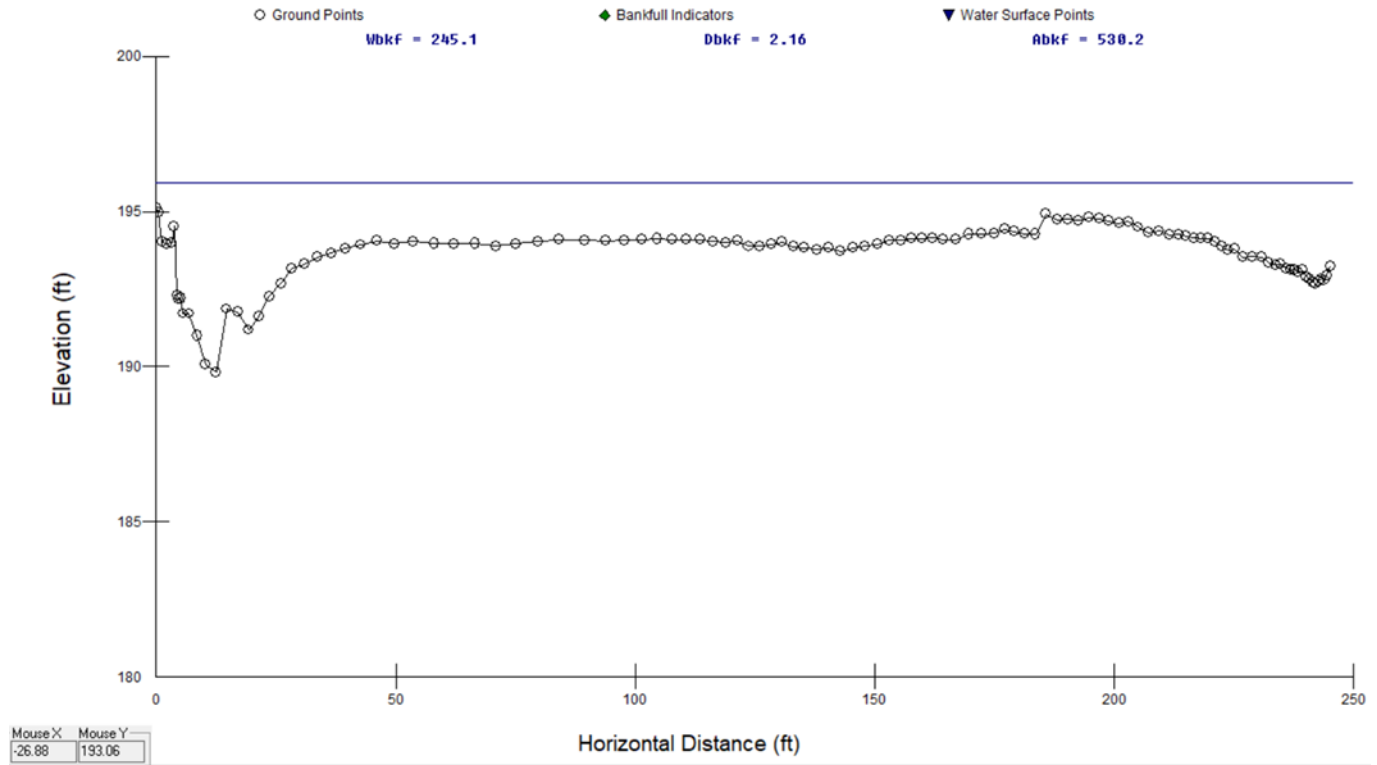
Figure 34: Cross-section EF 24, downstream from project area. The downstream cross-section shows the deep pool along the left bank, and a very aggraded bed leading to reduced cross-sectional capacity. Note that the Abkf at EF24 is 530 ft², or 33% of what it was upstream at EF17. This appears to be related to stream flow being routed into an old gravel pit on the right bank and a resultant loss of stream power in the main channel – particularly during low flows. That secondary flow path into the gravel pit on the right bank is also causing a deeper channel to develop along the right bank. Note the deepening channel at about 240 feet from left bank. The sediment observed downstream indicates that at higher flows the EFWR will push the sediment downstream.

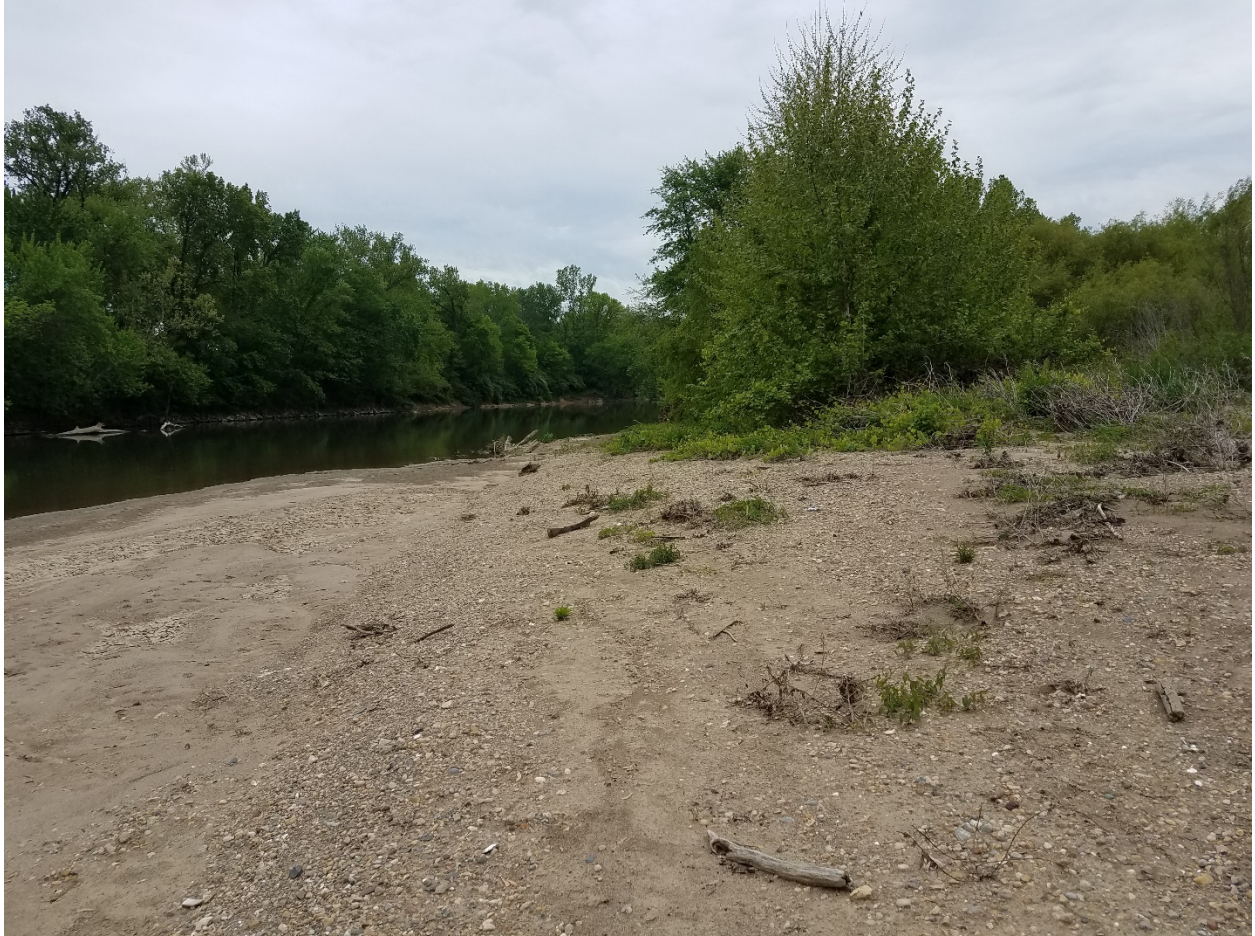
Figure 35: Point bar in the downstream portion of the study area, near EF24. Note smooth transition of the point bar onto the adjacent floodplain and the rock placed along the toe of the outside of the meander bend on the opposite side (left bank).

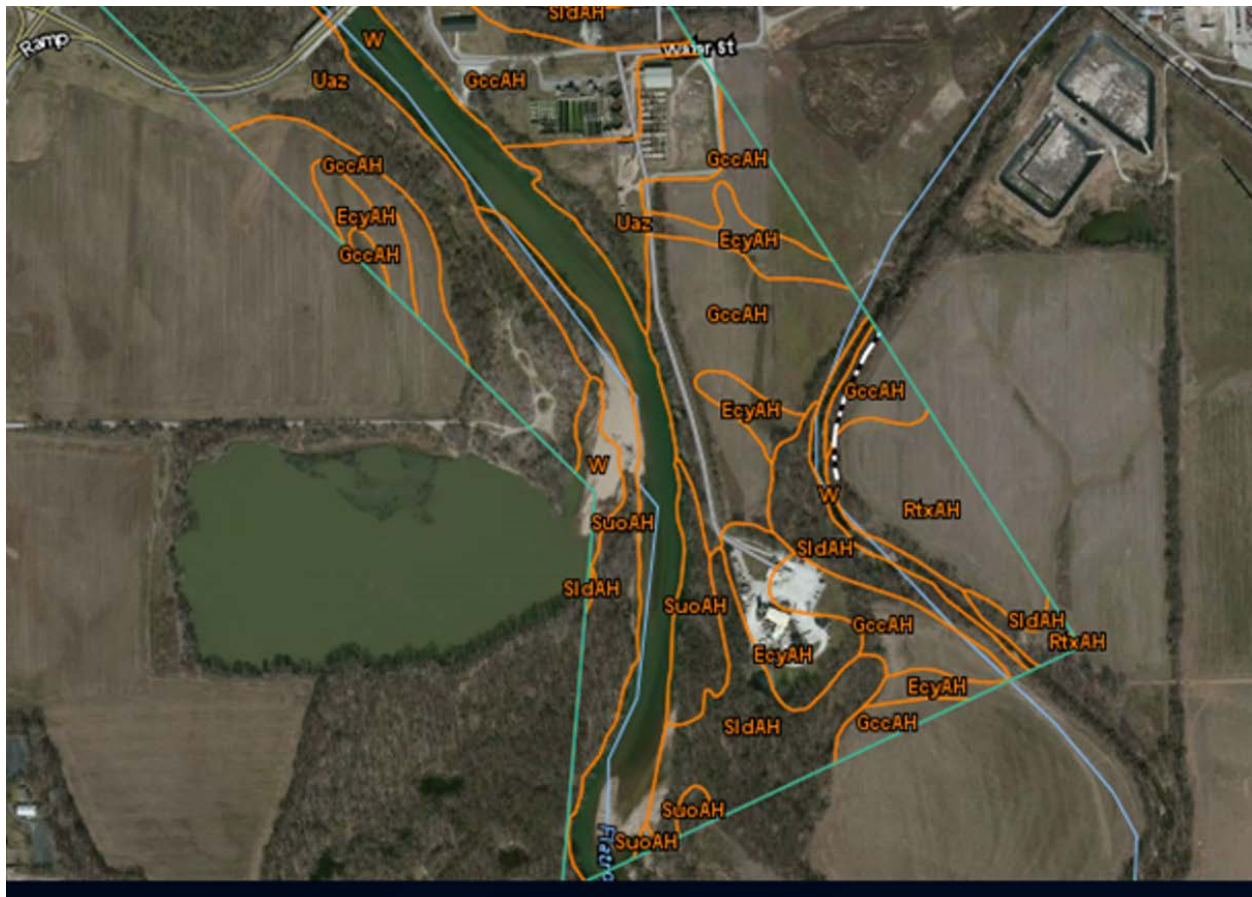
Figure 36: Soil associations in the downstream portion of the study area. Note the left bank is primarily a Genesee silt loam floodplain, with a small area of Uaz, or sandy Udorthent in the middle portion, and Stonelick (SuoAH) fine sandy loam downstream. The right bank is initially sandy Udorthent that changes to Stonelick fine sandy loam downstream. The former sand and gravel pit can be seen on the left side of the image. While the point bar with a deep pool is normal alluvial channel geometry, note that the point bar breaks into the old sand and gravel pit at stages, or river water surface elevations, less than the bankfull stage. This is concerning because it may send a wave of channel-bed instability upstream, and increase downstream meandering.

Sediment transport is also being affected by the old sand and gravel pit shown in Figure 36. The breach on the right bank is diverting stream flow and sediment into the pit at fairly low discharges. That routing of flow and sediment out of the main channel will result in continued channel adjustments both upstream and downstream. Further analysis is recommended to help determine the most appropriate methods for minimizing this hazard.

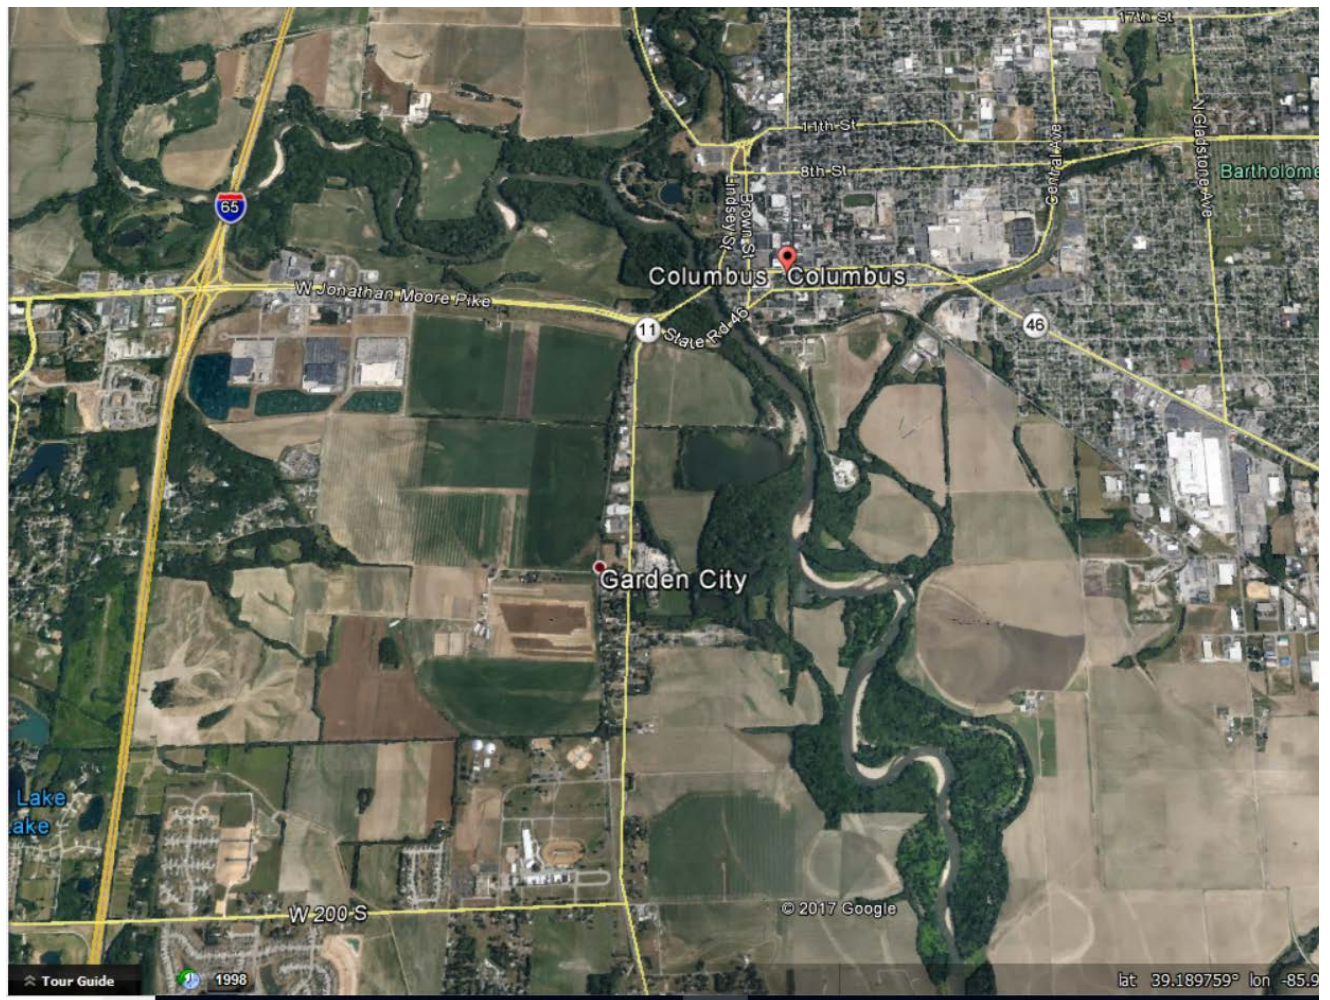
Figure 38: Bright sand bars from the Driftwood River in the upper left of the image continuing down through the main channel of the ERWR in the right center of the image, indicate sediment transport through the project area. The absence of extensive side bars or mid-channel bars indicates that transport is relatively stable, but the long straight portion of the study area without bars indicates localized disruption.
