**Historic Preservation Report for  
The Columbus Pump House**  
Prepared by Richard McCoy & Associates  
November 2013

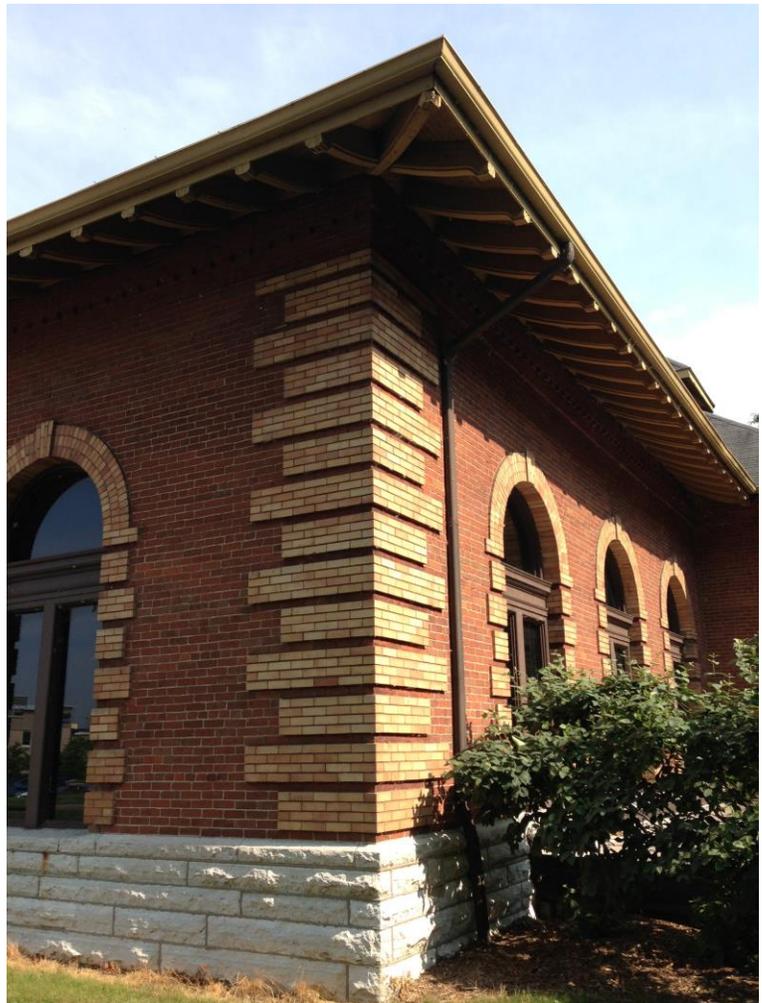
The rough-hewn, limestone walls rise up from the ground and are likely resting on a concrete foundation. On top of these lower-level walls are brick walls that are load bearing, solid, and purported to measure eighteen inches thick. Originally the roof was covered in slate tiles and the windows framed with wood – from historic photos it appears that some of the windows had the capacity to open. Steel trusses support the roof structure and are tied into the masonry walls near the interior roofline with metal bars. Decorative elements on the exterior walls were completed in a lighter color brick and are shown around entranceways, corners, and windows.

There have always been two main entrances to the building, one at the northern end that is framed with a carved limestone lintel with the words “Columbus Power House” at the top; the other at the southeastern side of the building. This entrance originally contained a sliding wood door that would have been used by locomotives and other heavy machinery to supply coal to the building – evidence remains in the basement of another concrete abutment that would have allowed for rail tracks to extend further into the building. It appears that there were at least three lower level entrances. Historic photographs show a variety of smokestacks piercing the roof; but their original configuration also is unclear as they have been altered over time.

Northwest Corner of Building Showing Decorative Elements

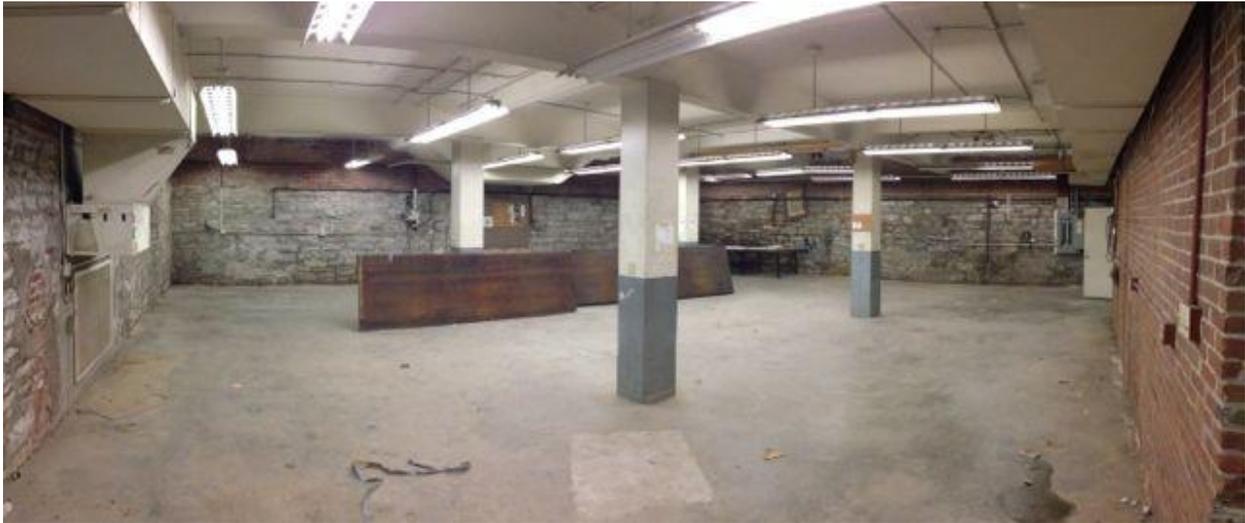
Little is known of the condition of the building when the city sold it in the 1950s, but it is known that the interior of the building was significantly altered when Southern Machine Company took possession of the building. They poured concrete floors on the lower level and added concrete floors to create a second level. These floors remain today.

**The Lower Level Main Area Showing Concrete Floors added by Southern Machine Company in the 1950s**

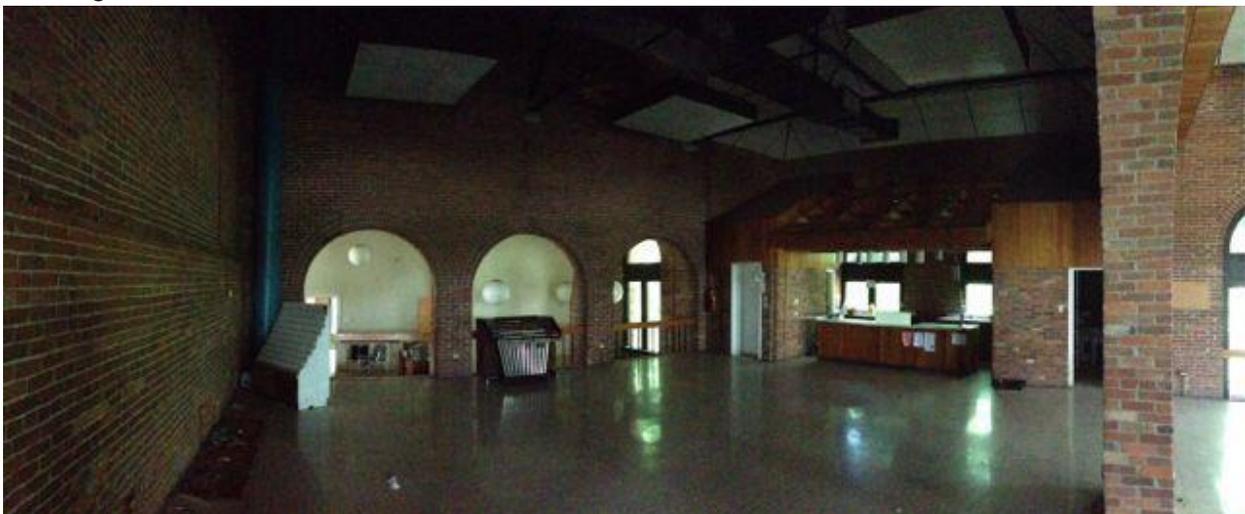
When the building was renovated in the early 1970s to accommodate the Senior Center, Columbus architect James Paris made significant alterations to the interior to make it more open. He altered the two east-west loadbearing walls in the center of the building. In these walls he added curved arches as wall openings (in the style that was used originally in other places in the building). He also added a kitchen, office, and meeting spaces and created a central meeting room that features a shuffleboard area.

**The Central Area of the Building Showing Three Opening Created by Paris and the Kitchen and Elevator**

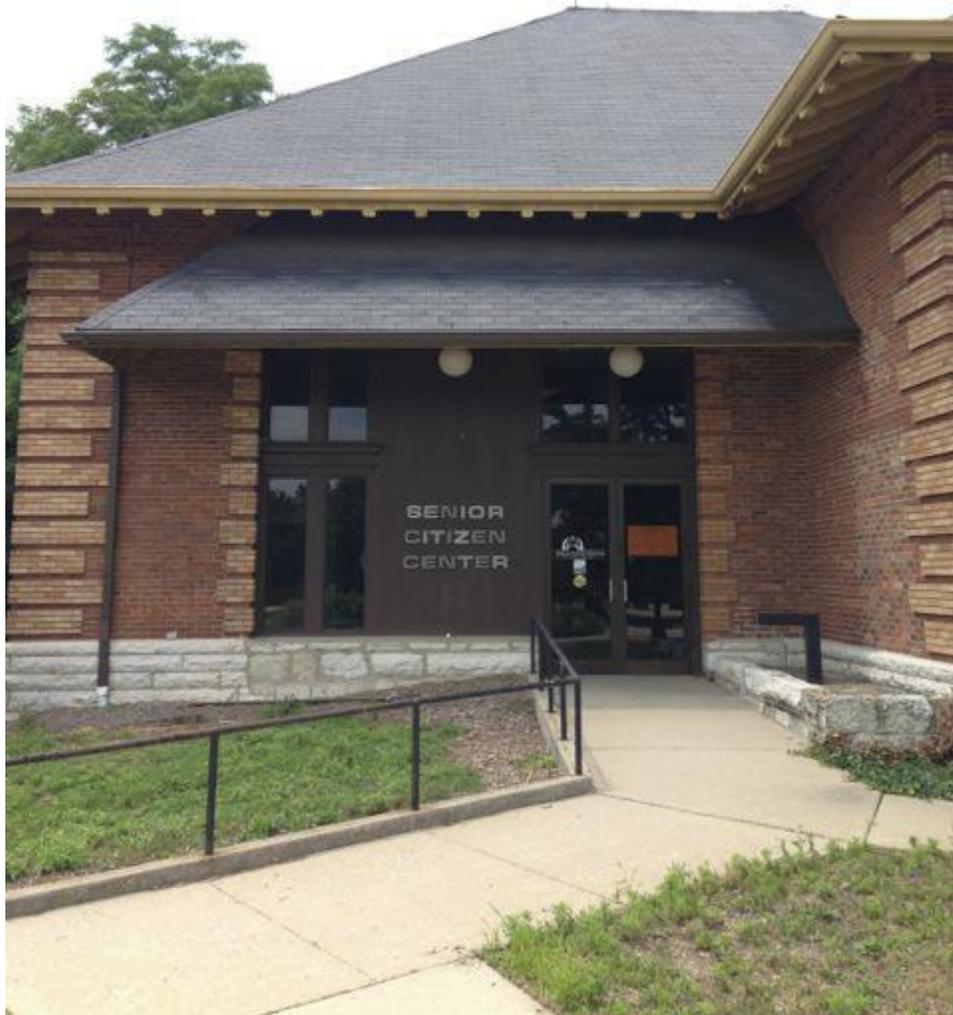
**The Main Entrance of the Building Showing the Paris-Designed Entrance and Roof Overhang**

The most significant alteration that Paris made to the exterior of the building was to re-work and expand the southeastern entrance of the building. What was an entrance used for loading coal became a traditional double door entrance with an added roof overhang and three sets of windows.

All of the windows and doors were also replaced at this time.
