**RE: Final Report
Phase I Environmental Site Assessment
Bartholomew County Court Services Center
507 3rd Street and 215 Franklin Street
Columbus, Indiana 47201
August Mack Project Number JT0460.710.0002**

PHASE I ENVIRONMENTAL SITE ASSESSMENT

Bartholomew County Court Services Center

507 3rd Street and 215 Franklin Street

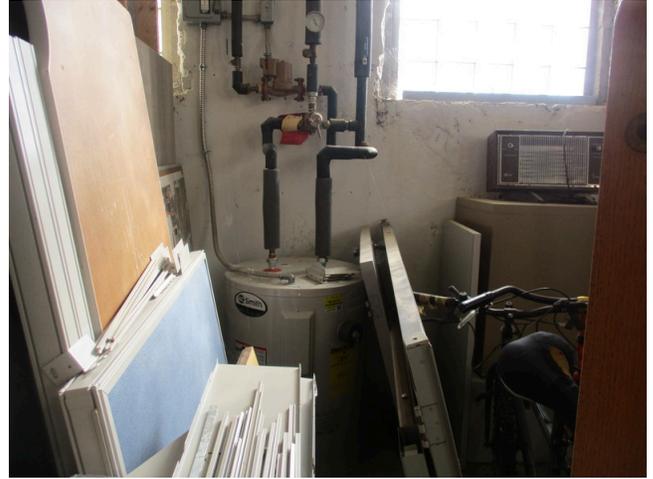
2

View within basement of on-Site building

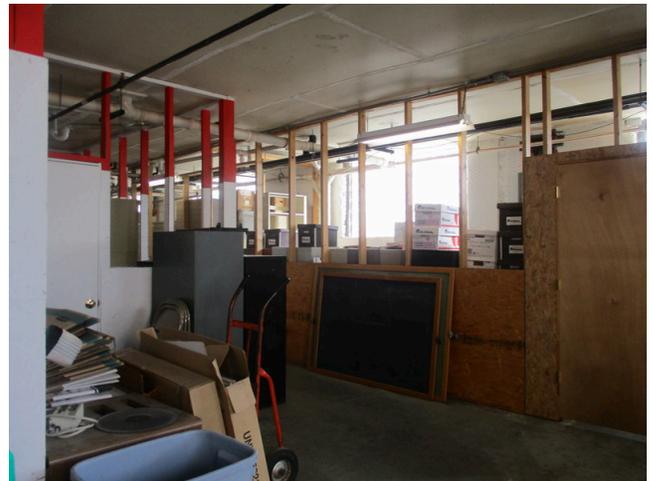
4

View within basement of on-Site building

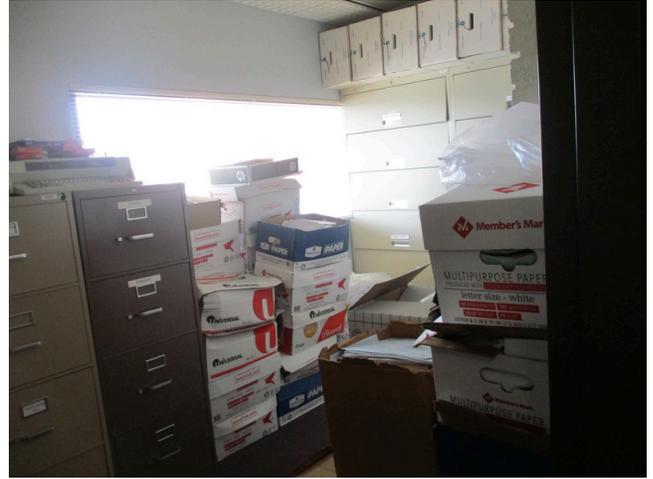
6

View of storage room within on-site building

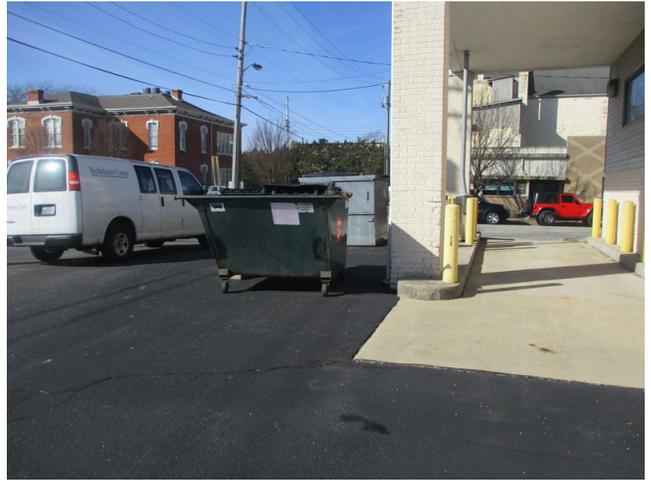
18

Attached drive-through area on southern exterior portion of on-Site building

The south exterior portion of the Study Site building had an attached drive-thru area. The exterior portion of the Study Site consisted of asphalt paved parking with solid waster dumpsters on the south and southeast portions of the Study Site. Strips of mown grass and trees were also observed around the building and Site perimeters.

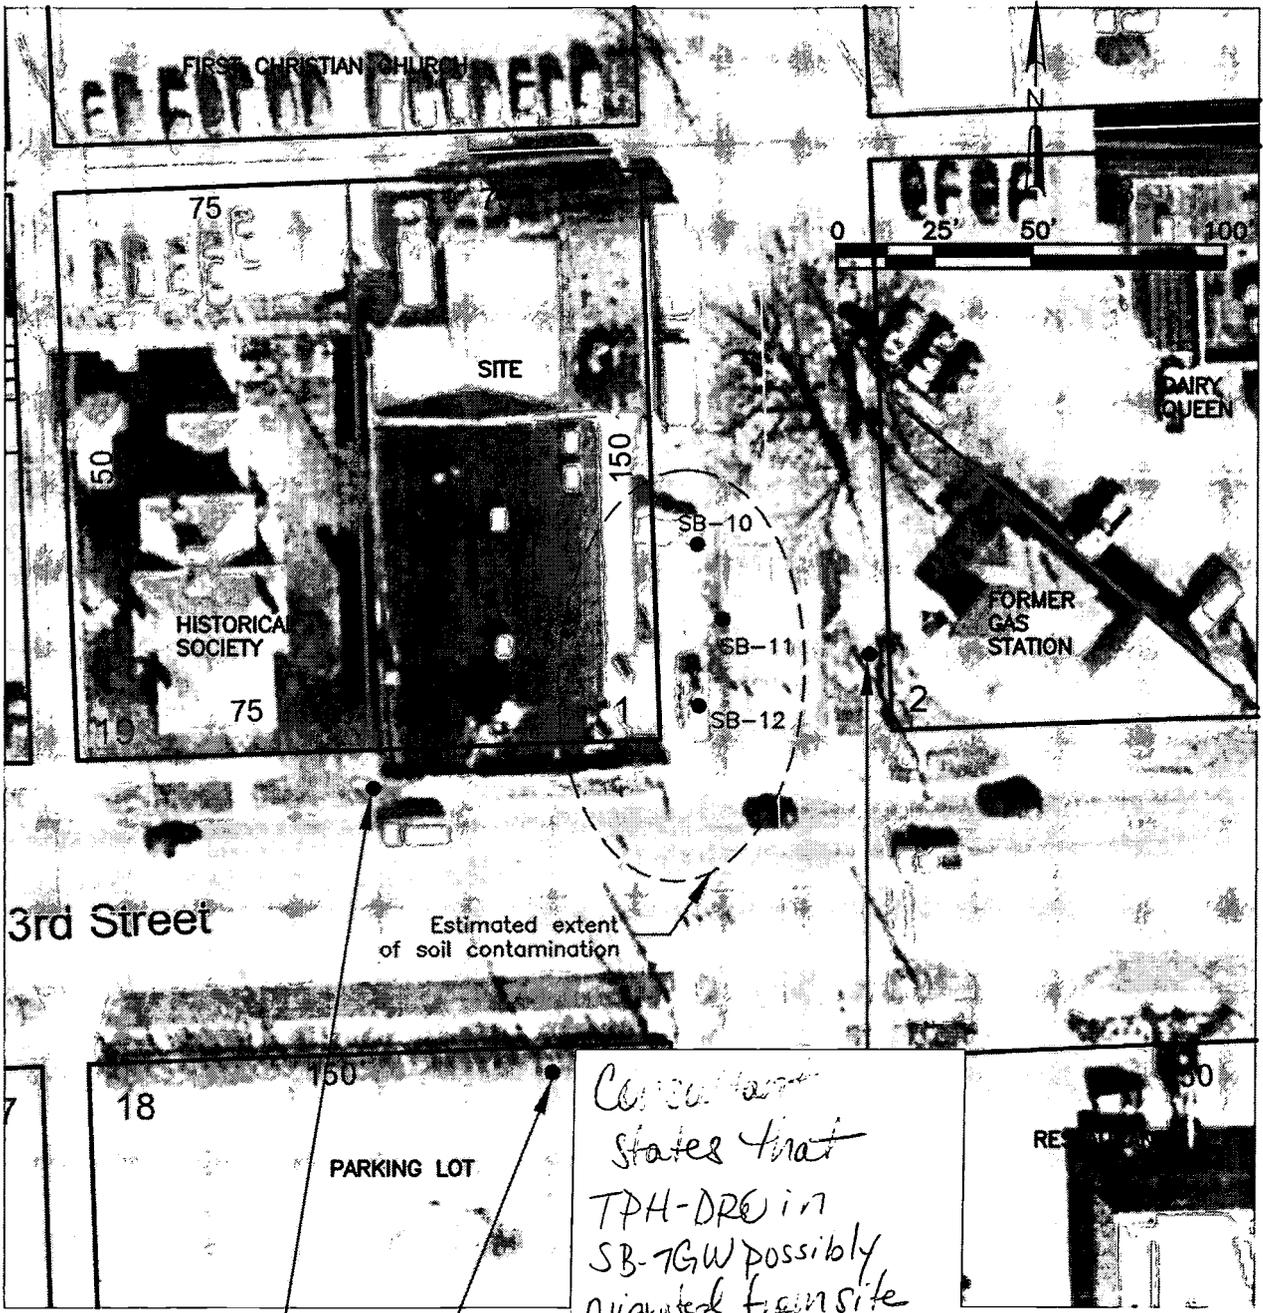
STRAND ASSOCIATES, INC.®
 ENGINEERS
 4-229.001
 FIGURE NO. 3.2

SB-8A (23-24')
 TPH - ND
 SB-8B
 TPH - ND
 SB-8GW (26-30')
 TPH - ND
 MBTEX - ND
 PAH - ND

SB-7A (23-24')
 TPH - ND
 SB-7B (29-30')
 TPH - ND
 SB-7GW (26-30')
 TPH (DIESEL) - 4.7ppm
 MBTEX - ND
 PAH - ND

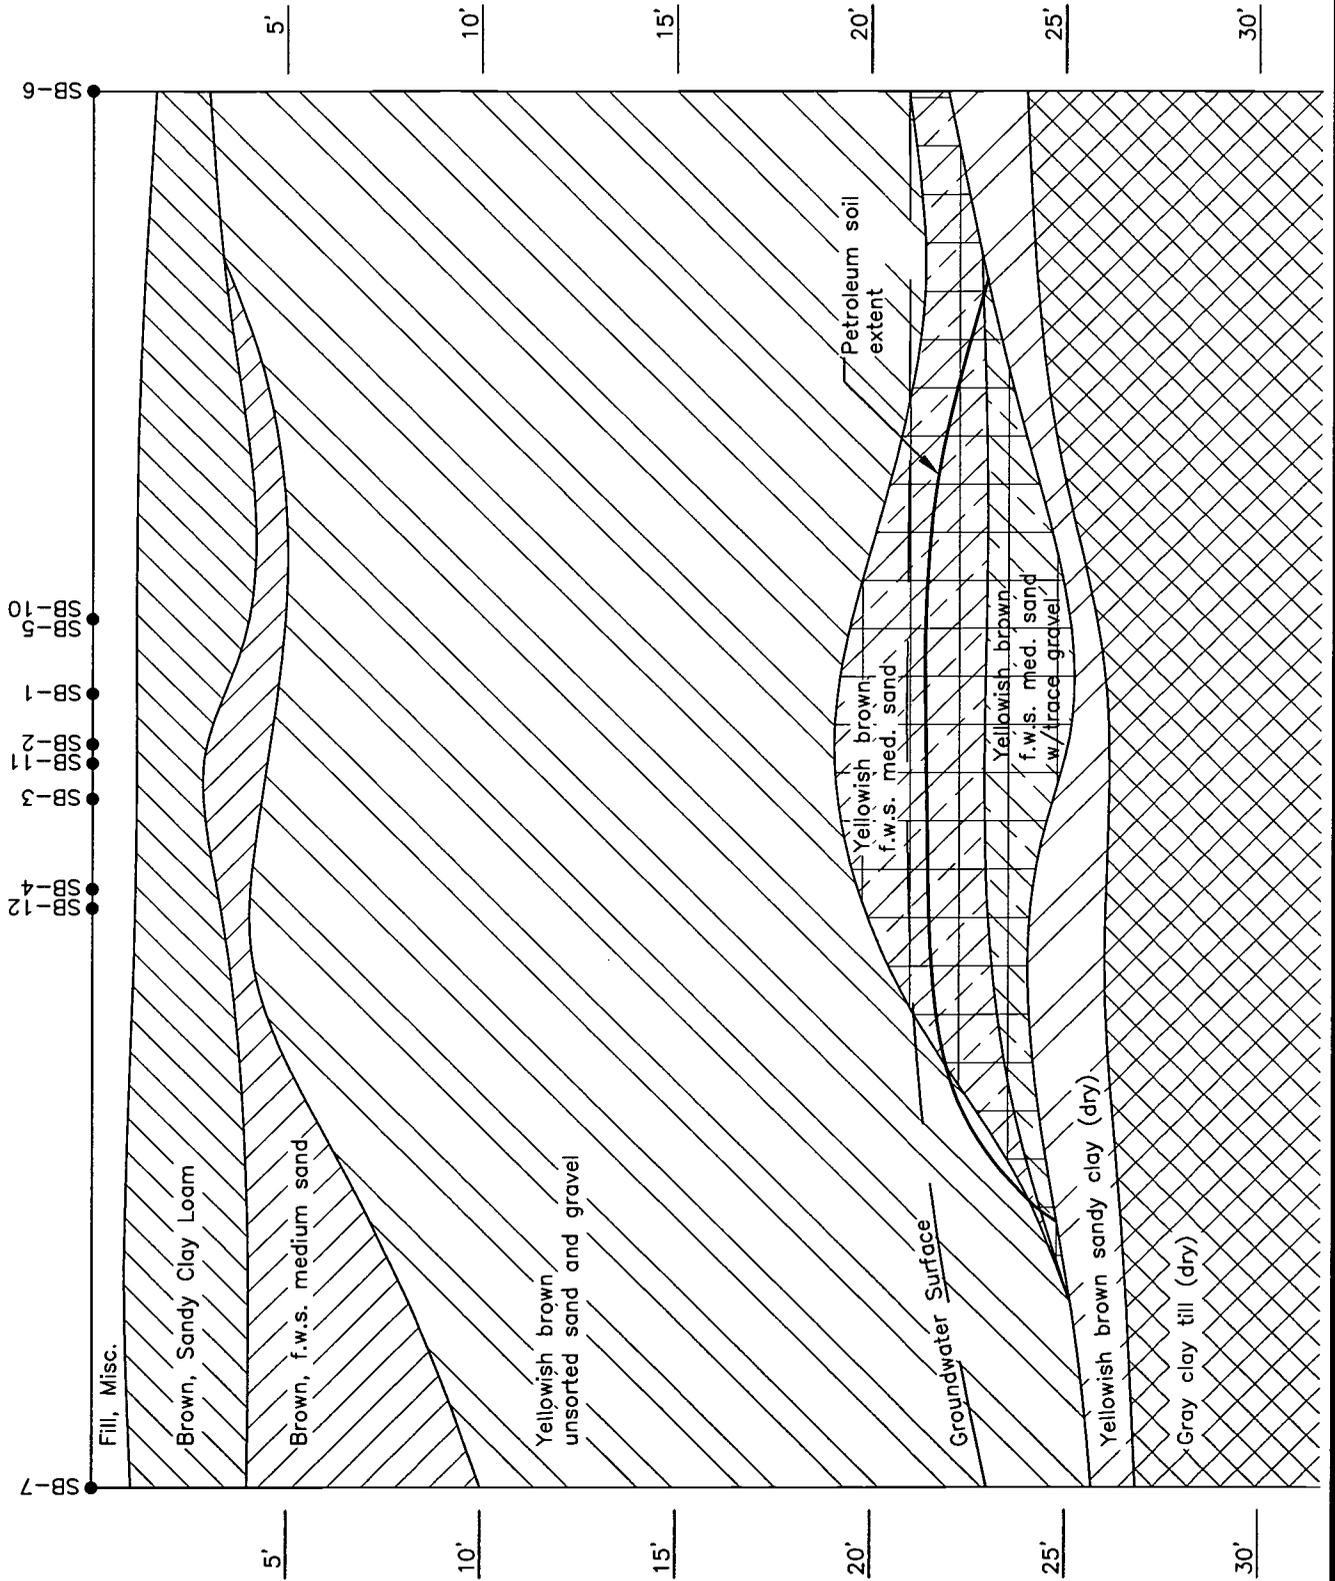
**GEOLOGIC CROSS SECTION
FORMER NATIONAL ICE CO.**

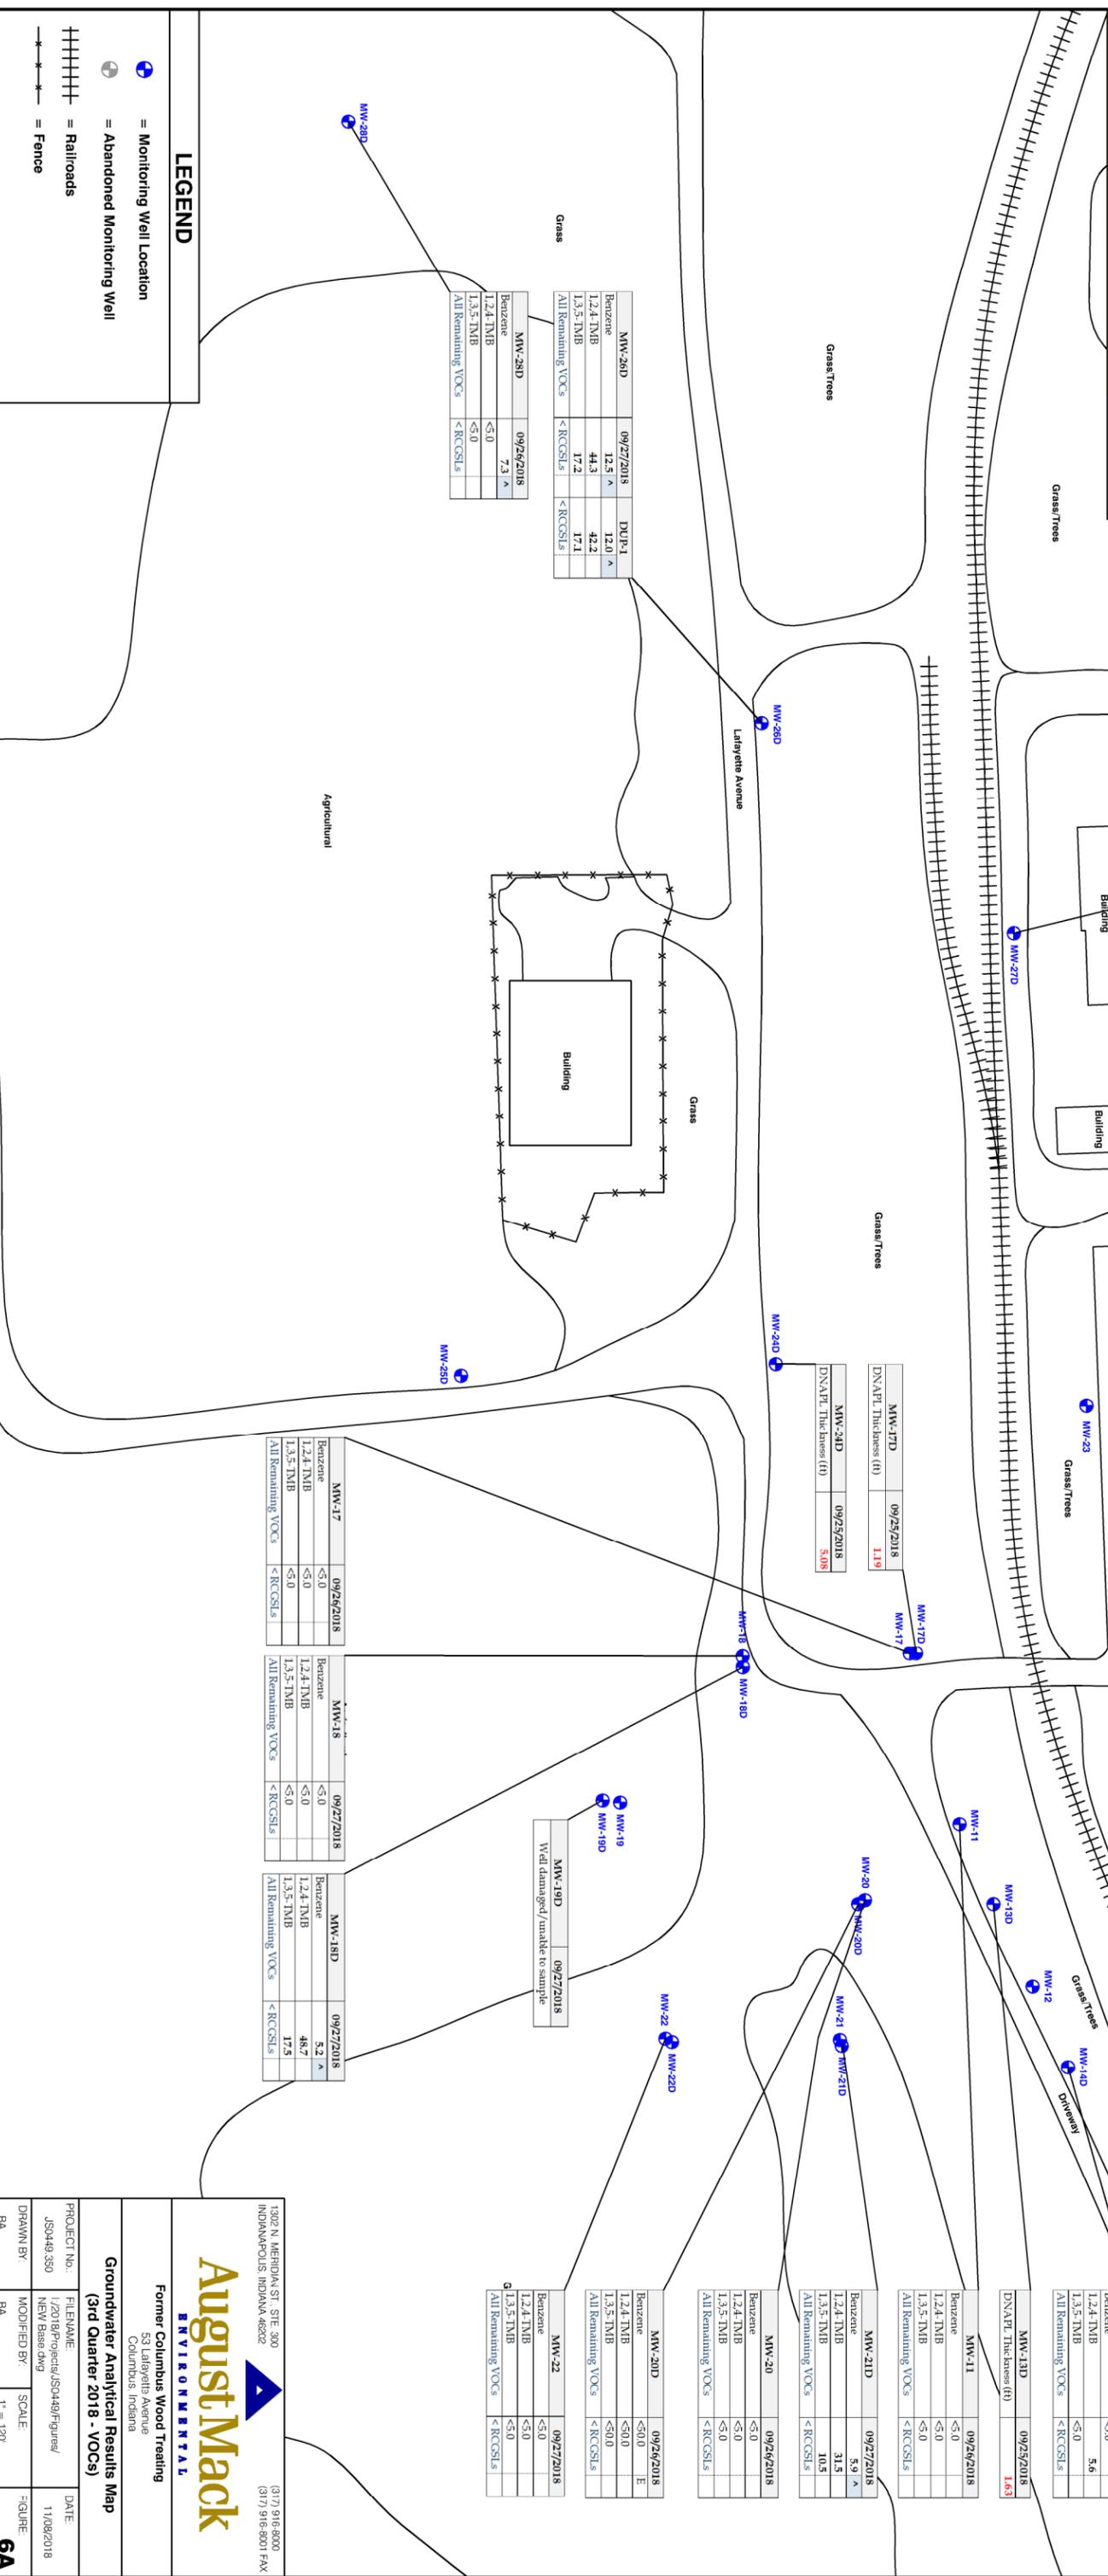
** = Result exceeds 2018 IDEM RCG COM/IND VIGWSLS

MW-26D	09/27/2018	DUPL
Benzene	12.5 *	12.0 *
1,2,4-TNB	44.3	42.2
1,3,5-TNB	17.2	17.1
All Remaining VOCs	< RCCSLs	< RCCSLs

MW-28D	09/26/2018
Benzene	7.3 *
1,2,4-TNB	<5.0
1,3,5-TNB	<5.0
All Remaining VOCs	< RCCSLs

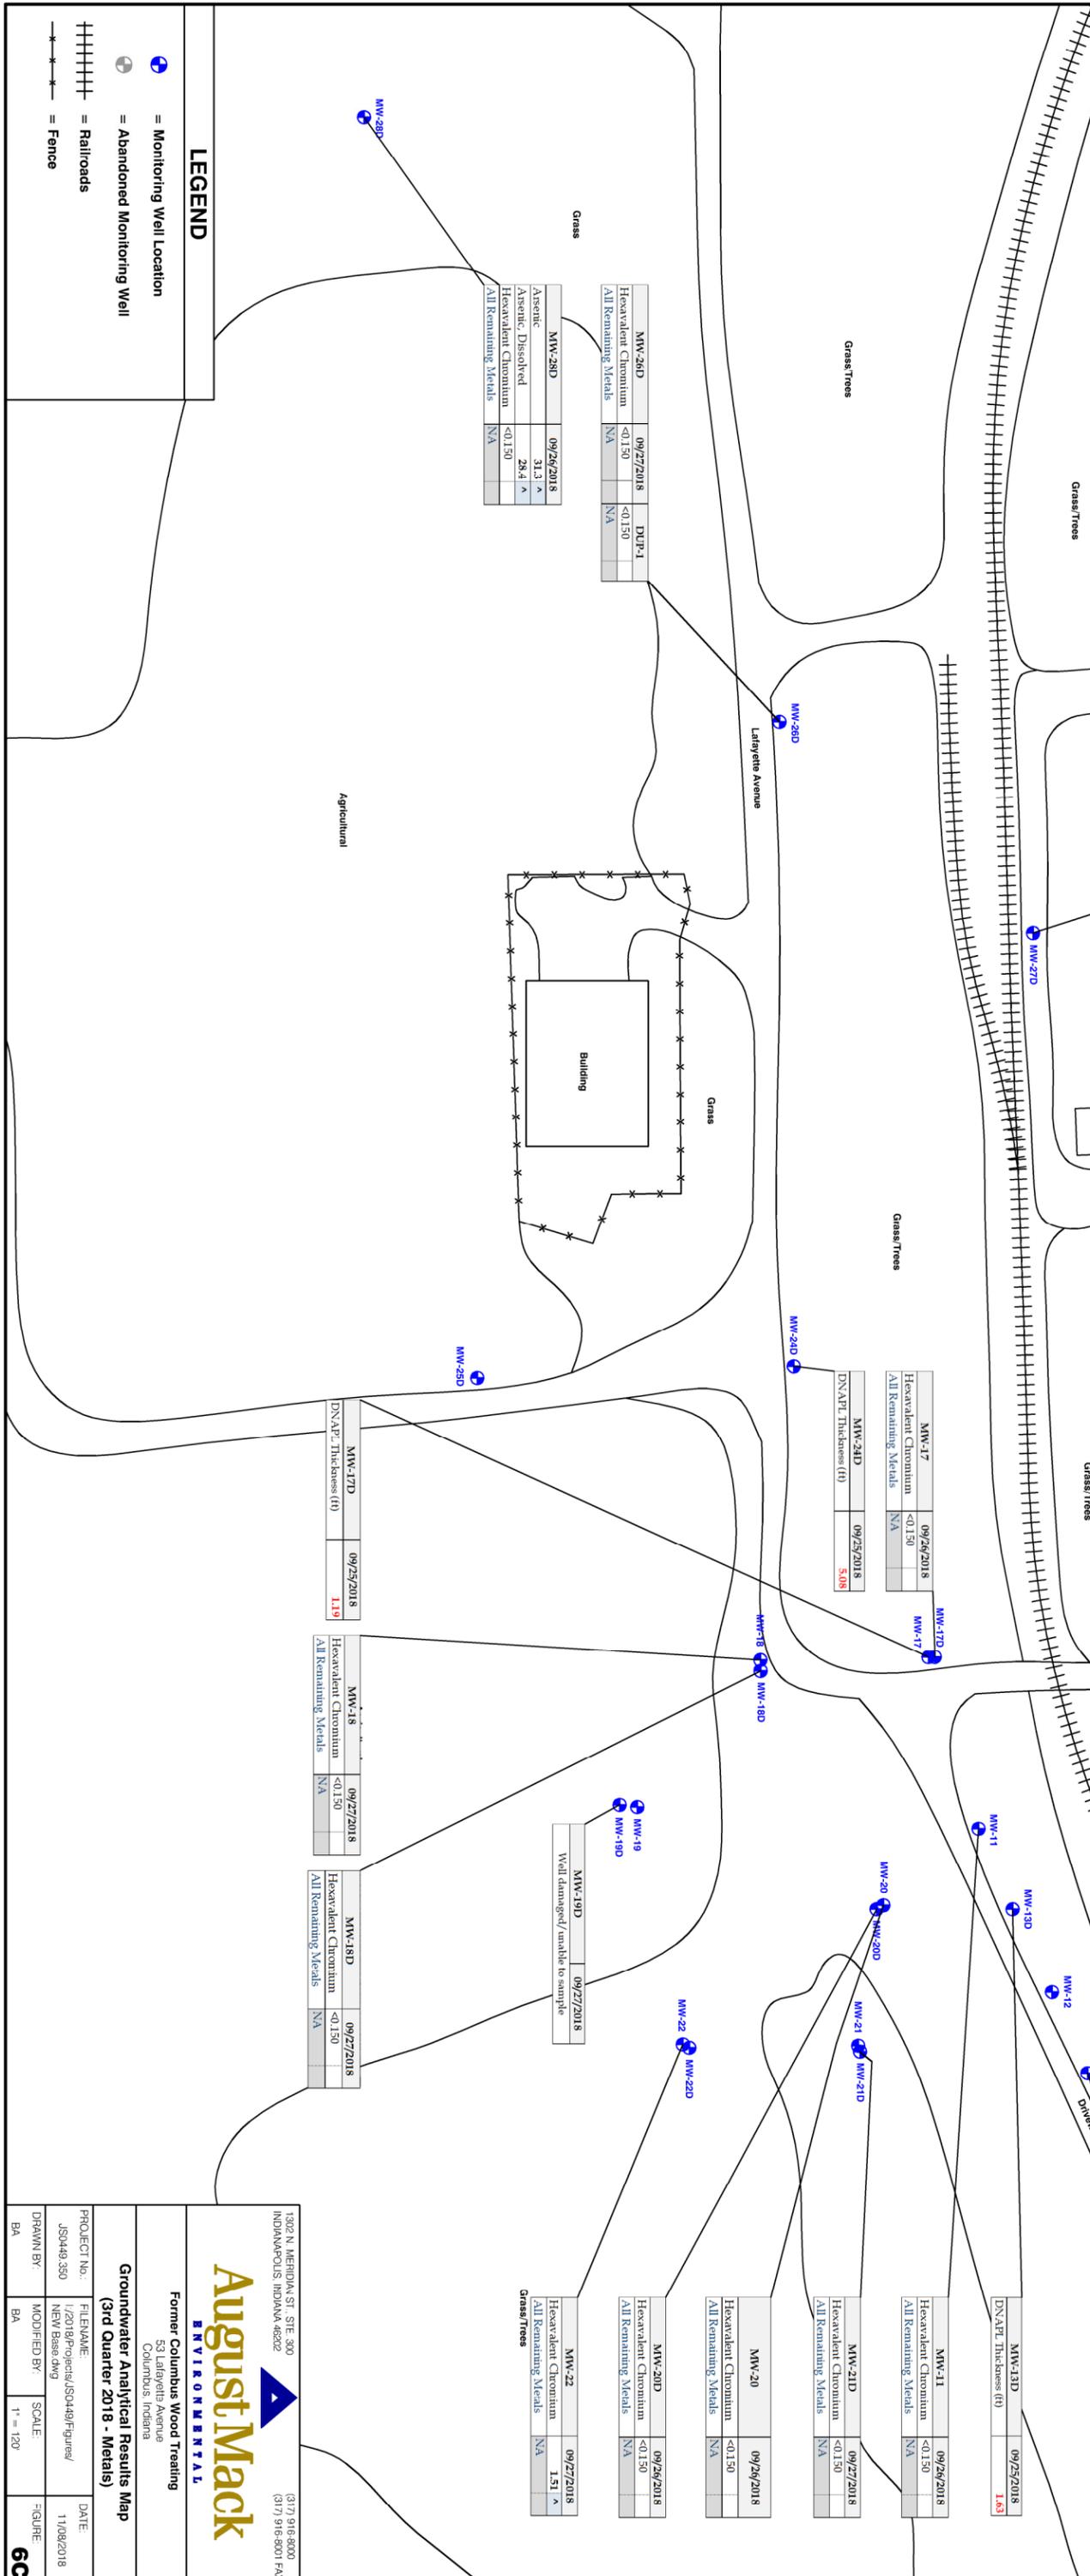
Abbreviations and Notes:
 All results reported in micrograms per liter (µg/L).
 IDEM = Indiana Department of Environmental Management
 RCG = Remediation Closure Guide; NE = Not Established; SL = Screening Level; NA = Not Analyzed
 E = Reporting limit (RL) exceeds closure level due to dilution and/or method limitations.
 (COM/IND)VIGWSLs = (Commercial/Industrial) Vapor Infiltration Ground Water Screening Levels
 VOCs = Volatile Organic Compounds; SVOCs = Semi-volatile Organic Compounds; #= feet
 < RCGSLs = Constituent concentrations reported below their respective RCG SLs or as below laboratory SLs.
 Groundwater samples not collected from MW-2, 13D, 15, 16, 17D, or 24D due to fee phase product encountered.
 * = Result exceeds 2018 IDEM RCG RESIDENTIAL TAP SLs
 ** = Result exceeds 2018 IDEM RCG COM/IND VIGWSLs
 *** = Result exceeds 2018 IDEM RCG COM/IND VIGWSLs

MW-26D	09/27/2018	DJLP-1
Hexavalent Chromium	<0.150	<0.150
All Remaining Metals	NA	NA

MW-28D	09/26/2018
Asenic	31.3 μ
Asenic, Dissolved	28.4 μ
Hexavalent Chromium	<0.150
All Remaining Metals	NA
