**RE: Final Report  
Phase I Environmental Site Assessment  
City Site  
53 Lafayette Avenue;  
703, 711, and 801 2nd Street  
Columbus, Indiana 47201  
August Mack Project Number JT0460.710.0001**

PHASE I ENVIRONMENTAL SITE ASSESSMENT

City Site

53 Lafayette Avenue and,  
703, 711, and 801 2nd Street  
Columbus, Indiana 47201

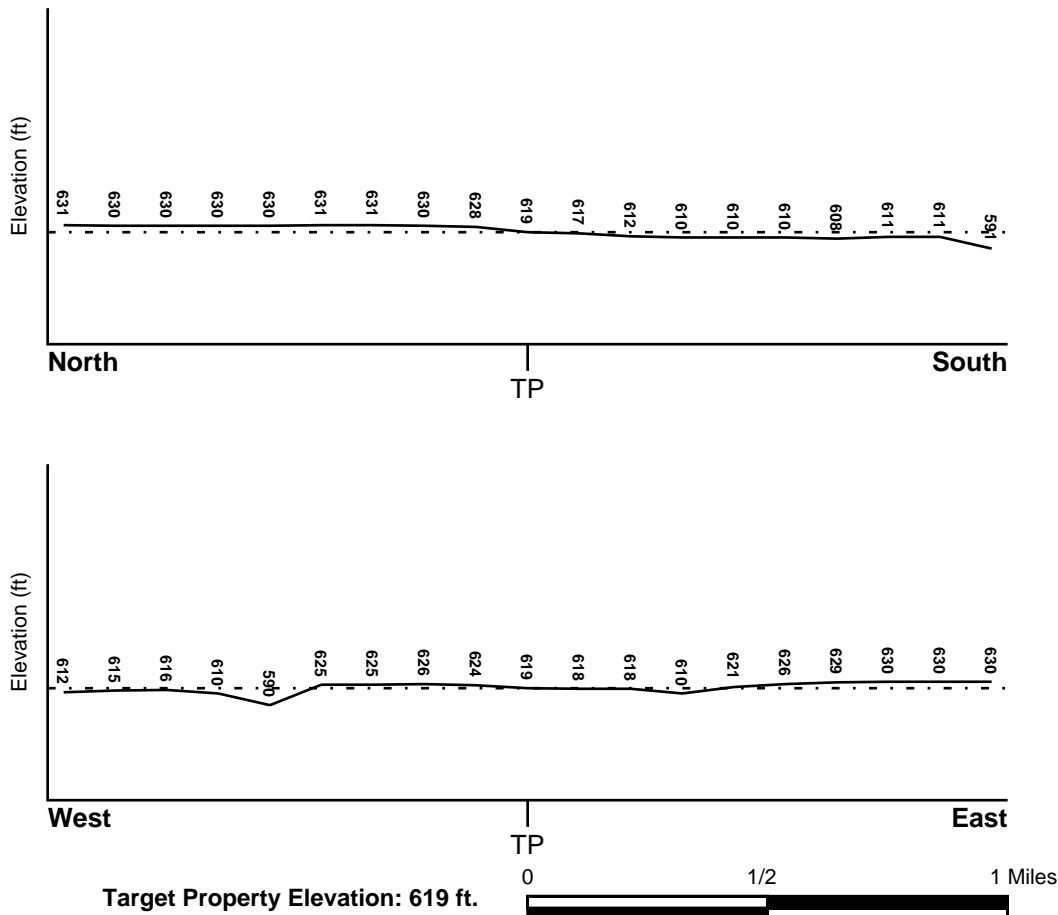
### SURROUNDING TOPOGRAPHY: ELEVATION PROFILES

Source: Topography has been determined from the USGS 7.5' Digital Elevation Model and should be evaluated on a relative (not an absolute) basis. Relative elevation information between sites of close proximity should be field verified.

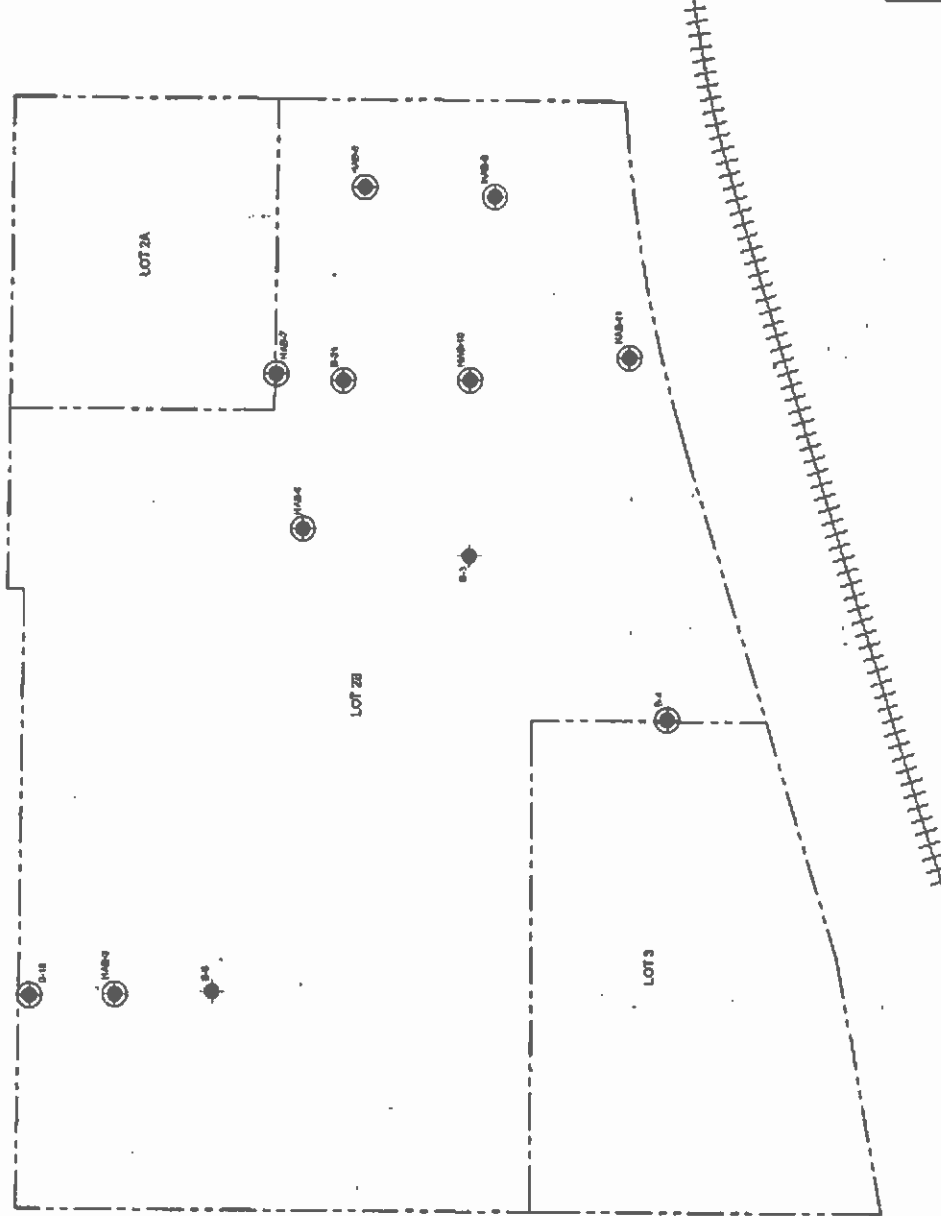
**HADE & ALDRICH**  
COLUMBIAN CONSULTING INC.  
LOT 2A, 2B AND 3  
COLUMBIAN, INDIANA

**NOTE:**  
BORINGS LOCATED FROM INDEPENDENT LAND SURVEYING DRAWING  
NUMBER 071008 REPLACING DATED 17 JUNE 2008.
