Assessing the Effects of the Removal of a Low Head Dam on a Portion of the East Fork White River at Columbus, Indiana

Prepared for the City of Columbus, and the Columbus Redevelopment Commission, December 2017

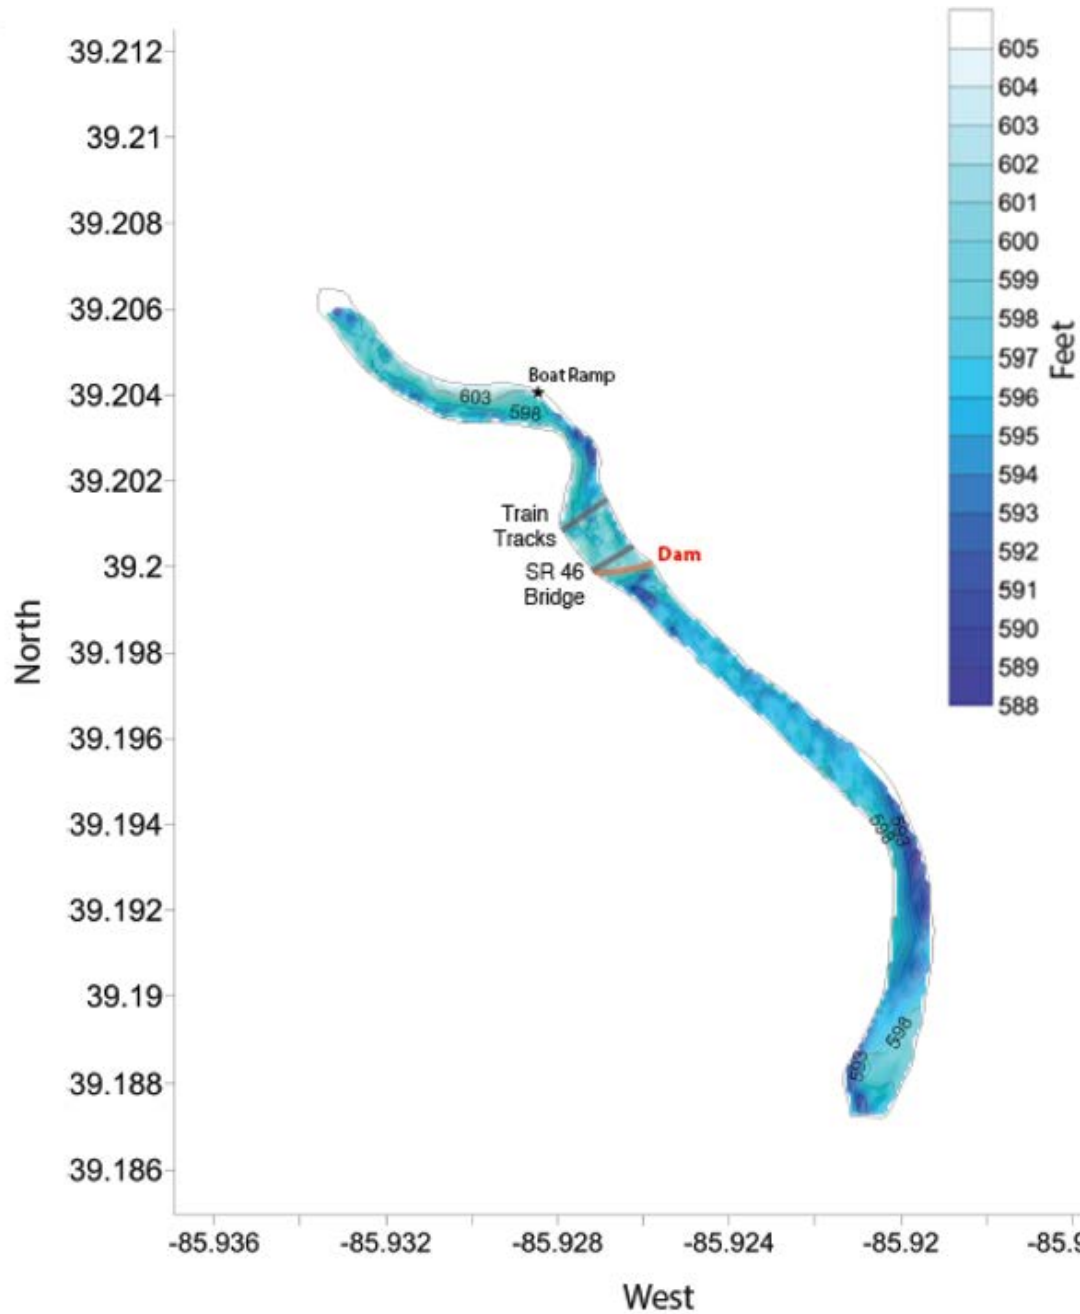
Figure 3: Bathymetric Map of the Study Area, East Fork White River at Columbus, IN. On this general map of the study area the dark blue of the pools stands out, as well as the scour near the right bank in front of the dam. The pools, together with the point bars indicate that sediment is being transported through the system. The light blue in between the bridges shows the sediment behind the dam. Figure 4 is a detail of this larger view.

A strong caution is given to consider the effect of the rubble in front of the railroad bridge on sediment transport. Field observations suggest that the rubble structure is acting as a grade control and altering sediment transport. The only deep portion of the channel is found in a break in the rubble (Figure 4).

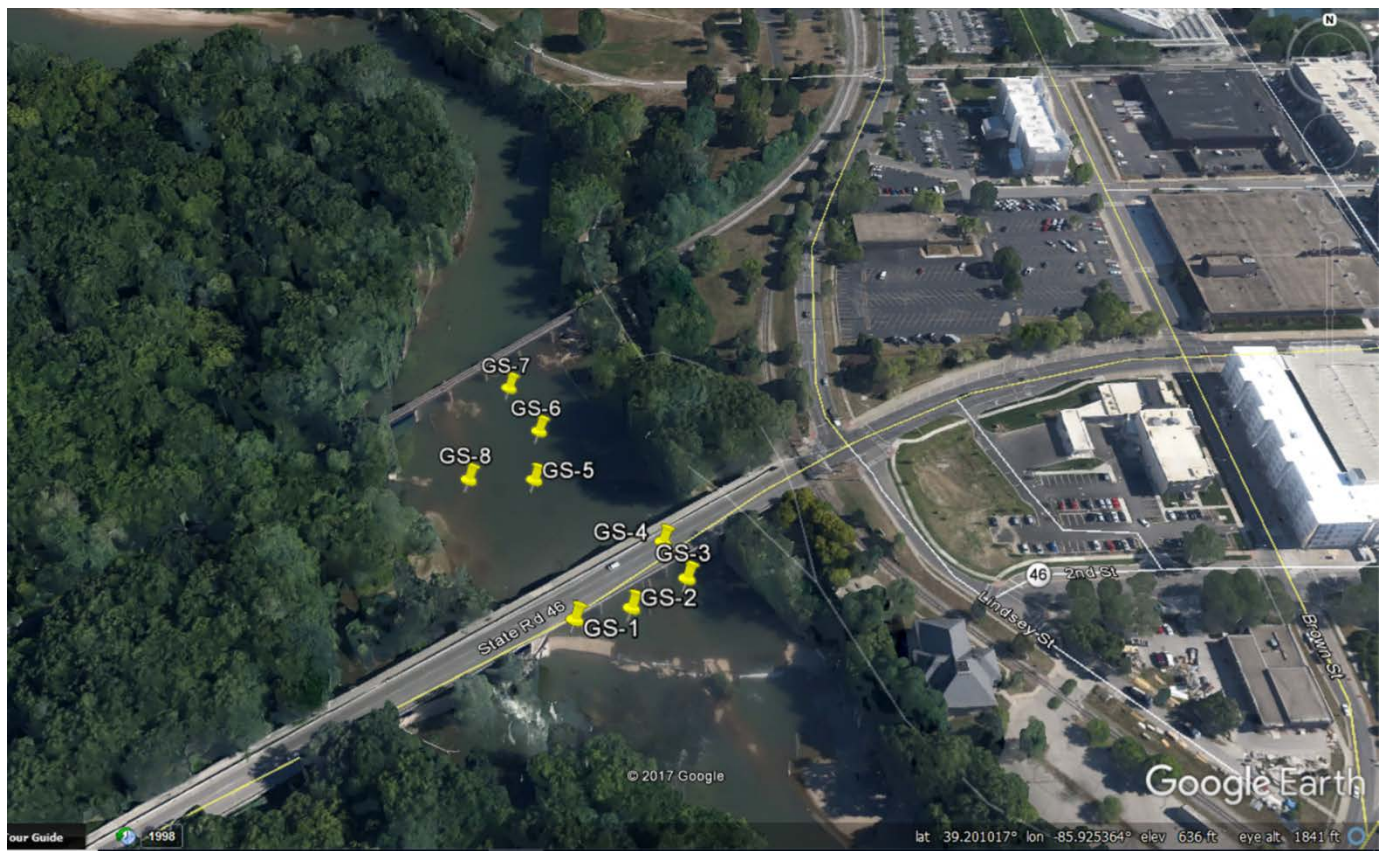
Figure 7: Sediment sampling locations upstream of the dam

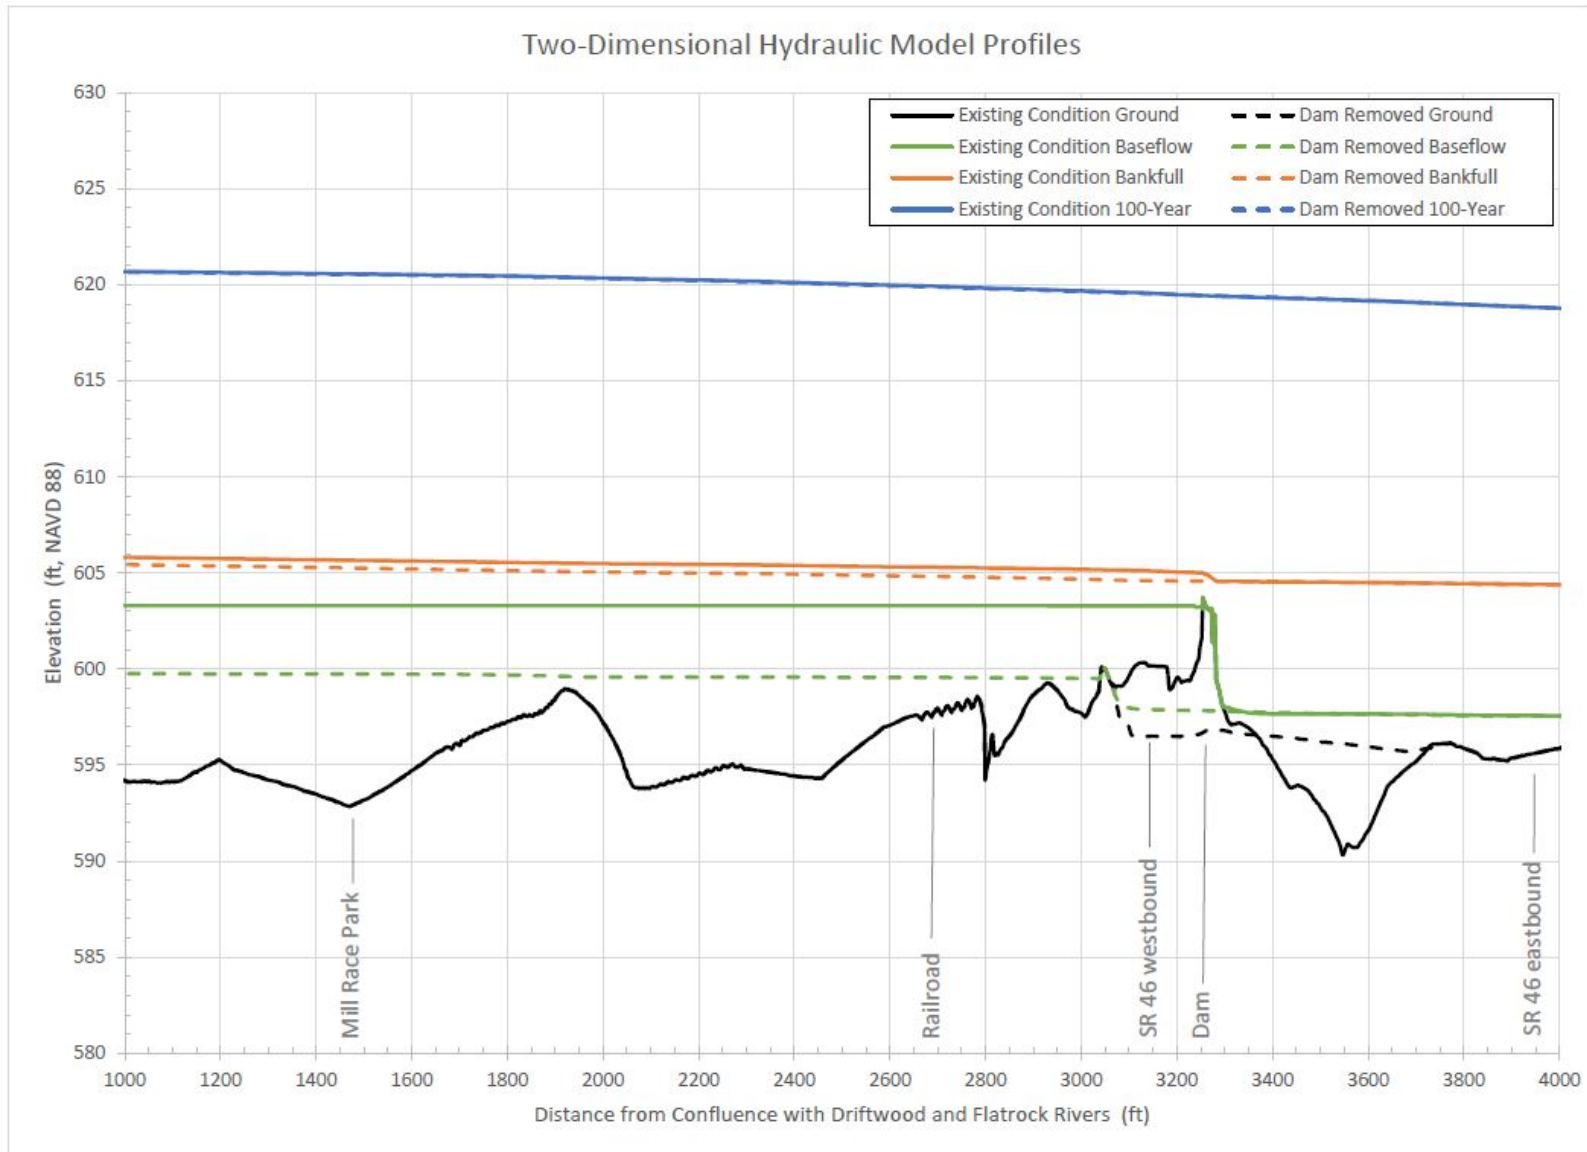
Figure 11: With and Without Dam Water Surface Profile Comparisons

If the dam is removed and no grade control structures are constructed to maintain current water levels, modification of the intake structure near Mill Race Park is likely necessary due to the lowered water surface elevation. The water surface is approximately 50 feet narrower on the north bank, as shown in Figure 12.

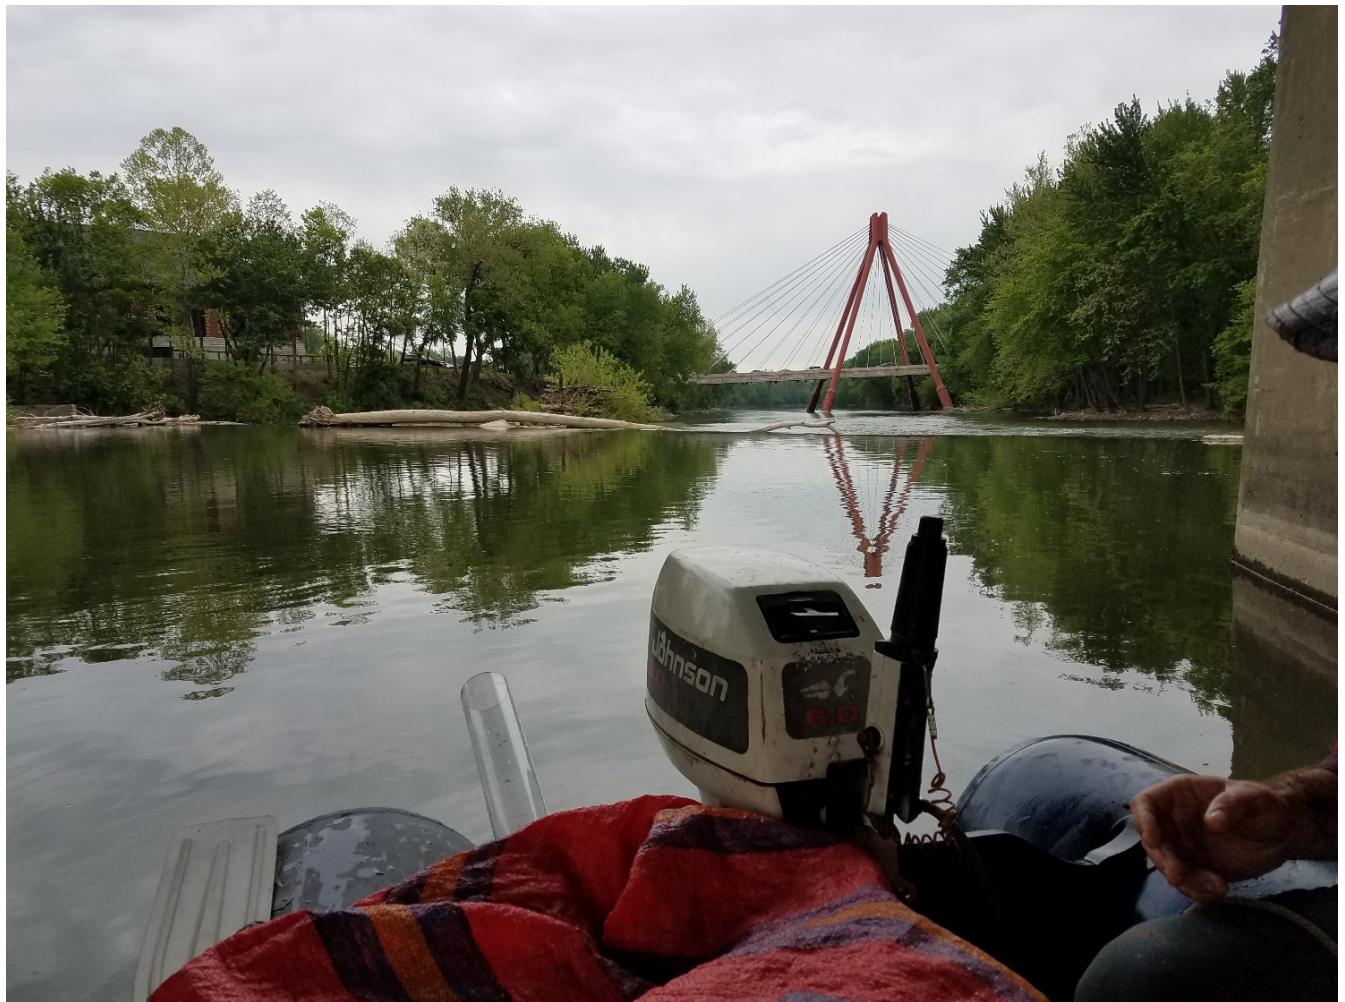
Figure 14: The project area as seen from under the west-bound lanes of 3rd Avenue Bridge. Stream flow is toward the Robert N. Stewart Bridge (red).

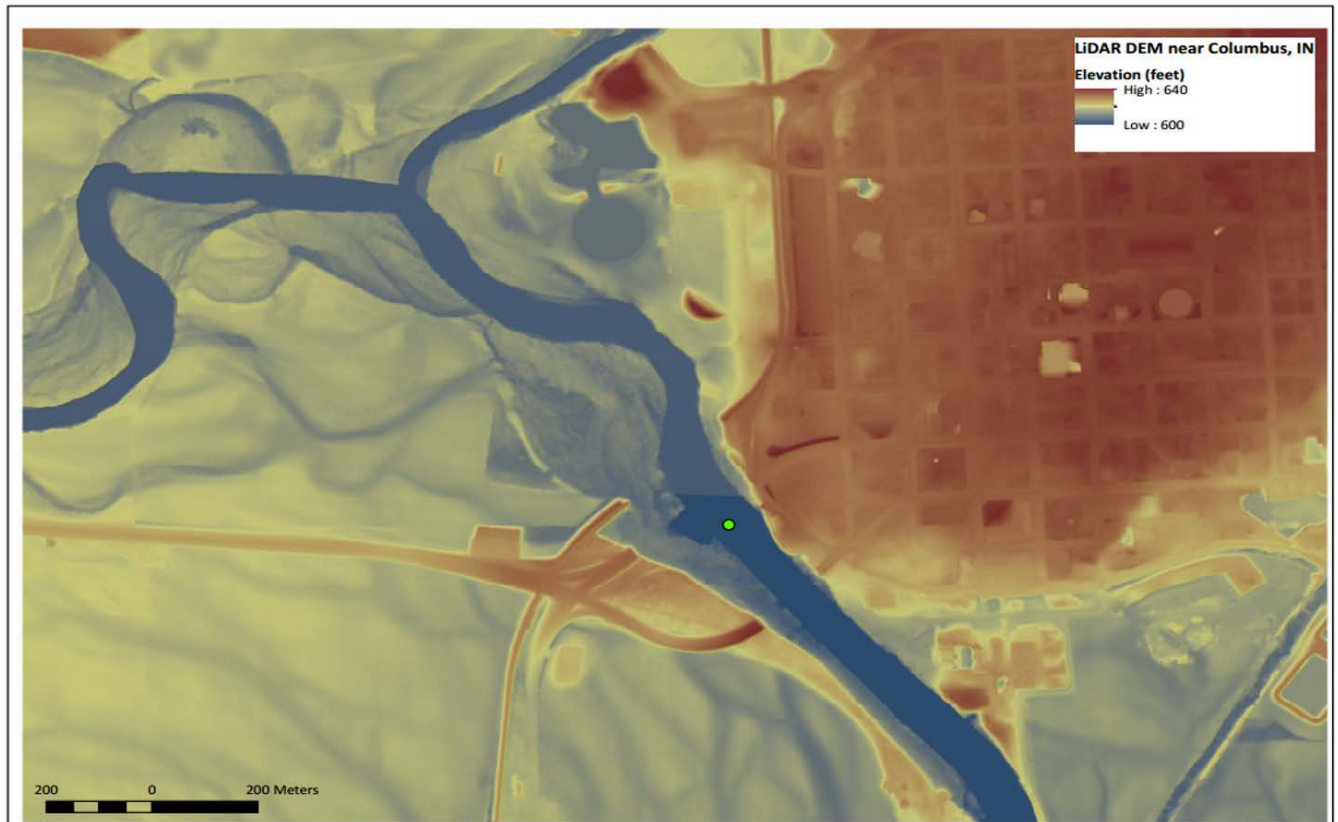
for flood waters (Figure 16). The setting is like the situation shown in Figure 13, but at the project area an even wider range of flows are pushed to the right bank. Figure 17 illustrates the lack of flood storage on the left bank side of the study area, the natural floodplain is all along the right bank, although floodplain access has been restricted by road bridges and non-levee embankments (NLE). Figure 17 also shows the effect of the low-head dam on channel width and depth.

Figure 17: LiDAR image of the East Fork White River at Columbus, IN 2011/2012 Indiana LiDAR, S. Letsinger, IGS

In Figure 17, stream flow is towards the bottom of the image, which means that the “left” bank of the river is on the right side of the image. The image is a false color depiction of topography and elevation, with reddish brown being the highest, and the darkest blue being the lowest elevation. The two sections of the SR 46 bridge are on the left side of the image and the old railroad bridge is seen just about them. The left bank is high and steep, as discussed earlier stream flow is being pushed to the right. Above the railroad bridge the broad floodplain formed at the confluence is easily seen, and it makes the constriction at the bridges even more obvious. The natural opening of the floodplain on the left bank downstream from the project area is also visible, although floodplain access has been lost by building non-levee embankments (NLE) structures along the bank and by filling on the floodplain. Floodplain access is also restricted on the downstream right bank by NLE structures (Figure 17). These structures are common throughout the Midwest and were often constructed to decrease the frequency of flooding on the floodplain to allow for more opportunities to plant the fields, or extract sand and gravel. What they have also done is increase the potential for bank erosion by containing higher flows and thereby increasing stress on the banks. In the project area, the modifications of channel width and depth by a combination of damming and filling are significant even at relatively minor flood levels, as can be seen in Figure 18. Immediately above the Haw Creek confluence, the geomorphic floodplain as defined by alluvial soil, is over 1-mile wide (WebSoil Survey), whereas there is less than 1000-feet of potential floodplain available in the project area. Figure 18 also shows that the EFWR will use its floodplain where it can.

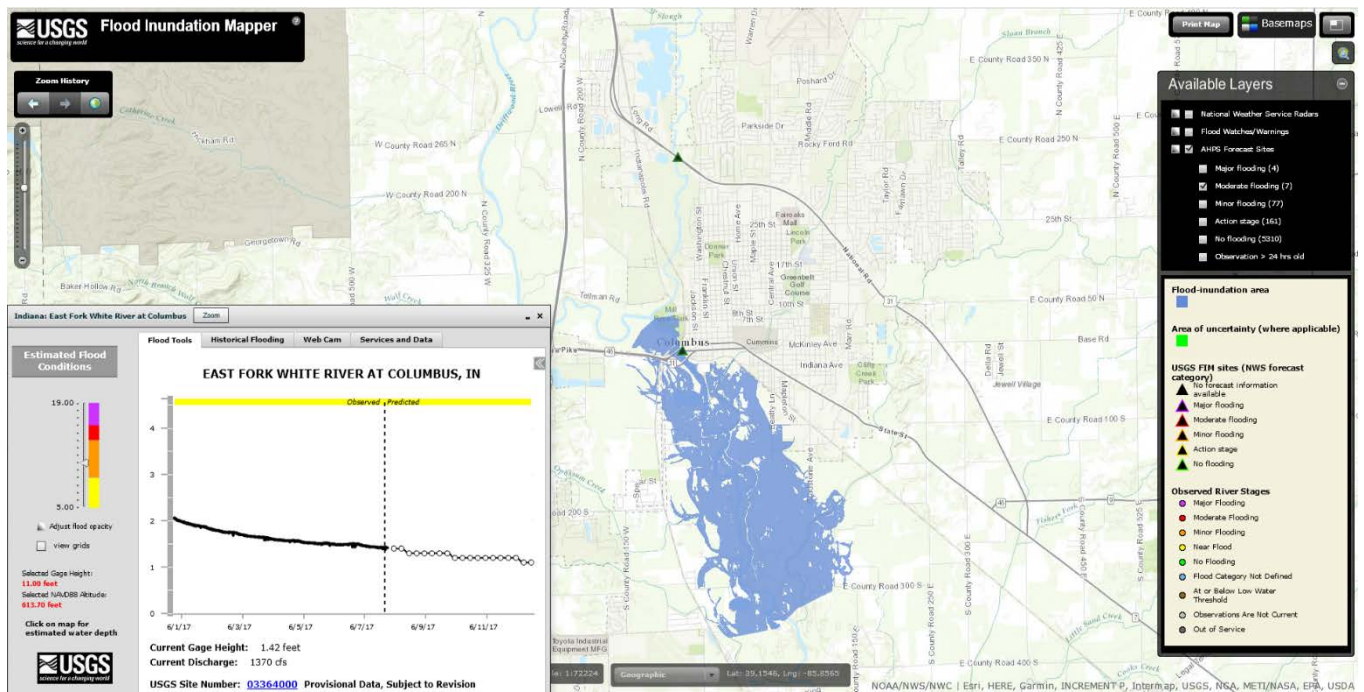
Figure 18: Depiction of minor stage (11-feet) flooding, East Fork White River at Columbus, Indiana. Note the long white non-inundated section of channel in the project area, located to the left of the green triangle. The green triangle marks the location of USGS gage 03364000 East Fork White River at Columbus, IN. The stream gage is located on the left bank by the dam.

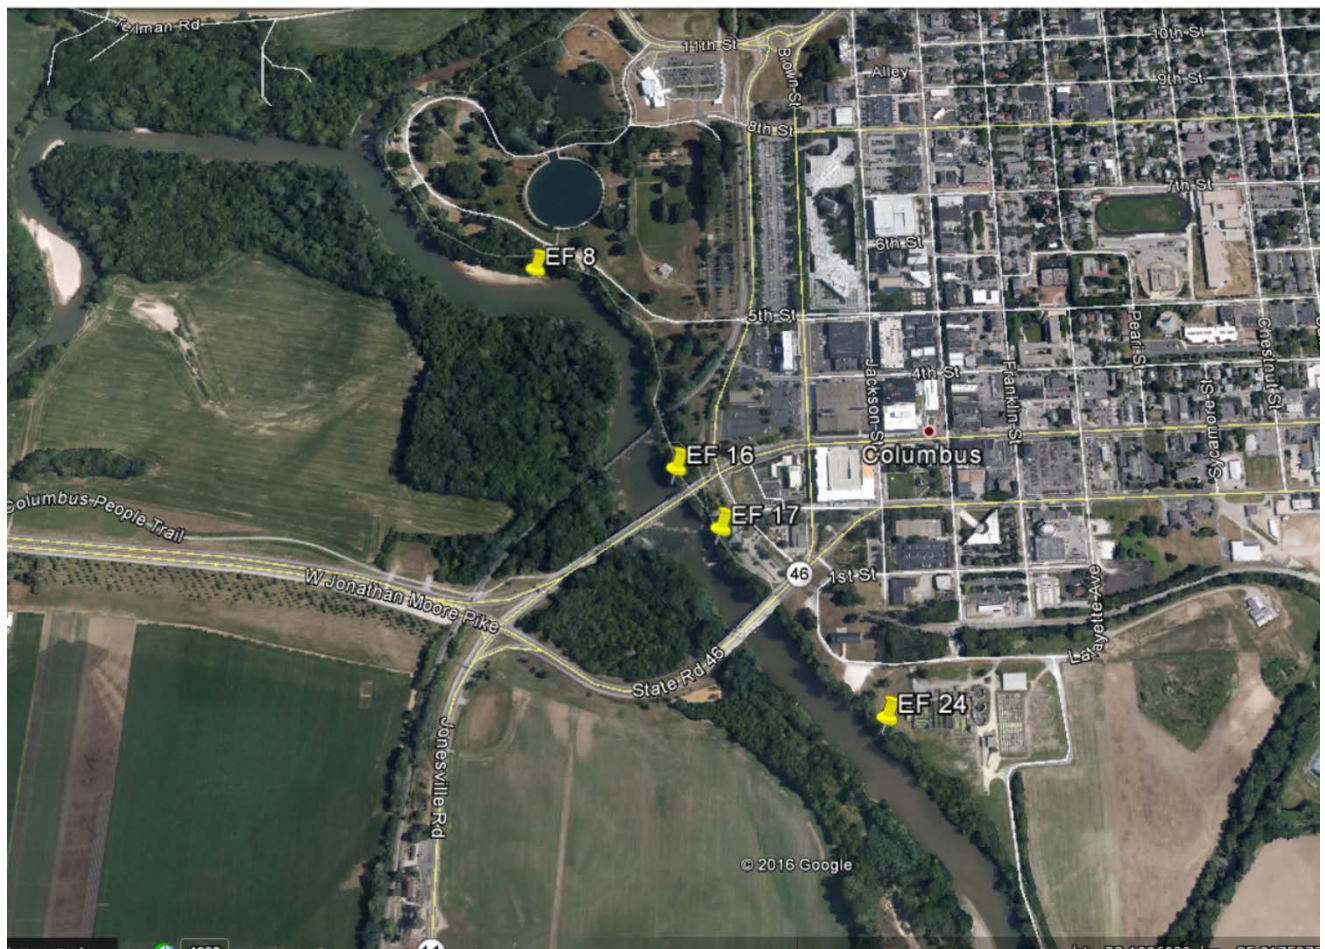
As discussed in the description of the study area in the Introduction Section, the EFWR just below the dam should have a bankfull width of 228 feet, and an average bankfull depth of 7.42 feet. Cross-sections through the study area show wide variability. Figure 19 shows the locations of four cross-sections that were selected to show the variability in channel width, depth and cross-sectional area in the study area. The cross-sections also allow for consideration of bank material, or boundary conditions in the channel. The descriptions and images of boundary conditions at a station, will then be used to describe channel bank conditions throughout the study area. Please note that these cross-sections are shown at an arbitrary site specific datum, and are not linked to the site survey.

Figure 19: Location of representative cross sections, East Fork White River at Columbus, Indiana (Image: Google Earth, 2016).

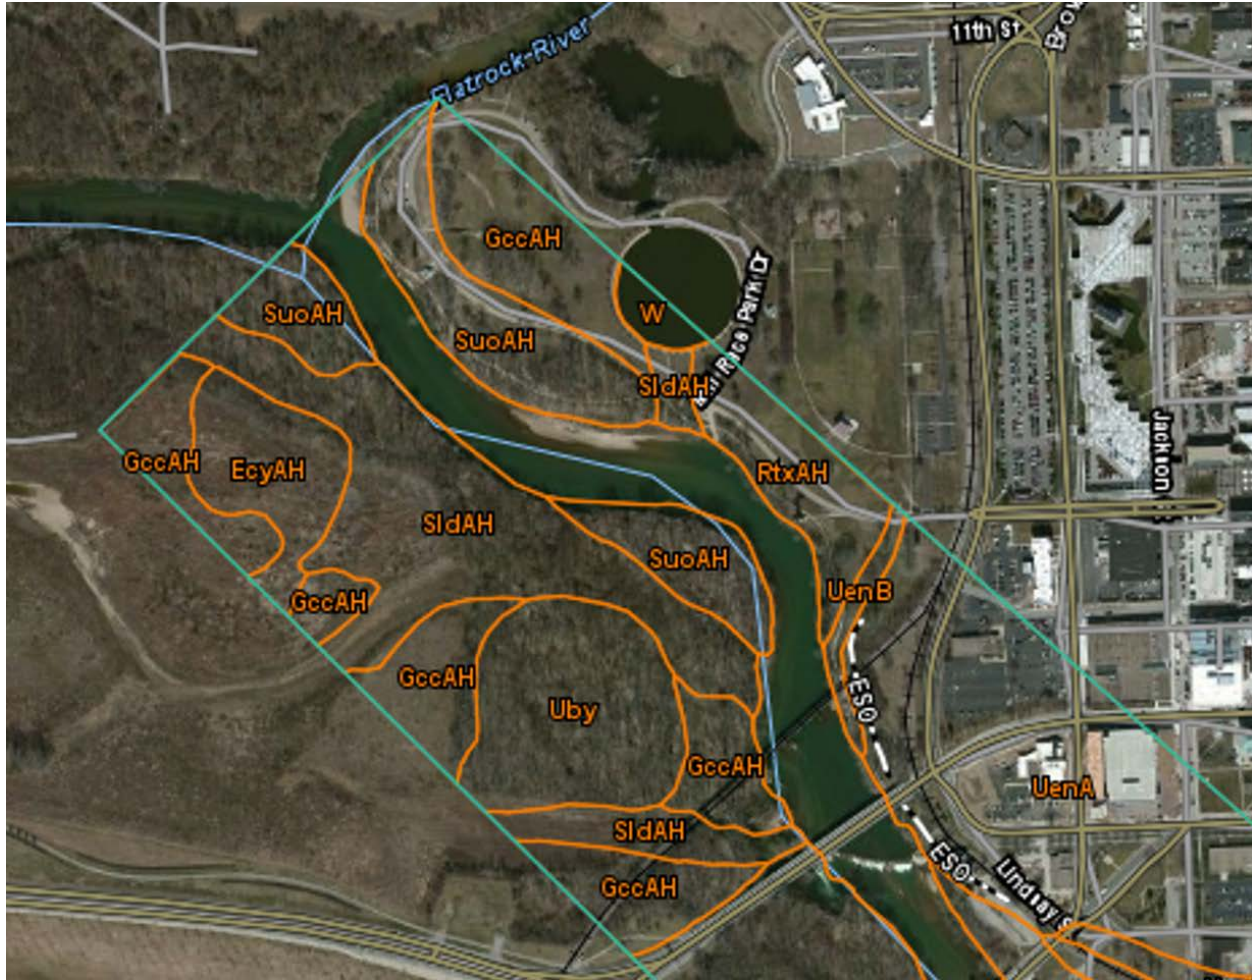
Figure 23: Soil associations upstream of the project area. Note that the soils on the left bank moving downstream are primarily SuoAH (Stonelick), and then RtxAH (Rossburg silt loam).

Soils on the right bank moving downstream are SuoAH, SidAH, and SuoAH, and then a small area of GccAH0

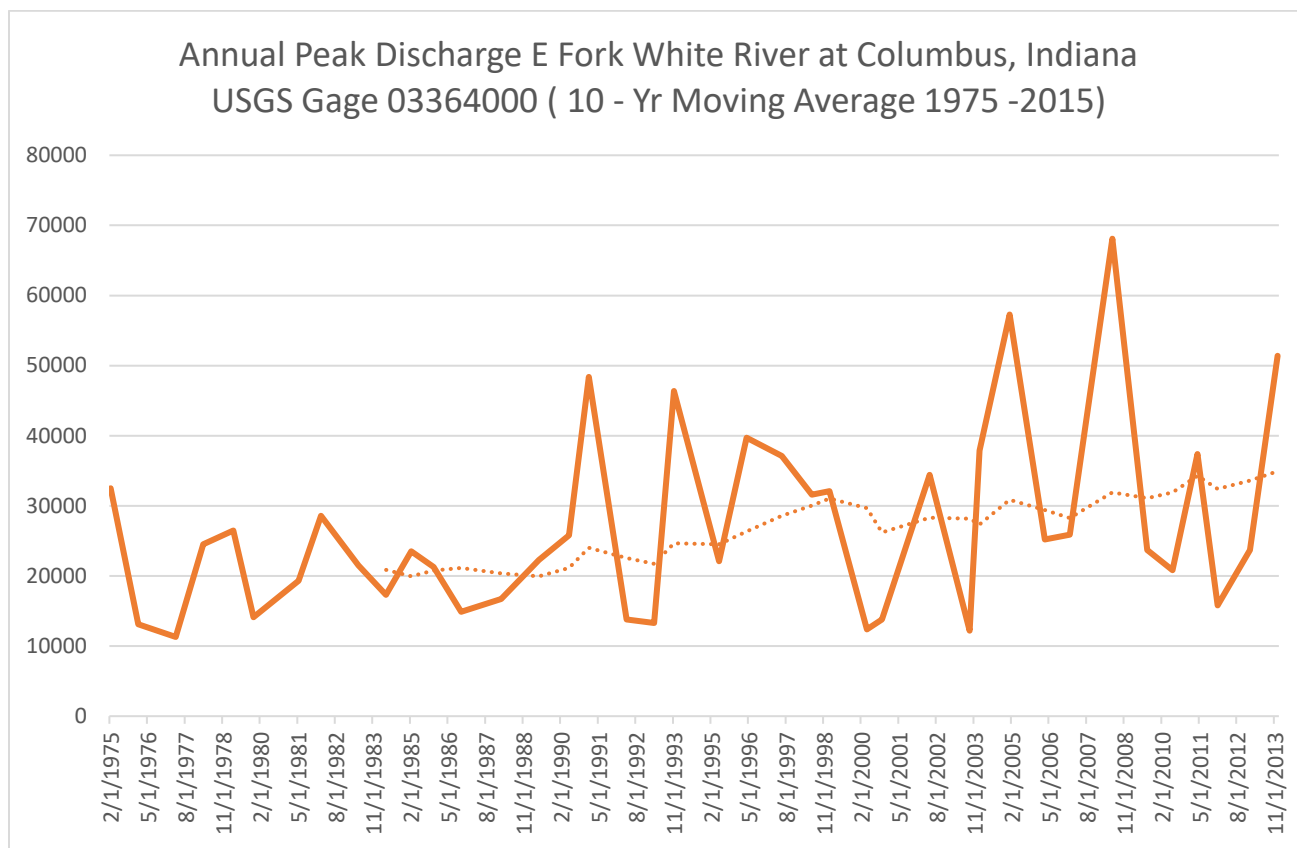
Figure 37: Annual peak discharge, East Fork White River at Columbus, Indiana. U.S.G.S. Gage 0336000. Note the dashed moving average shift in the 1990s.

A final factor to consider when thinking about the effects of removing the dam, is the continuing increase in the frequency of bankfull discharge events and increased peak discharges. A naturally functioning river is remarkably resilient to a wide range of flows. Human modification of channel and floodplain width, changes in channel depth, and even needed infrastructure like bridges, make it harder for a river to adjust to changing conditions. Removing the dam can only help the EFWR as it continues to adjust. One thing that was clear during this investigation was that the Driftwood, Flatrock, and East Fork White River are all showing signs of systemic change and adjustments. The banks on all three rivers are unstable in some areas, particularly in reaches without accessible floodplains. This indicates that the floodplains are functioning as “shock absorbers” to the increasing peak discharges, and highlights the need to preserve remaining floodplains
