**LOW HAZARD IN-CHANNEL DAM VISUAL INSPECTION REPORT**  
(Primarily non-embankment structures)

DAM NAME: East Fork White River Dam DATE: 2/3/2012 ID# 3-13

# LOW HAZARD IN-CHANNEL DAM VISUAL INSPECTION REPORT

# East Fork White River (In-Channel) Dam

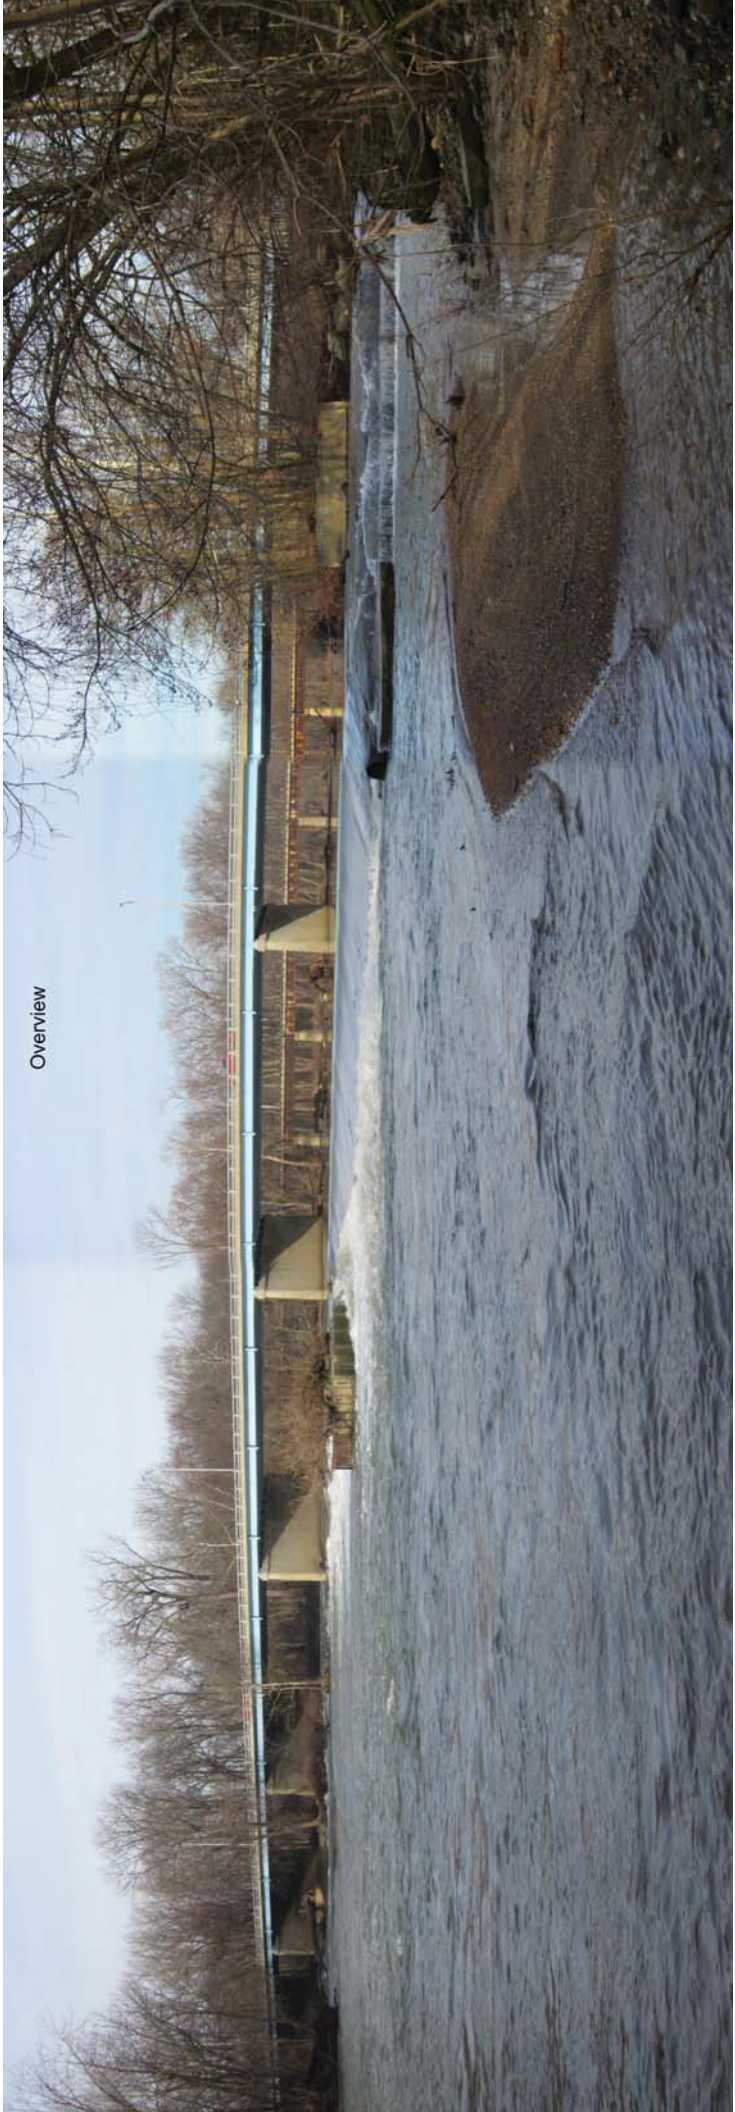
Left End  
(Concrete damaged)

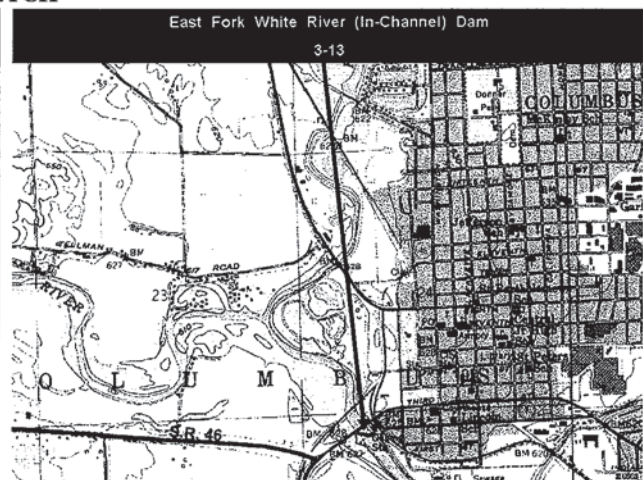
#### SKETCH

CONDITION OF OVERFLOW SECTION POOR CONDITION - 3 AREAS ALONG DAM  
SEEPAGE OBSERVED GOING THROUGH CRACKS OR BOILING UP  
BENEATH DAM. (BASKETBALL SIZE)

CONDITION OF ABUTMENTS: POOR CONDITION - LEFT (EAST) END HAS  
CONSIDERABLE FLOW EXITING UNDER DAM NEAR CMP  
OUTFALL. THERE WAS NO FLOW OVER CONCRETE DUE TO DRY SPELL.

OVERALL  
CONDITION: POOR - SIGNIFICANT UNDERMINING

- ☐ CLEAR DEBRIS OFF OF STRUCTURE
- ☐ REPAIR
- ☐ HIRE A PROFESSIONAL ENGINEER TO DEVELOP RECONSTRUCTION PLANS
- ☒ OTHER IF DAM NO LONGER SERVES A USEFUL PURPOSE IT SHOULD BE BREACHED & REMOVED FROM CHANNEL. THIS WOULD ELIMINATE DROWNING HAZARD INHERENT TO THIS TYPE OF DAM.

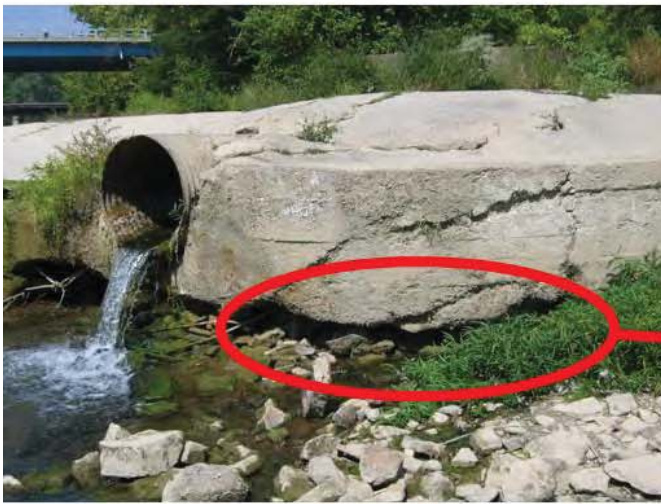
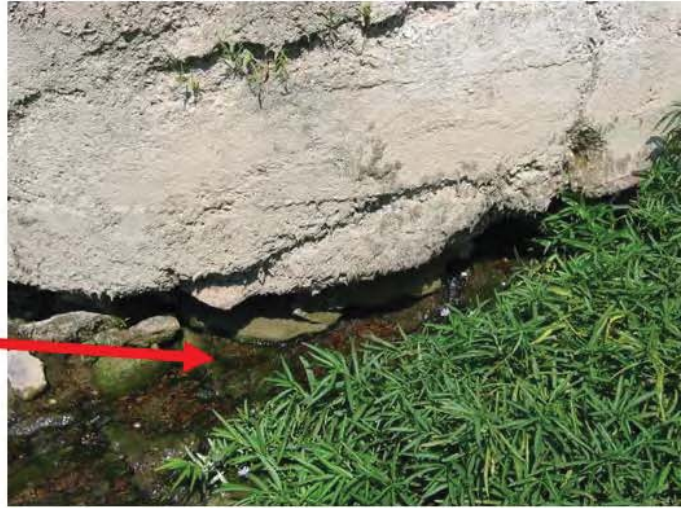
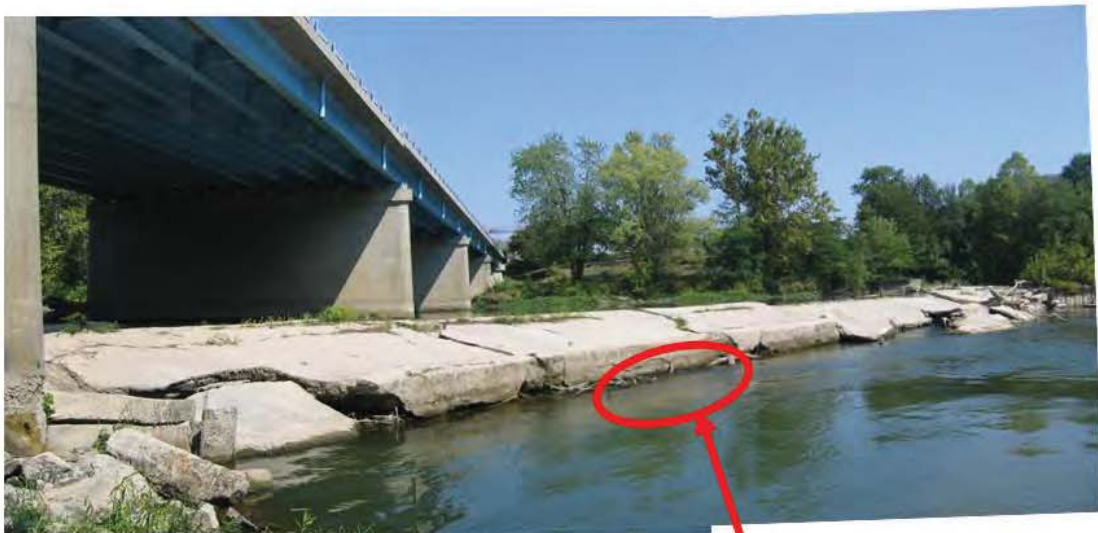
Area of 5  
basketball sized  
boils. Boils start  
about 55' left  
(east) of bridge  
pier & continue  
an additional 17'.
